BMPRO MOTOR FUNCTION WIRING

Bulletin Type:	TSB	Publication Date:	October 2022
Bulletin #(s):	22-079	Make(s):	Jayco
Job Code(s):	9801573	Model(s):	Eagle HT TT
Flat Rate(s):	9801573 – .25 Repair	Model Year(s):	2023

Incident:	Exterior Travel lockout switch does not disengage motor functions (jacks, awnings, slideouts, etc.)
Affected Units:	2023 Jayco Eagle HT TT
Parts List:	Parts Kit #: N/A
Misc. Tools & Supplies:	Square Driver, Screw gun, wire strippers, 3 way wago, 14 gauge stranded wire (Shop Supplies)
Parts Return Information:	N/A

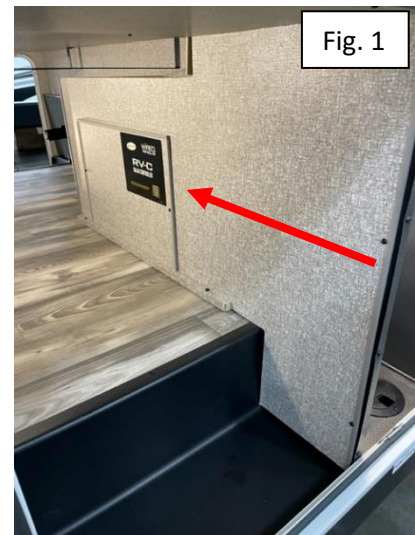
Fig. 1

1. Locate the BMPro access cover located in the Off Door Side pass through storage and remove the two screws using a #2 square bit and a screw gun. Save screws for reinstall.

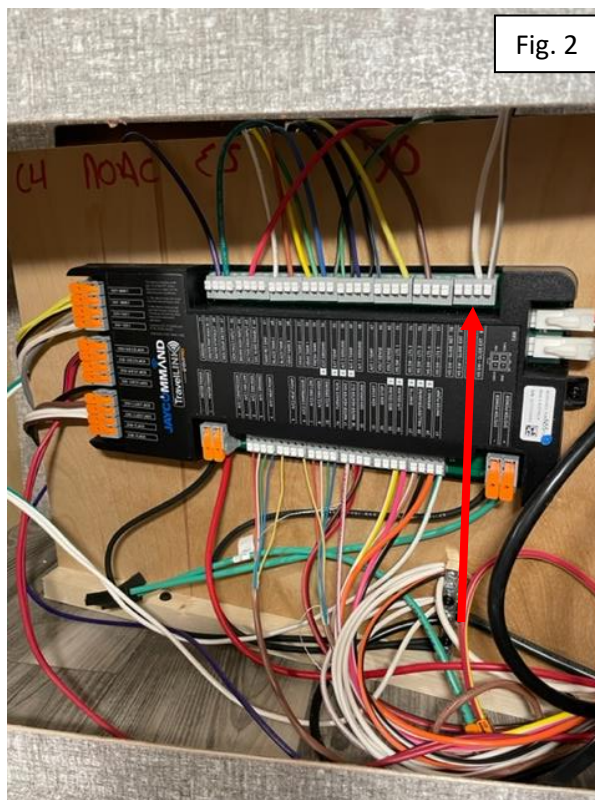
Fig. 2

2. Remove the white wire in the #80 slot on the BMPro. (Figure 2)
3. Using (2) 6" pieces of 14 gauge stranded wire, depress the white tabs on the BMPro and insert one into slot #62 and then one into slot #80. Using a 3-way wago, connect the original wire to the two jumpers. (Figure 3)
4. To test the fix, plug the pigtail into a testing box or vehicle and activate the 4-way flashers. While flashing, motor functions should not be functional. Turn the 4-way flashers off. Hit the "retract" button on the front landing legs. (Figure 4) All motor functions should be operable once again.
 - a. Note: This only applies to Eagle HT travel trailers that are equipped with the electric jack option. This does not affect trailers with auto leveling.
