## STAR ONLINE PUBLICATION

**Case Number:** S2208000010

**Symptom/Vehicle Issue:** CEL Check Engine Lamp On, Start Stop Inoperative

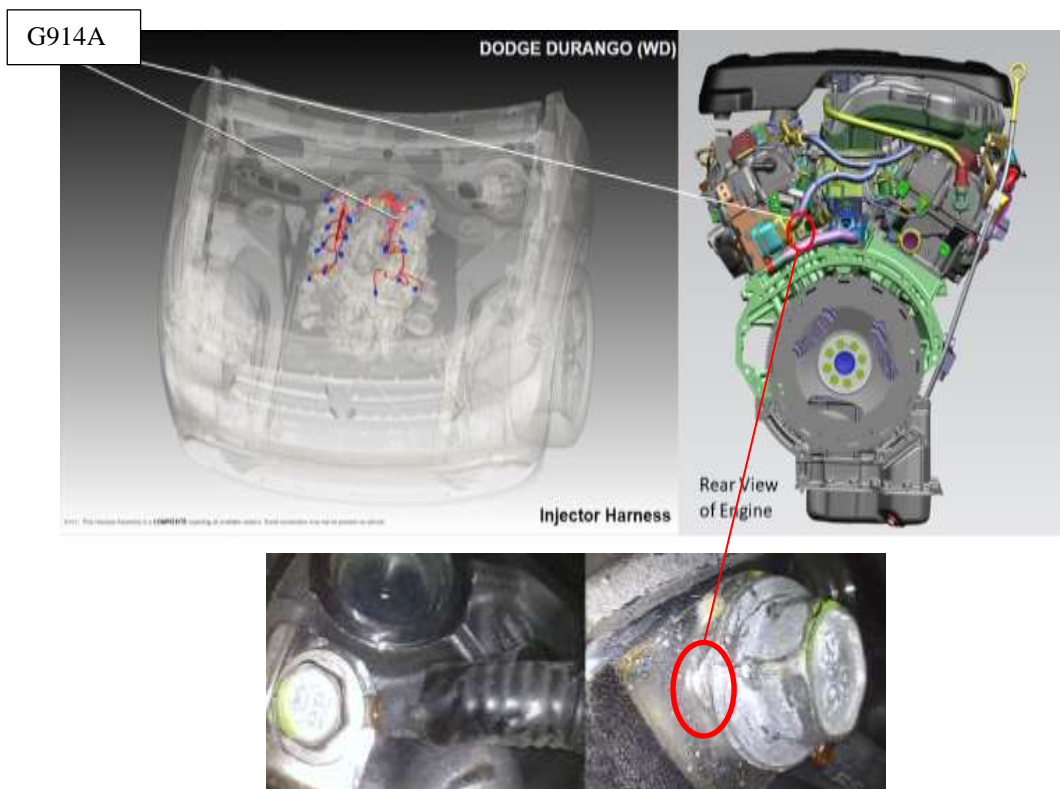
**Customer Complaint/Technician Observation:** Owner complaint Check engine lamp is on. Technician observed the vehicle is setting P1056 Intake Valve Control Solenoid 3 Circuit/Open, P1059 Intake Valve Control Solenoid 4 Circuit/Open, P0023 Bank 2 Camshaft 2 Position Actuator Circuit Open, P0020 Bank 2 Camshaft 1 Position Actuator Circuit Open as stored or active. All associated DTC's have this as a common ground as a possible cause.

**Repair Procedure:** Inspect ground location G914A, clean and secure. No parts required.
