Bulletin No.: PIT5951
Published date: 09/28/2022

PIT5951 Ink On Body Panels After Removing Protective Wrap

Brand:	Model:	Model Years:	VIN:		Engine:	Transmissions:
			from	to		
Buick	Envision	2022	All	All	All	All

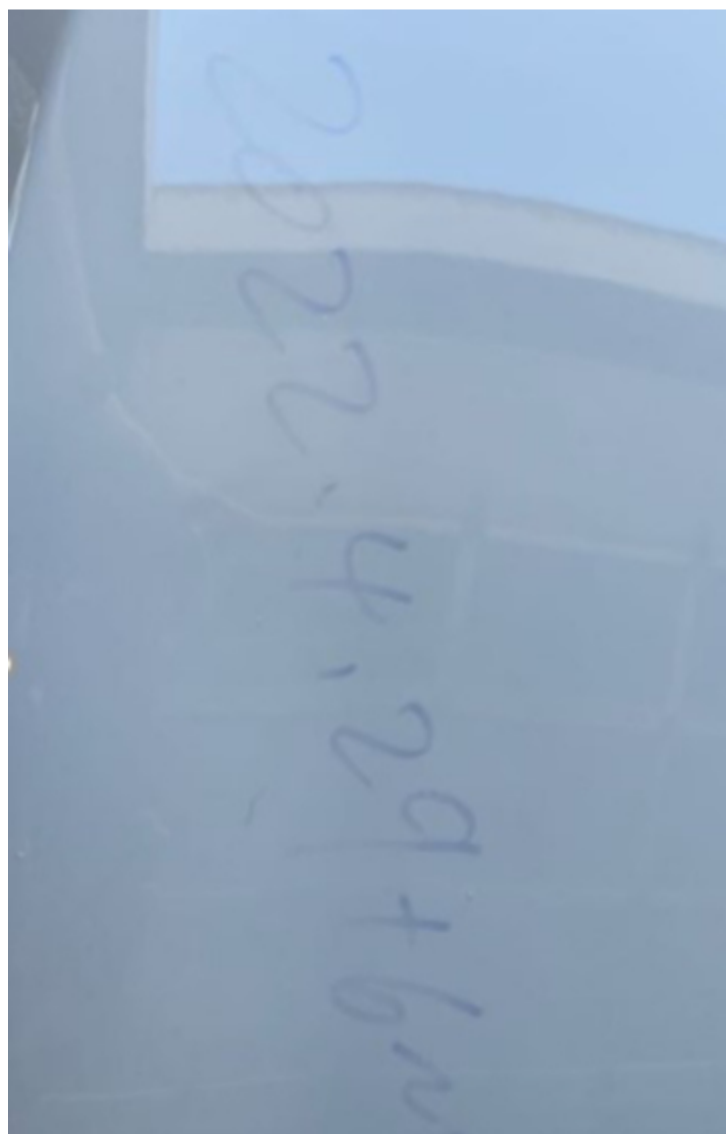
Involved Region or Country	North America
Condition	Some customers may comment that the writing on the plastic hood wrap has bled through into the paint.
Cause	The plant used the wrong type of marker for this operation.

Example of ink transfer from protective wrap

Clean the marker from the hood with Acrysol or equivalent , multiple applications may be needed to remove all the ink.
