Technical Service Bulletin

44 Repair Authorization - Q5 MY 23 Suspension Alignment

44 22 96 2066483/4 October 19, 2022. Supersedes Technical Service Bulletin Group 44 number 22-95 dated June 6, 2022 for reasons listed below.

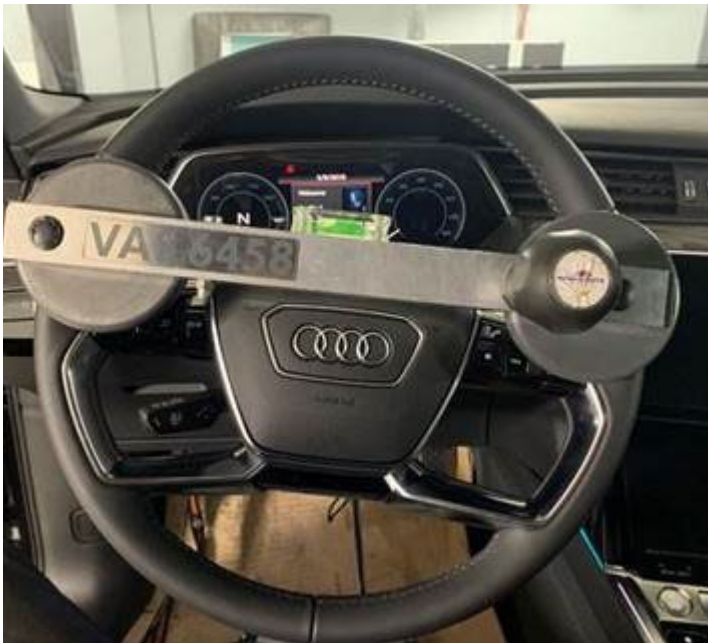
Figure 1. VAS 6458 installed with steering wheel off-center.

7. Install VAS 6458 (Steering wheel scale), and set the steering column all the way up and as far as possible from the dash panel. With the wheels straight take a clear picture in front of the steering wheel (Figure1).
