**Technical Service Bulletin, TSB #22-01**

Subject: Truma Combi Eco Plus pressure relief/drain valve

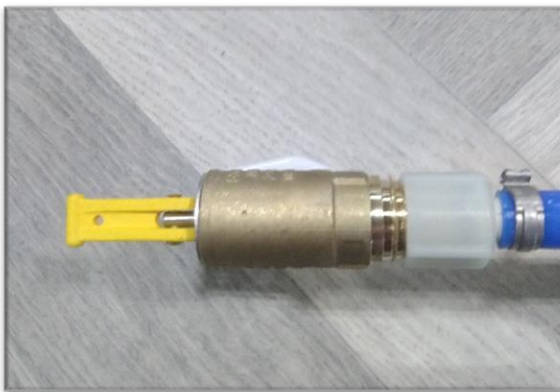
*Figure 1: Truma Pressure Relief Valve*

1. This TSB applies to all Ember units installed with a Truma Combi Eco Plus (Truma Combi).
2. Per manufacturer instructions, Ember ships all units to the dealer with the Truma Combi pressure relief/drain valve open.
  - This valve must be closed prior to operating the Truma Combi.
  - Failure to do this will result in water draining immediately beneath the front of the coach.

3. Location of the pressure release/drain valve:

| 17' and 19' Overland Series - configuration 1 | In the partitioned area beneath the front bed or murphy couch. Remove the wooden panel to access. |

| 17', 19', and Tandem Axle Overland Series - configuration 2 | In the storage area beneath the front bed or murphy couch. Accessible through a cut out in the bulkhead panel. |
| Tandem Axle Overland Series | In the partitioned area beneath the front bed or murphy couch. Remove the wooden panel to access. |
| ROK/ROL | In the partitioned area beneath the futon sofa |

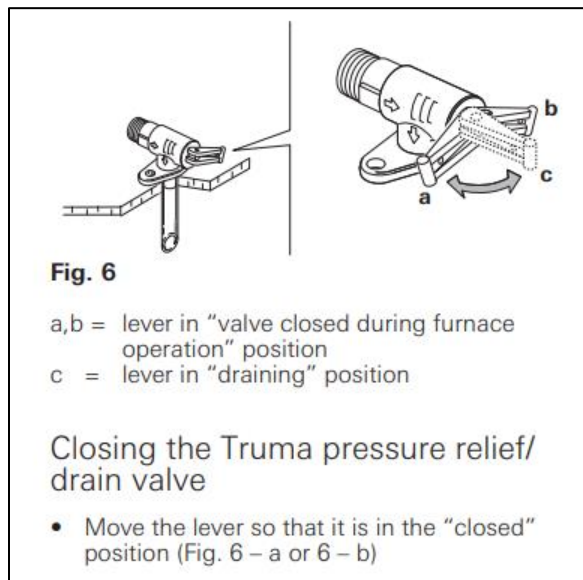
*Excerpt from the Truma Combi Eco-Plus Operators Manual*

- Please review the manufacturer's operating manual for important safety information before proceeding.
- This valve is to be placed in the closed position prior to operation of the unit's water system.
