Service Bulletin

Bulletin No.: 22-NA-198

Subject: Information on Dimpling of Front Fascia Due to Incorrect Front Splitter Fasteners Installed at PDI

Brand:	Model:	Model Year:		VIN:		Engine:	Transmission:
		from	to	from	to		
Chevrolet	Corvette Z06	2023	2023	—	—	—	—

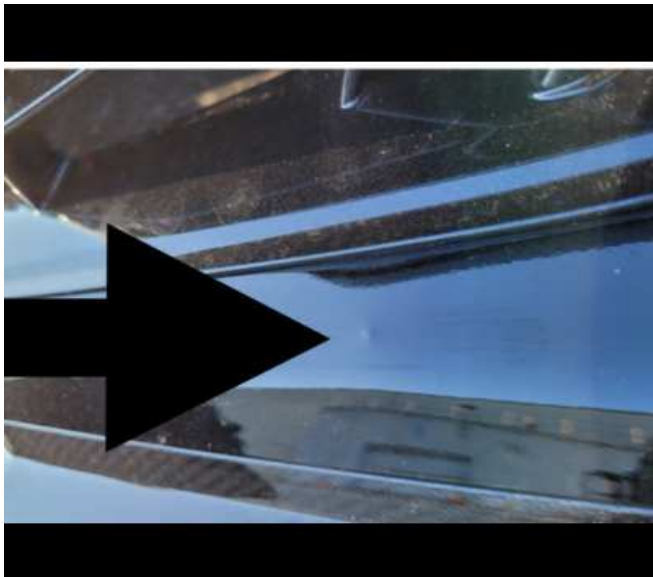
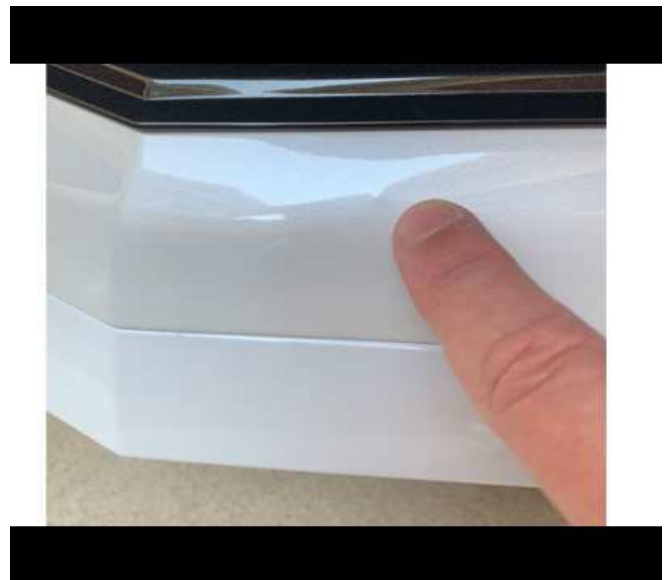
During the installation of the front splitter kit, it is important to install using the correct fasteners.

There are four long fasteners included in the front splitter kit. They should **NOT** be used due to the longer fasteners possibly creating a dimple on the front fascia.

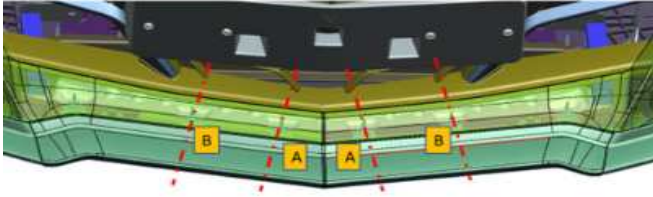
6163500

Fasteners A and B — Should use part number 11547755

Important: There will be 4 extra bolts of Part Number 11589012 in the original hardware kit after performing installation. These bolts can be discarded.
