STAR ONLINE PUBLICATION

Case Number: S2208000151

Symptom/Vehicle Issue: Check Engine Lamp (CEL) On, Diagnostic Trouble Code (DTC) U11E9 Lost Communication with Active Grill Shutter (AGS)

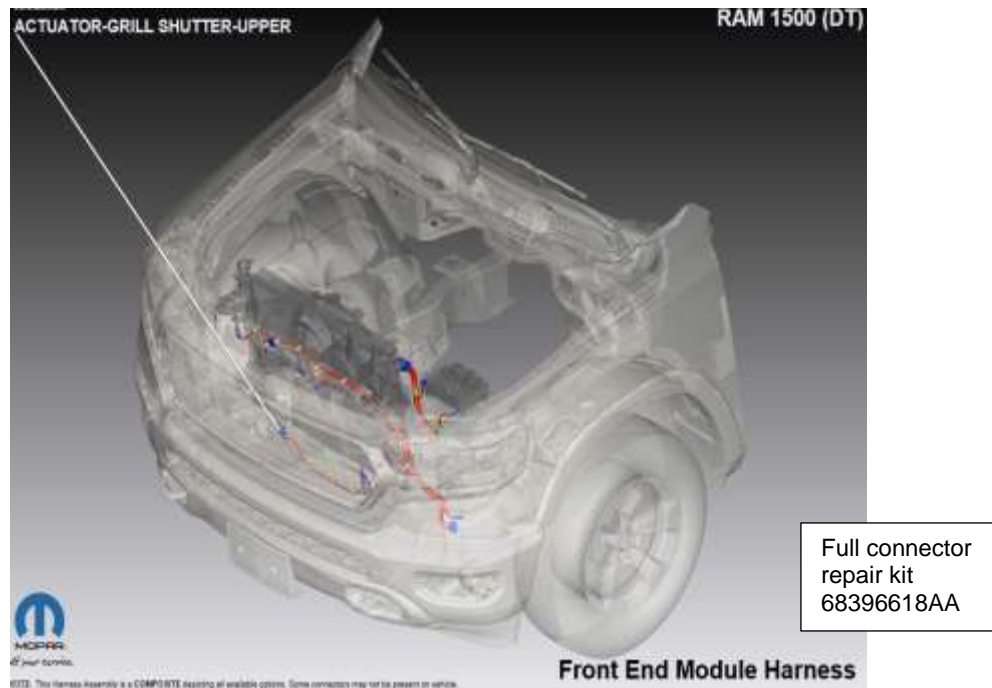
Customer Complaint/Technician Observation: Owner complaint that the CEL is illuminated on the cluster. Technician observed the vehicle is setting Diagnostic Trouble Code (DTC) U11E9 Lost Communication AGS as active, stored, or pending.

Repair Procedure: Inspect the upper AGS connector D2826A, black 4-way, ensure the connector is clean and fully engaged. Review the inline connector XY110A black 16-way and inspect for any signs of corrosion, repair as required Fig 1 and 2.

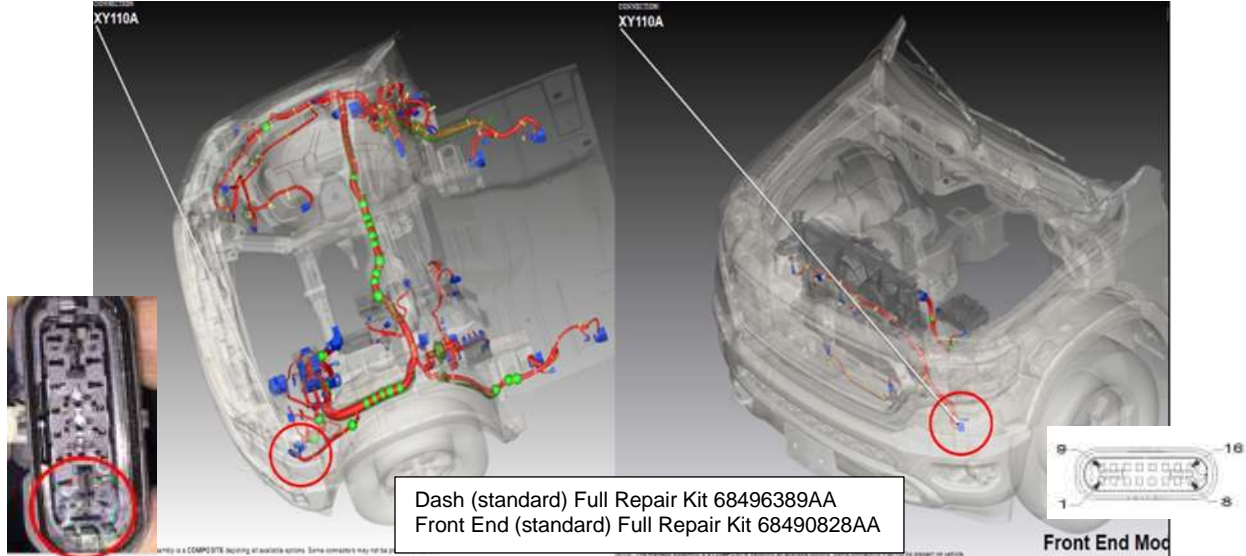
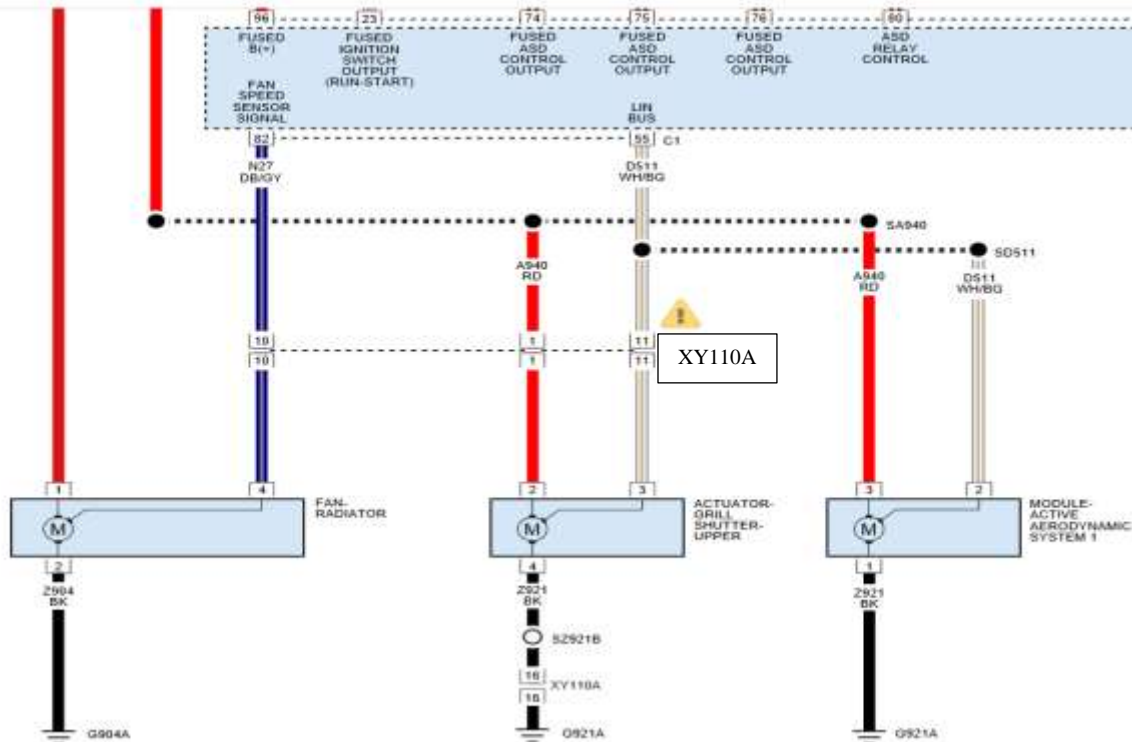
Fig 2

Wiring Diagram - COOLING SYSTEM - 5.7L
