Technical Service Bulletin

91 MIB2+ High: sporadically or permanently no sound from all sources

91 22 36 2060464/4 October 11, 2022. Supersedes Technical Service Bulletin Group 91 number 22-05 dated June 6, 2022, for reasons listed below.

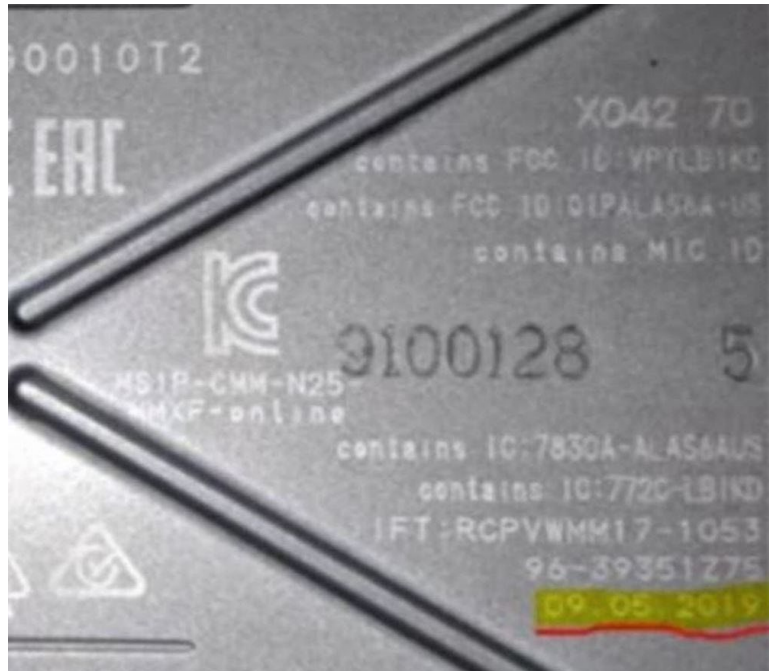
1. Check the production date of information electronics control module 1, J794 (address word 005F) on the housing of the control module. The production date is printed on the bottom right (Figure 1).

Tip: The date on the J794 is in DD.MM.YYYY format.

Figure 1. Production date, located on the right side.

If the date is between 03/16/2019 and 05/22/2019, then replace the control module.

2. If the production date is between 05/22/2019 and 02/27/2020, please contact TAC.
3. If the production date is after 02/28/2020, this TSB is not applicable. Continue diagnosis for the root cause of the concern.
4. For warranty claims, please attach a photo of the label with the production date information for the electronics control module 1, J794 (address word 005F) to the claim.
Please take photos and upload them into DOC-IT with the repair order. Photos should:
 - Have a date stamp and VIN reference.
 - Be taken in focus and with sufficient light.
