# Special Bulletin

# SP22-308A

## CHANGE ORDER NO.7 - ABLE Provision. Video Plate Installation

Prevost vehicles

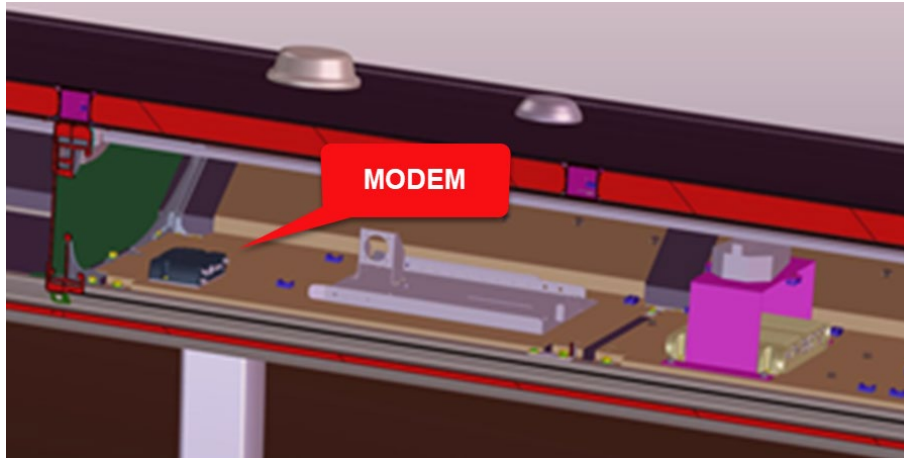
Before

3. Relocate the modem as shown.
