# ***SERVICE PROCEDURE***

22513

**SUBJECT: SAFETY RECALL**  
**Steering Gear on certain 2022 and 2023 IC Bus<sup>®</sup> CE, FE Chassis, SFC and TC commercial buses, International<sup>®</sup> WorkStar<sup>®</sup> and Prostar<sup>®</sup> model trucks and HV<sup>™</sup>, HX<sup>®</sup>, LT<sup>®</sup>, MV<sup>™</sup>, RH<sup>™</sup>, and Lonestar<sup>®</sup> series trucks built 06/01/2021 through 06/07/2022 built with R. H. Sheppard HD94E, M100P, M110P, HD94P, XD120P, MD83P, SD110P, M83P, M90P, or M80P model steering gears**

## **DEFECT DESCRIPTION**

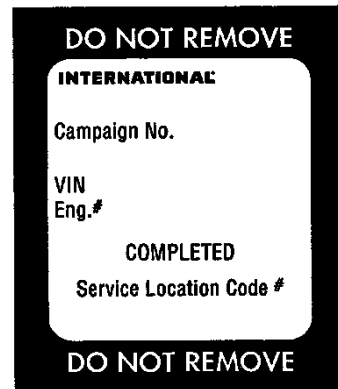
Each vehicle corrected in accordance with this campaign must be marked with a CTS-1075 Campaign Identification Label.

Complete the label and attach on a clean surface next to the vehicle identification number (VIN) plate.
