## Thor Motor Coach Technical Service Bulletin

| TSB # | <b>TSB 22-13</b> | | |
| Description/Title: | 2022 Omni & Magnitude with Firefly software(v7.25 or later) | | |
| Affected Product Line(s): | Certain model year<br>2022 Omni & Magnitude | | |

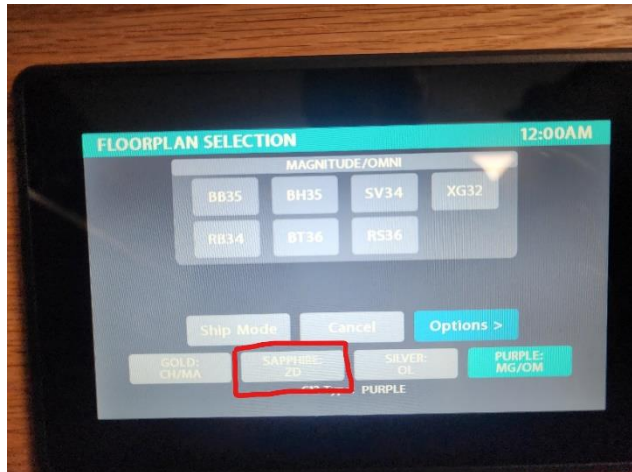
FIG 1

I/C controls may appear on the touchscreen's electrical page—they will not control anything.

1. Press and hold the floorplan button.
2. Go to floorplan settings/options page
3. Select "Sapphire" in the bottom row of buttons (Fig 1, circled in red)
4. On this page, you will see "Inverter Brand" selection which lists both a "MAGNUM" and "XANTREX" selection (Fig 2, circled in red).
  - a. If either button is blue (indicating selected), that is the cause of I/C controls appearing on the screen.
5. Both of those buttons must be deselected, just like the Red circled area in Fig 2 shows below.
