Bulletin No.: PIT5855F
Published date: 10/26/2022

PIT5855F Heated and Ventilated Seats Inoperative

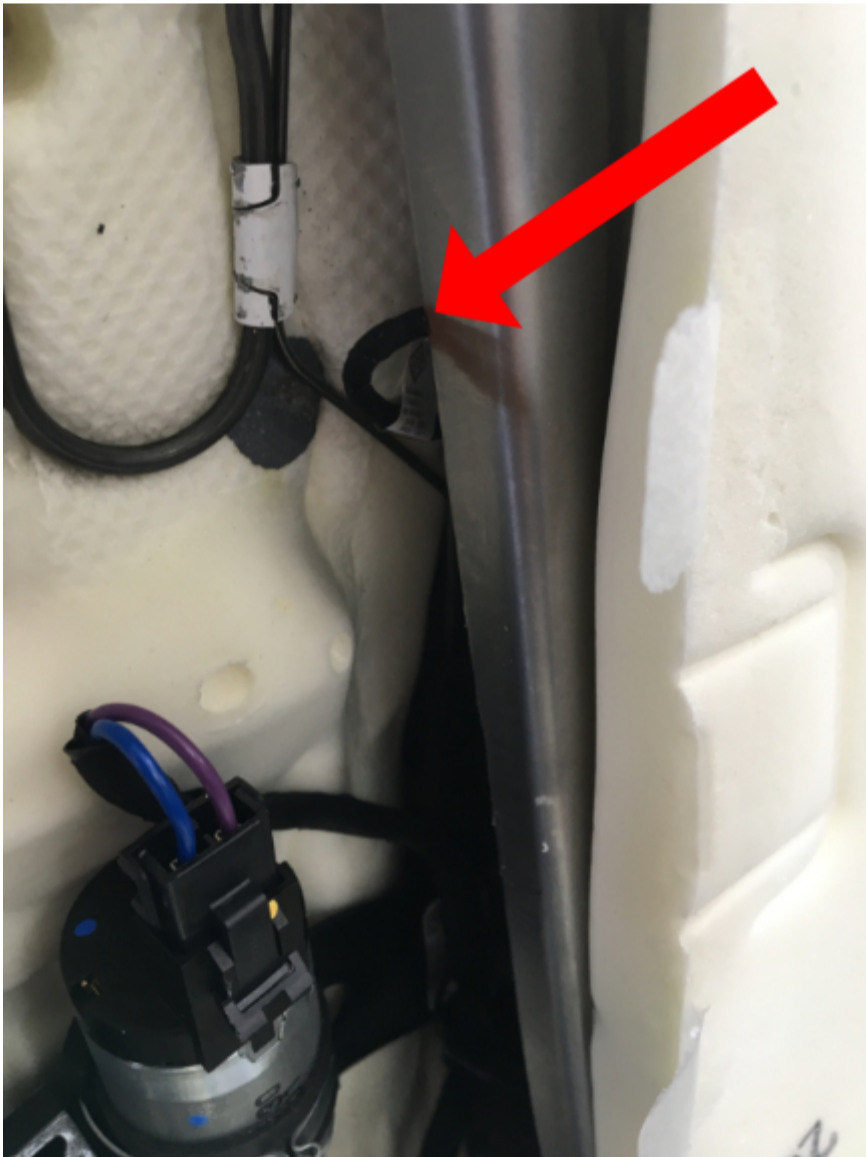
If no damage is found in this area, also inspect the harness along the side of the seat frame as shown in the two photos below.

Repair the damaged circuits following the correct procedure in SI for wire and connector repair.
