## Technical product information

<b>Topic</b>	Water leaking from the mechanical water pump - Low coolant level warning displayed - W12 TSI
<b>Market area</b>	Russische Föderation (5RU),Australia E04 Bentley rest Asia and Australia (6E04),China 796 VW Import Comp. Ltd (Vico), Beijing (6796),Germany E02 Bentley rest Europe (6E02),Japan E03 Bentley Japan (6E03),Korea, (South) E08 Bentley South Korea (6E08),United Arab Emirates E06 Bentley Middle East and Africa (6E06),United Kingdom E01 Bentley UK (6E01),United States E05 Bentley USA and rest America (6E05)
<b>Brand</b>	Bentley
<b>Transaction No.</b>	2065919/4
<b>Level</b>	EH
<b>Status</b>	Released for publishing
<b>Release date</b>	07-Nov-2022

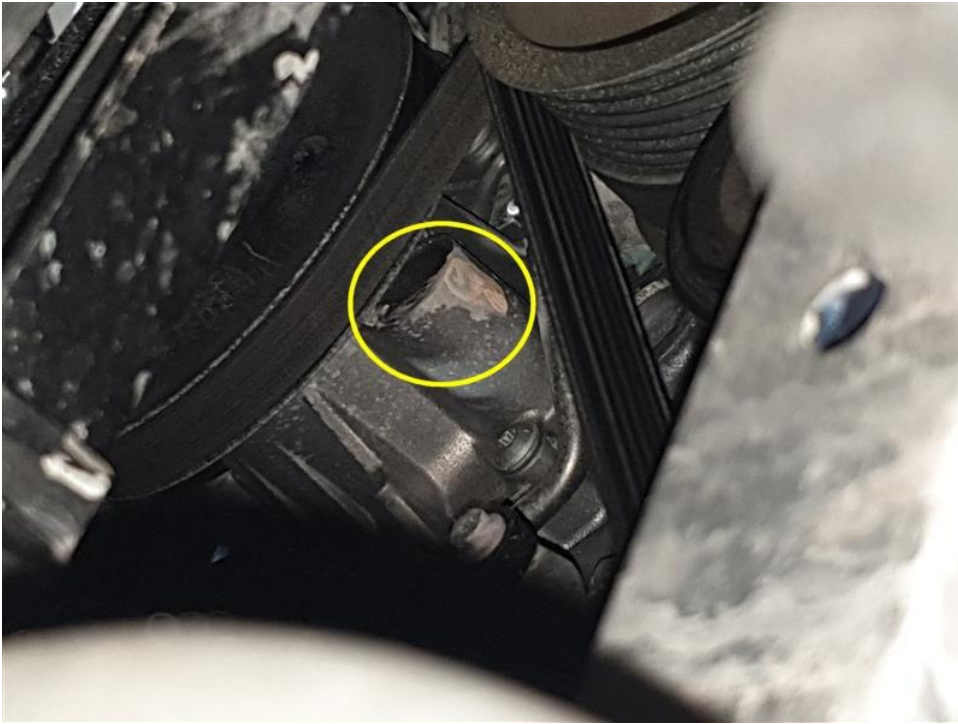
Figure 1

Refer to the video located within the Bentley Hub reference TPI 2065919/- this video shows an example of a coolant pump with no leak although there is a small coolant witness mark evident (Figure 1) in this scenario the coolant witness mark should be cleaned off (using a suitable cleaning agent) to the condition shown in Figure 2

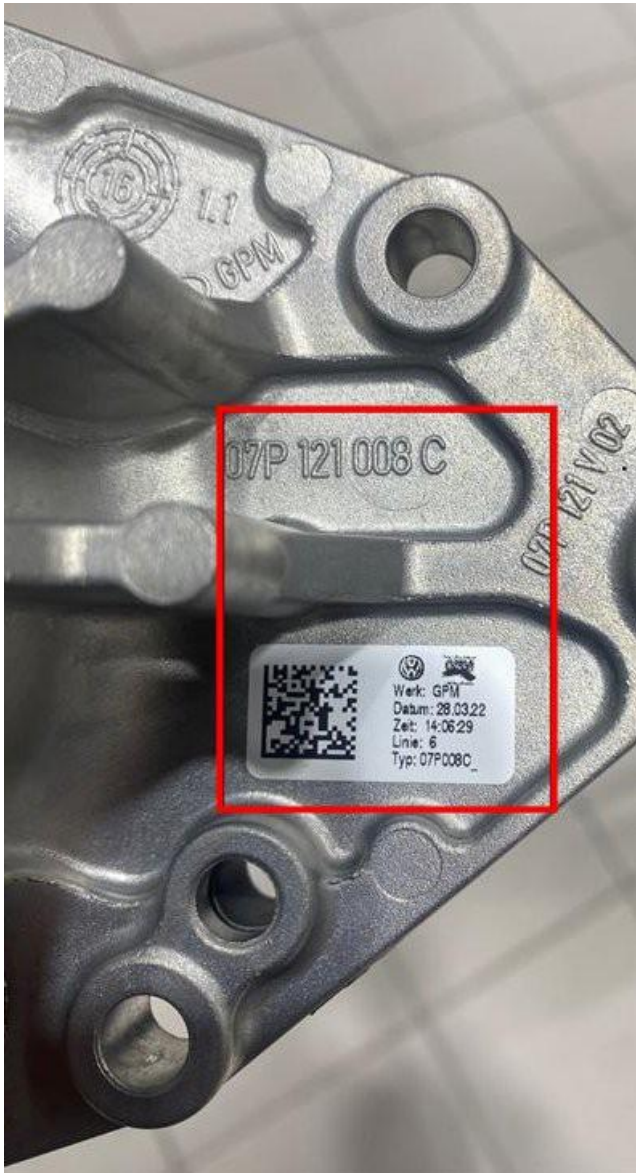
- The operative must raise a technical DISS query or respond via an already open DISS query ensuring the following is attached to the DISS query:
- Clear photo of the coolant level
- Clear photo of the mechanical coolant pump part number 07P 121 008C (Figure 3)
- Current ODISlog

NOTE: The photo shown in Figure 3 is a C level coolant pump (shown removed from the vehicle for photographic purposes) a borescope may have to be used for photos of the coolant pump when fitted

- Record a clear video of the coolant leak whilst carrying out the pressure test
- Request permission to replace the mechanical coolant pump 07P 121 008C due to a leak from the mechanical coolant pump whilst conducting the pressure test

5) Once permission has been given via the technical DISS query, replace the mechanical coolant pump - Refer to Rep.Gr 19
