# Technical product information

<b>Topic</b>	Unable to run basic settings within the Adaptive suspension control unit (J775)
<b>Market area</b>	Bentley; worldwide (2WBE)
<b>Brand</b>	Bentley
<b>Transaction No.</b>	2055693/3
<b>Level</b>	EH
<b>Status</b>	Released for publishing
<b>Release date</b>	02-Nov-2022

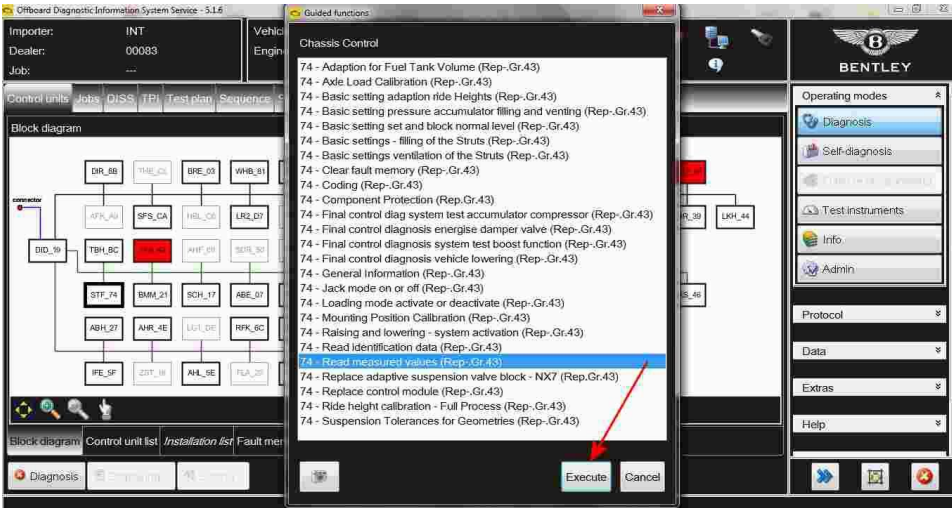
Figure 3

- Select Read measured values (Figure 3)

1) Navigate to address 74

- Select Guided functions
