# Technical Service Bulletin

## 68 Wind deflector bearing and/or latching element broken

68 22 39 2068367/1 November 2, 2022.

Model(s)	Year	VIN Range	Vehicle-Specific Equipment
A5 Cabriolet	2019 – 2024	All	Not Applicable

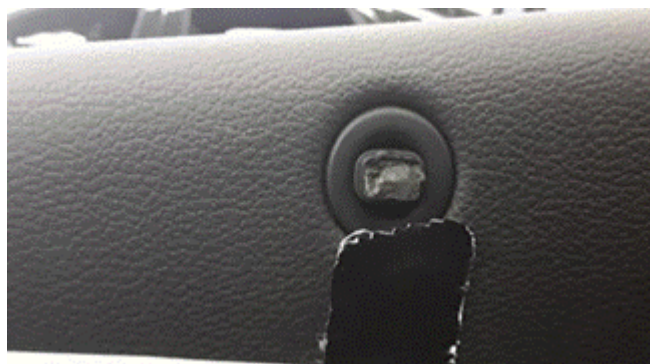
*Figure 1. The wind deflector bearing pin is broken off in the mount.*

Small parts kit 8W7 898 174 is available to replace the damaged components of the wind deflector. The wind deflector need not be replaced entirely in these cases.

This damage is caused due to outside influence. Replacement of the wind deflector or the small parts kit is not to be claimed under warranty. Counsel the customer as to the specific folding/unfolding sequence of the wind deflector to avoid the recurrence of this damage.

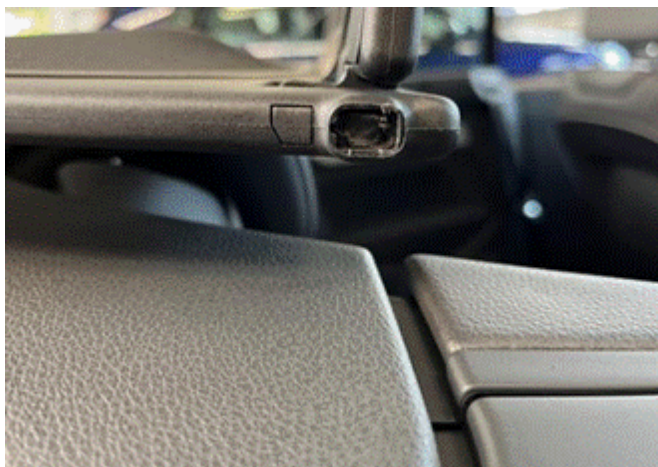
Figure 2 shows the broken wind deflector bearing on the deflector.

*Figure 2. The wind deflector bearing pin is broken off of the deflector structure.*

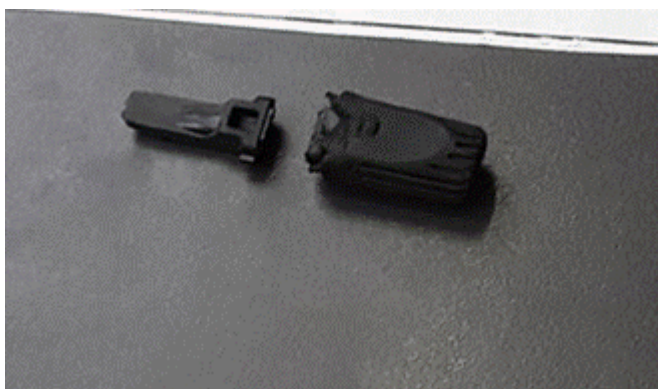
Figure 3 shows the broken pieces of the wind deflector bearing when the broken pieces are removed.

*Figure 3. Removed pieces of the broken wind deflector bearing pin.*

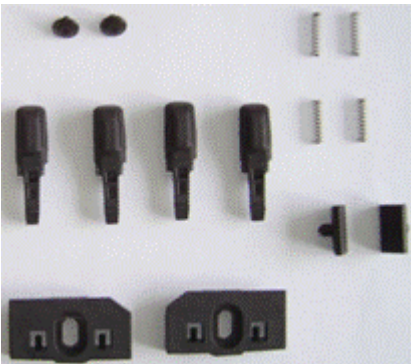
Always check with your Parts Department and/or ETKA for the latest information and parts bulletins.		
Part Number	Part Description	Quantity
8W7898174

Small parts kit	1
