Title: Recall 22518 SDS Template to Enable Con-Rod

Applies To: A26A Engine

This service procedure will guide the technician in applying a template using Service Diagnostic Solutions (SDS) for VIN in Recall 22518

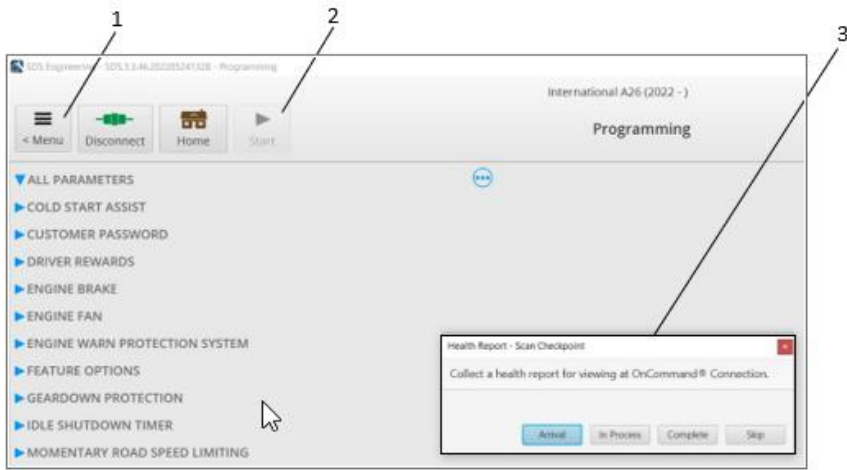
Figure 1. SDS Pro Screen

1. Menu tab
2. Health Report - Scan Checkpoint
3. Start Tab

10. Complete the health Report - scan checkpoint (figure 1, then item 3).

15. Click Start tab (figure 1, item 3).

19. Under Menu tab (figure 1, Item 1) Click **"ALL Parameters"** tab, type in the **Search/Filter box "3900"** to confirm parameter change has been successfully updated.

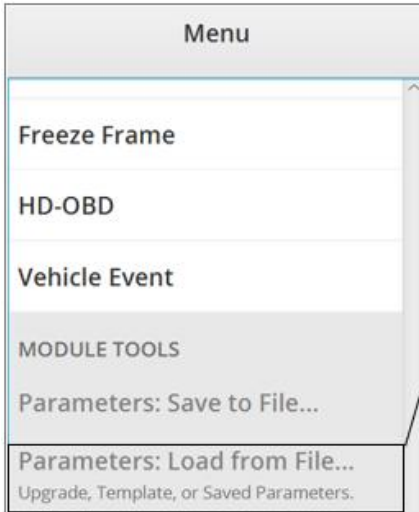
Figure 2. SDS Menu Tab

11. Click Menu/Parameters/Load from File (figure 2, Item 1)

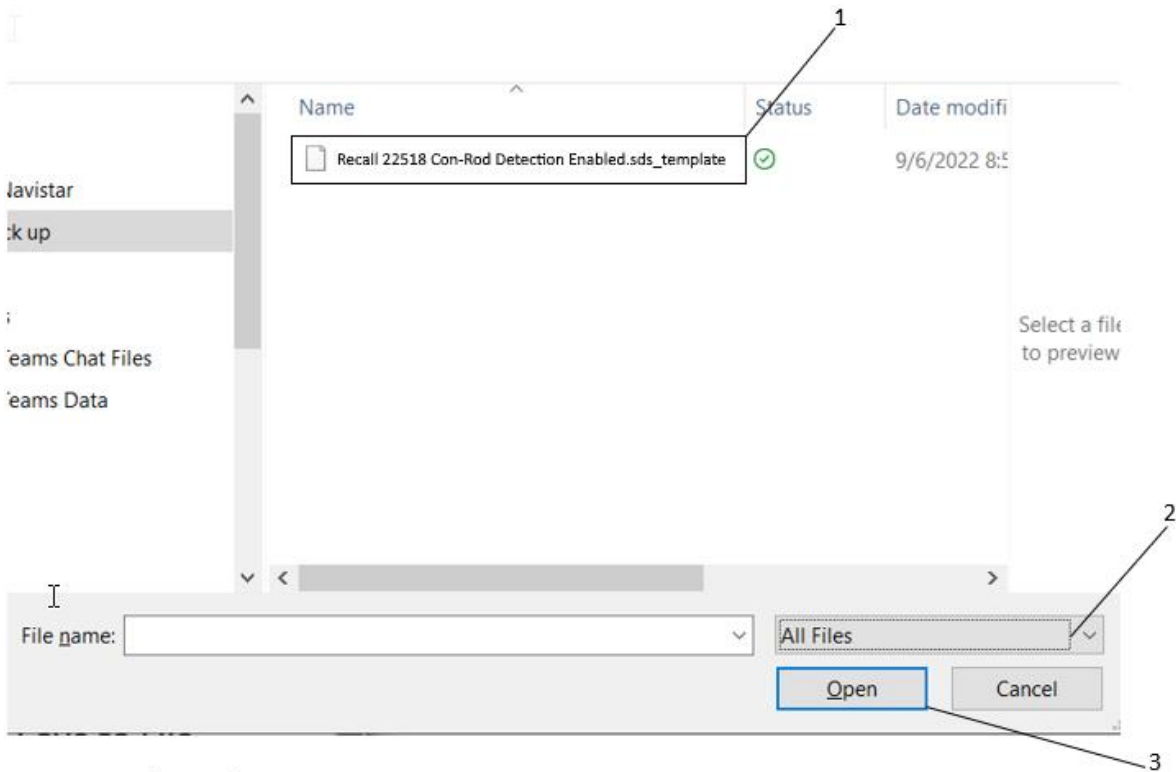
Figure 3. Load Template Screen

1. Recall 22518 Con-Rod Detection Enabled.sds.template
2. All Files
3. Open

12. Ensure ALL files is selected (Figure 3, Item 2).

13. Select Recall 22518 Con-Rod Detection Enabled.sds.template (Figure 3, Item 1).

14. Click Open (Figure 3, item 3).
