STAR ONLINE PUBLICATION

Case Number: S2108000219 – REV. A

Symptom/Vehicle Issue: Intercooler I/C Coolant Temp Missing On The Performance Page App

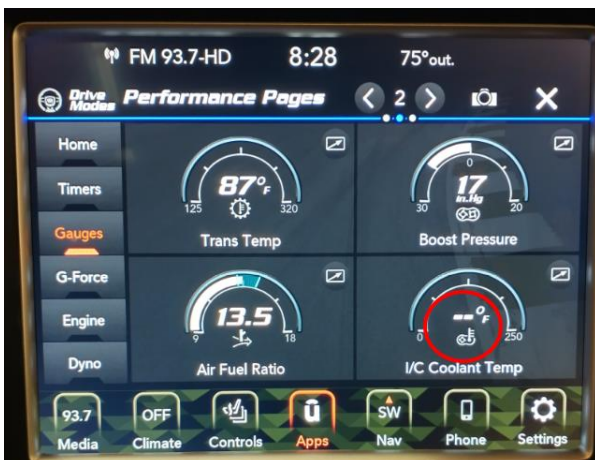
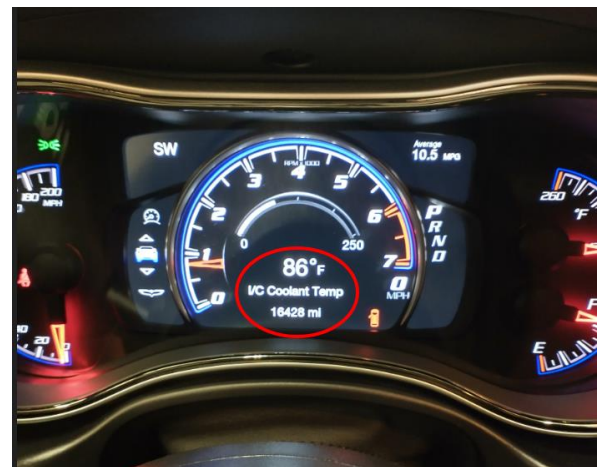
Technician Observation: The customer may notice I/C coolant temp not showing on the performance page of radio screen.

Discussion: The I/C temp is supposed to display on both cluster and radio screen in the performance page app.

1. Verify if the I/C coolant temp displays on the cluster correctly
2. If the I/C temp is blank on performance page of radio screen, but displays ok on the cluster, the issue is radio software related.

Do not replace the radio head unit for this concern. Software fix for this issue is planned in Q1 2023.
