Customer Satisfaction Notification Z23

Radio Frequency Hub Module

2022 (WL) Jeep® Grand Cherokee

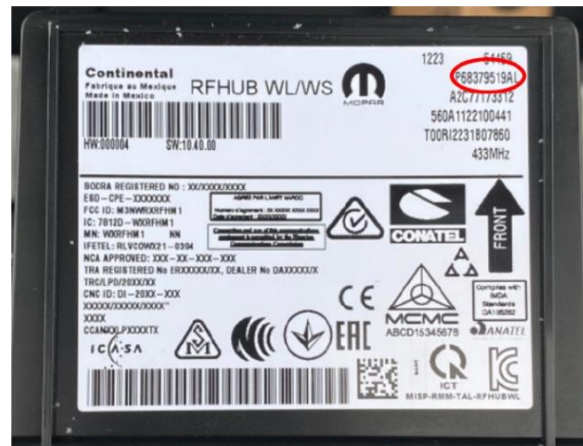
Figure 1 – RFHM Label

1. Using a trim stick or equivalent, disengage the retaining tabs of the rear header trim panel from the inner roof panel and remove the trim panel.
2. Lower the headliner to access the Radio Frequency Hub Module (**RFHM**) located at the center rear.
3. Inspect the label part number on the **RFHM** (Figure 1).

- Does the **RFHM** part number end with an “AM”?
 - If “Yes” proceed to step 4.
 - If “No” reinstall the inner roof panel trim and return the vehicle to the customer.

4. Disconnect the battery negative cable.
5. Disconnect all the wire harness connectors at the **RFHM**.
6. Remove the retainers and remove the **RFHM** from the vehicle and **DISCARD**.
7. Align the **NEW RFHM** to the retainers and secure them.
8. Reconnect all the electrical connectors.
