## ISATA 5 WIND SENSOR INOPERATIVE WITH KEY OFF FIX

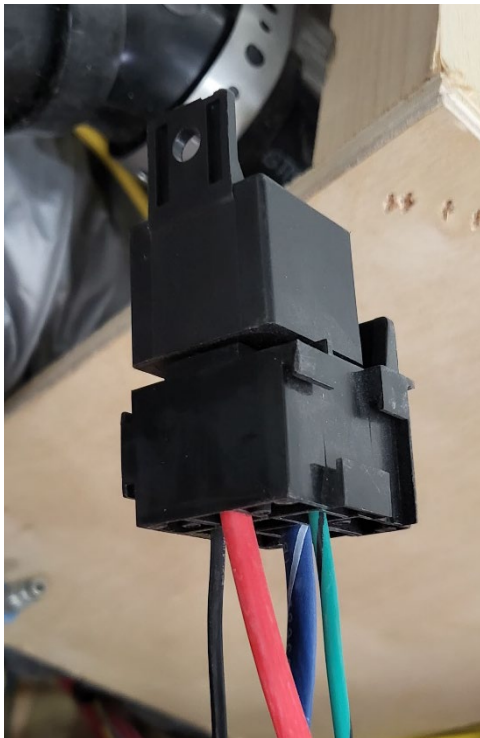
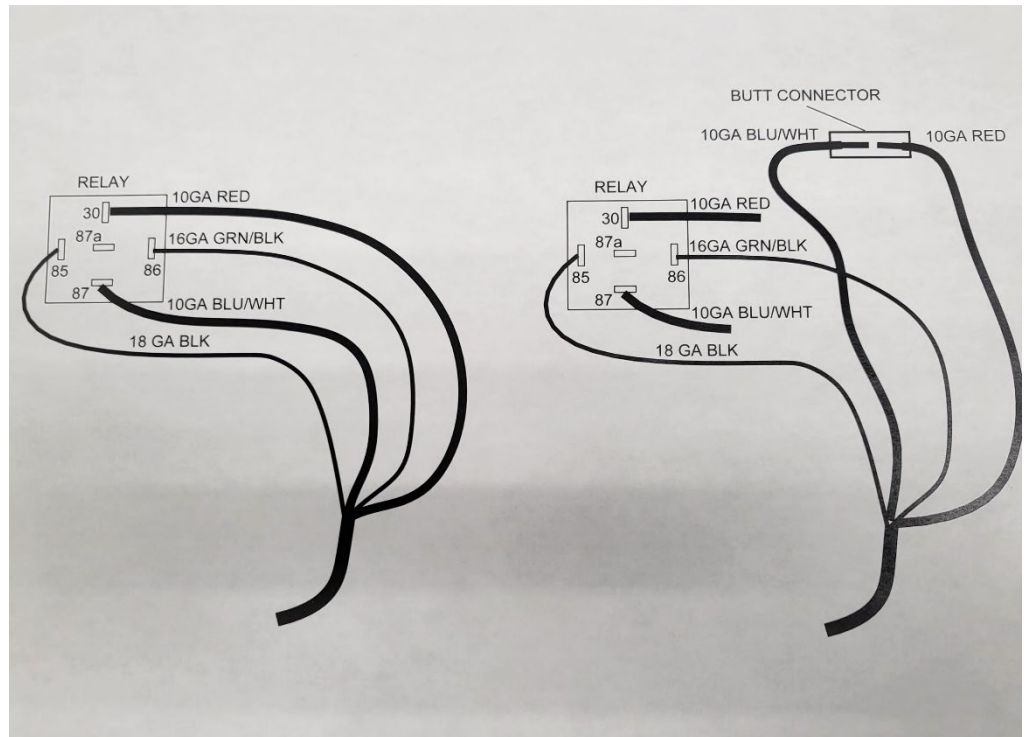
To fix this first locate the ignition lock out relay. 30FW and 34DS relays are located in the bedroom wardrobes and can be accessed by removing one of the lower drawers. 28SS is accessed by removing the removable panel in the back of the linen cabinet. You are looking for a relay that has a large RED, BLUE/WHITE wires along smaller BLACK and GREEN/BLACK wires (see picture). Cut the RED and BLUE/ WHITE wires away from the relay and butt connect the RED wire to the BLUE/ WHITE wire.
