SIB 61 01 20

2022-11-28

## ACCESSORIES DO NOT POWER UP FROM THE FRONT 12 V POWER SOCKET PLUG

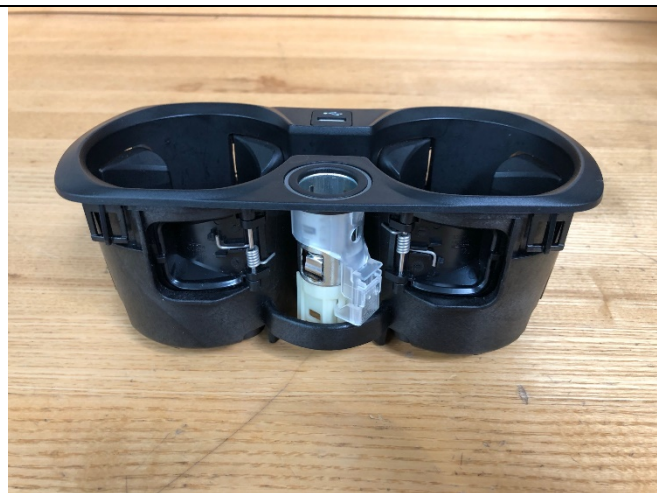
1. Remove the center cupholder.

Refer to **REP 51 16 202** Removing and installing/replacing front cupholder.

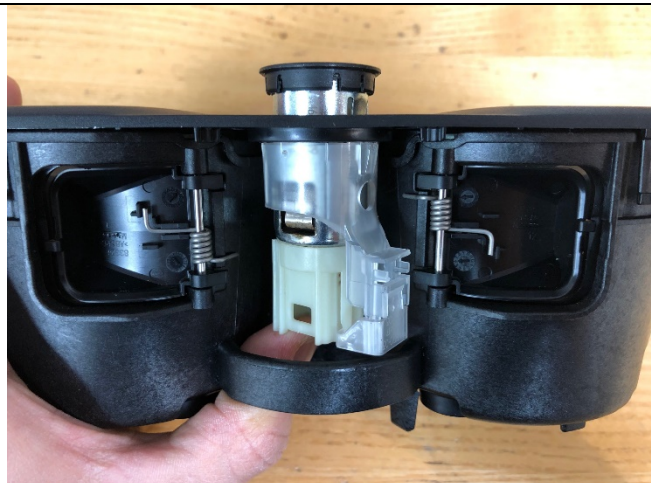
2. Push the original plug-in socket from the bottom up.

**Note:** Clear plastic bracket stays in place.

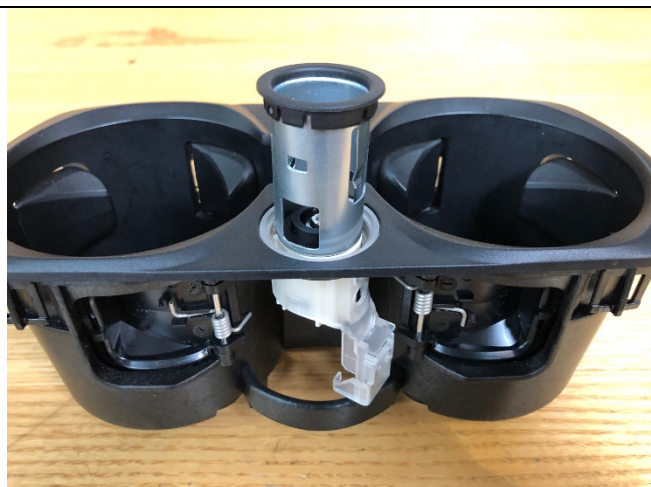
3. Install new plug-in socket by sliding from the top section of the cupholder.

4. Reinstall cupholder and test system for proper operation.
