Timing Gear Plate, Inspection

M-212-001

All Mack Powered Trucks 2017 to current

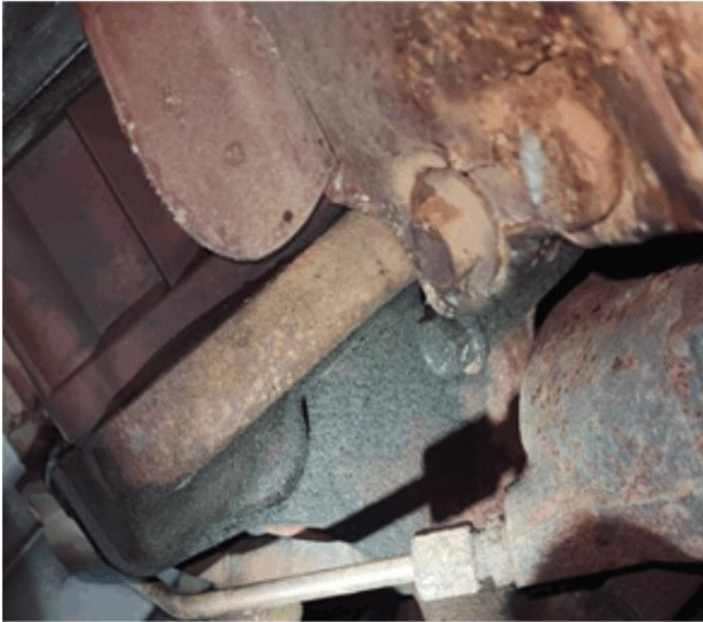
Oil Weep is determined by the appearance of a thin accumulation of oil on the exterior of a part. The area will look like a dark stain or look damp in appearance (but not wet or dripping) and will likely collect dust and dirt.

Reference images of an oil weep (not a valid warrantable repair)

Dark spot or stain

Note: An oil weep is a normal condition seen around mechanical joints and does not require a repair.

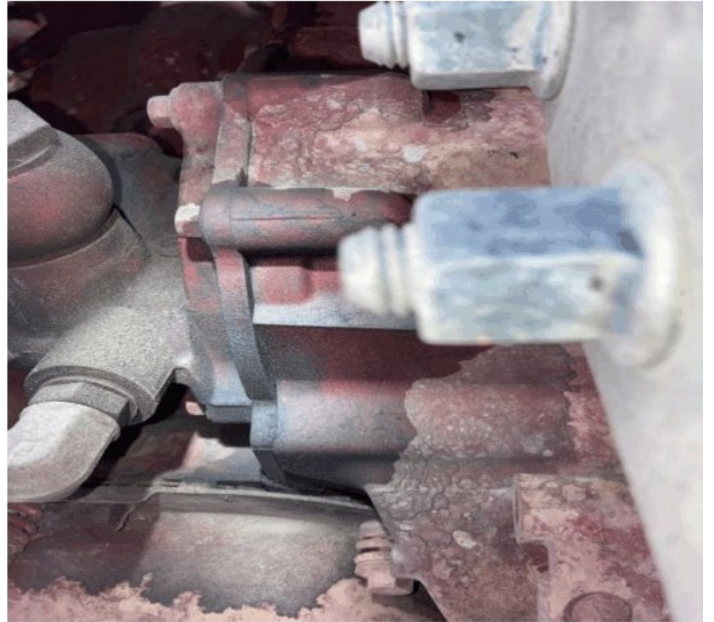
Collection of dirt and dust (not active)

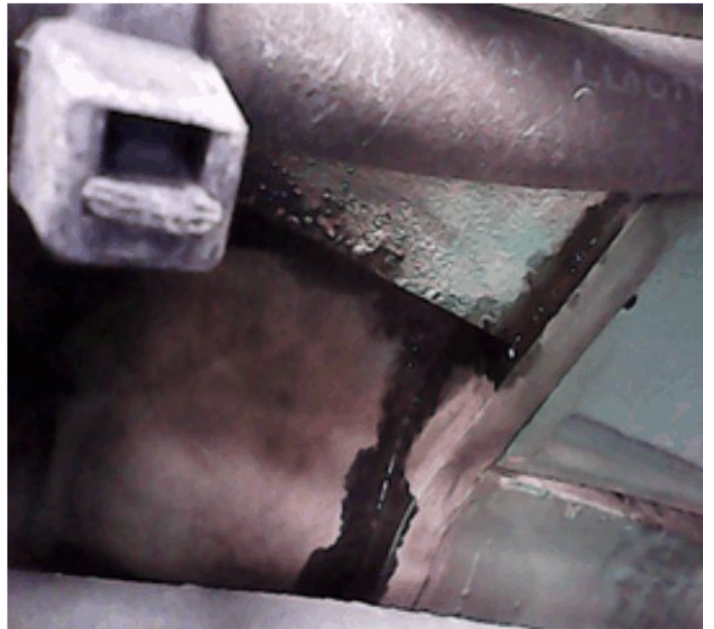
Oil Leak is determined by the identification of oil actively accumulating on the exterior of a part. The area will be visibly saturated, can be seen actively accumulating and running from the area.

Reference images for an oil leak (valid warrantable repair)

Oil standing or dripping from a component

Note: An active leak is the only leak that is considered a valid warrantable repair.
