STAR ONLINE PUBLICATION

Case Number: S2208000062

Symptom/Vehicle Issue: Heated Steering Wheel Does Not Operate

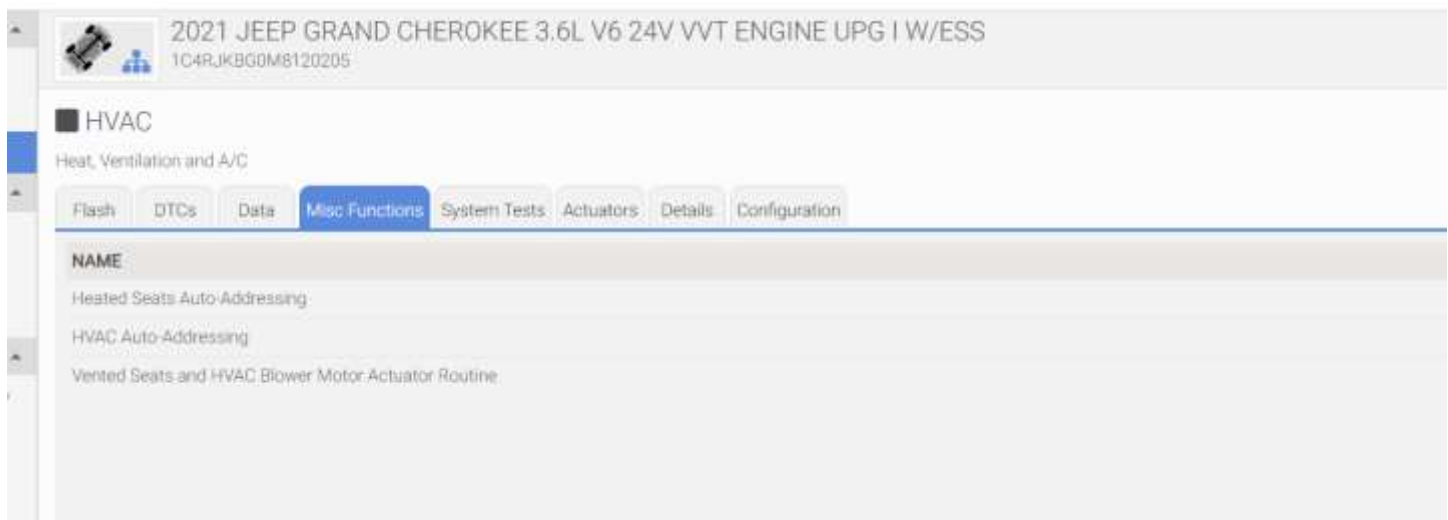
Discussion: Using the wiTech access the HVAC module Misc Functions tab and perform the Heated Seats Auto-Addressing function to sync CSWSM to enable.
