Case Number: S2208000113

Symptom/Vehicle Issue: No Start, DTC P0615 Starter Control Circuit Open

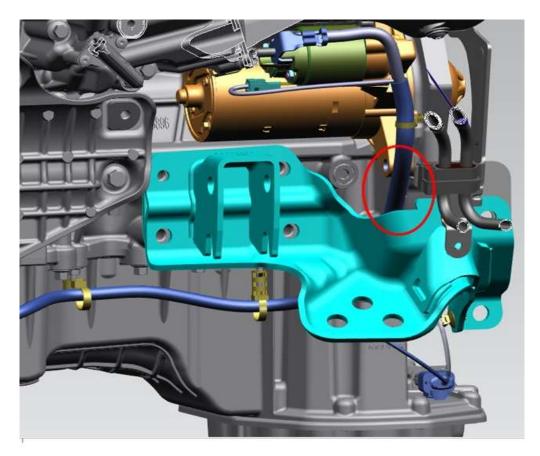
Discussion: Inspect the harness routing at the engine support bracket near the starter motor as highlighted. Examine the harness at this location for any signs of harness to bracket chaffing or pinching. Repair any harness/circuit damage per the harness/circuit repair guidelines in service library. Isolate the harness contact area to ensure no further contact as needed.
