STAR ONLINE PUBLICATION

Case Number: S2208000191

Symptom/Vehicle Issue: Passenger Power Adjustable Mirror Does Not Operate, Service Blind Spot Message Displayed on Cluster

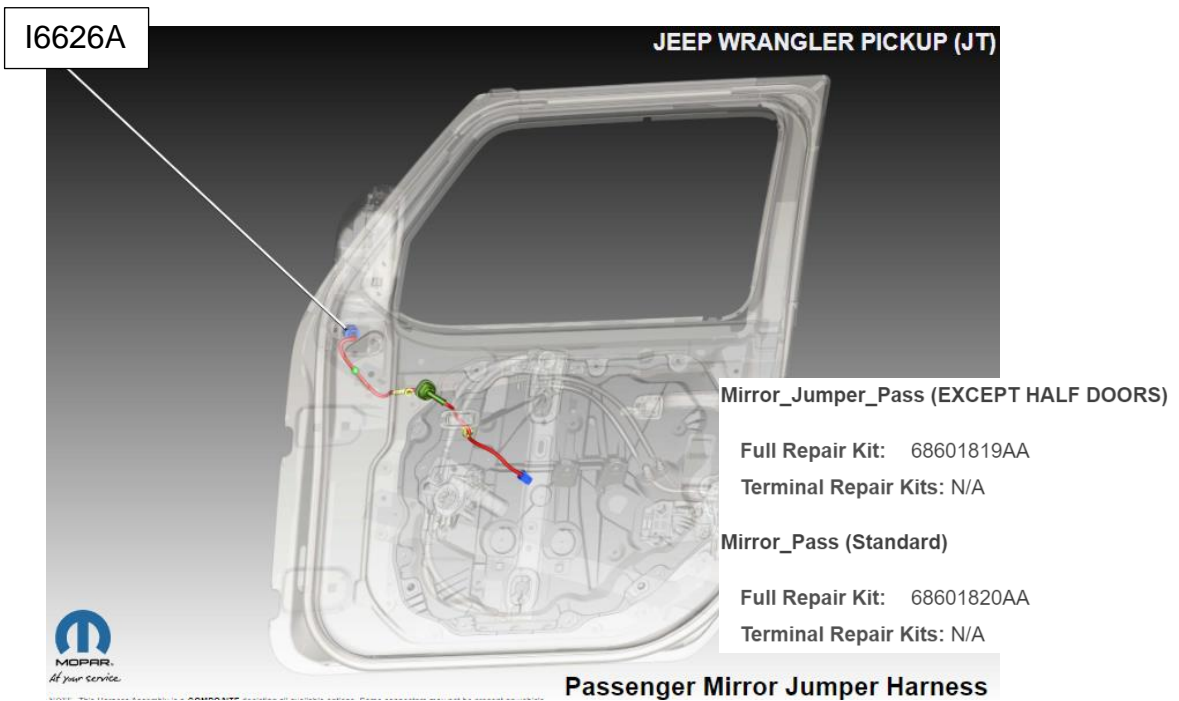
Repair Procedure: Inspect the I6626A 10-way black component connector, review for damaged or pushed out terminals. Use the push-pull-push method to secure unseated connectors, no parts required.
