STAR ONLINE PUBLICATION

Case Number: S2208000054 Rev. A

Symptom/Vehicle Issue: Left Headlight, Park Lamp Flickers Or Is Inoperative. B162A, B163A, B1632, B16CF

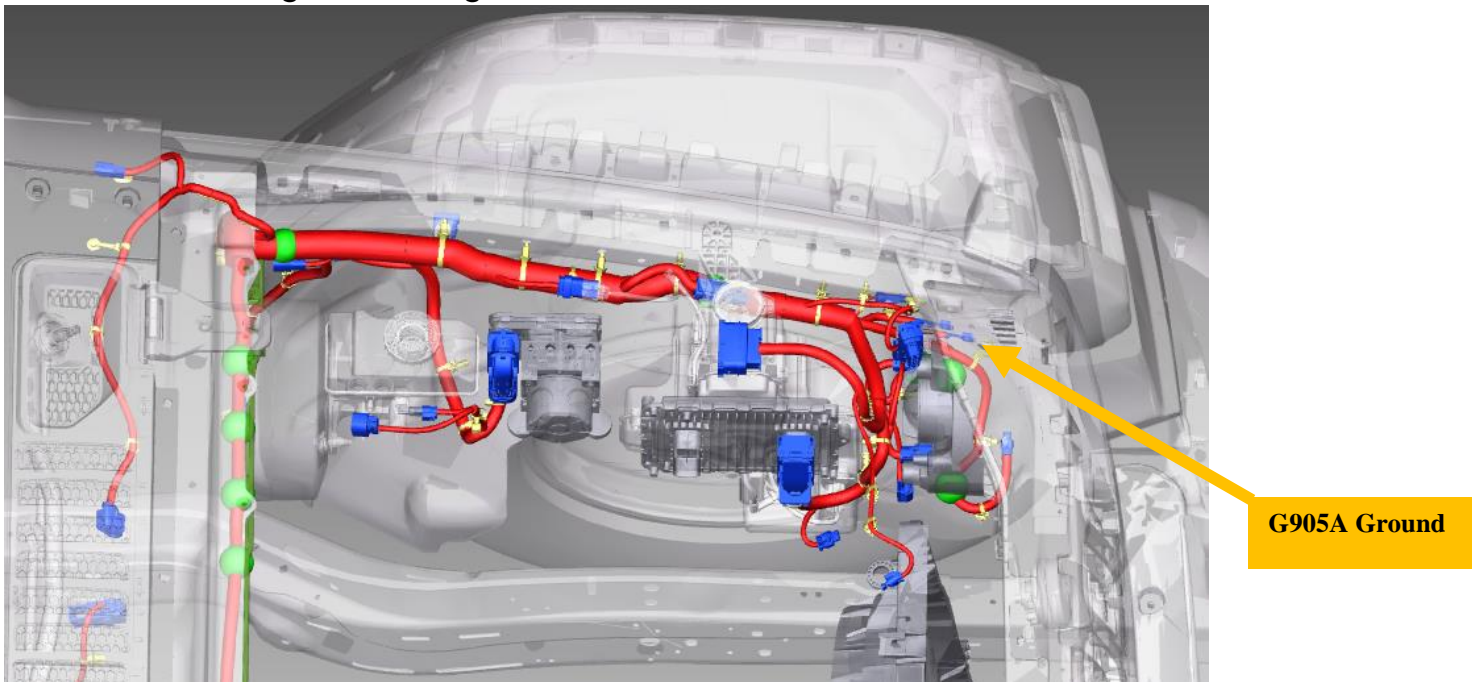
Discussion: The customer may bring the vehicle in for a flickering and/or inoperative left headlight and park lamp. Upon scanning the vehicle you may one or more of the following DTC's B162A, B163A, B1632, B16CF. This may be caused by a loose G905A ground.

Diagnosis: Inspect the G905A ground located behind the left headlight housing. Confirm that the ground is tight and secure.

Repair Procedure: Resecure the ground and confirm the left headlight and park lamps operate normally. If the concern is still present, follow the DTC flow charts to root cause the concern.
