**NUMBER:** 23-048-22

Door Trim Panel Bolster Delamination

2022 (LA) Dodge Challenger

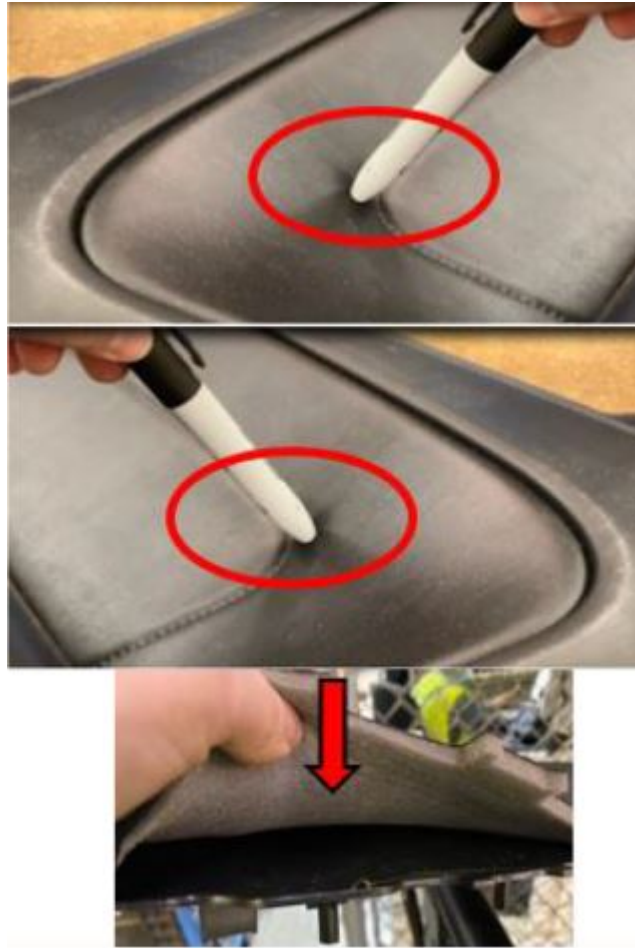
Fig. 1

- One or both of the right or left door trim panel upper insert material is loose, or separating from the door trim panel backing.

1. Inspect both door panels for loose or separating material (Fig. 1) .

**NOTE:** Pressing on the door panel material with an object or hand (Fig. 1) , may be necessary to verify loose or separating material.

### Loose Or Separating Door Panel Material

2. Was any of the material on either door panel loose or separating (Fig. 1) ?
- YES>>> Proceed to [Step 1](#) of the Repair Procedure.
  - NO>>> This bulletin has been completed, use inspect LOP (23-20-22-9X) to close the active RSU.

**NOTE: When replacing one or both door panels, transfer any and all components from the old door panel(s) to the new door panel(s).**

1. Replace one or both door panels **as required**. Refer to the detailed service procedures available in DealerCONNECT/Service Library under: Service Info>23 - Body / Doors - Front / Panel, Door Trim / Removal / Installation.
