WMQ3 – Retrofitting Loudspeaker Booster (Stop Delivery)

Revision: This bulletin replaces bulletin Group 9 215/21 WMQ3, dated May 13, 2022.

Model Line: **Cayenne (9YA/9YB)**

Concerns: **Loudspeaker booster**

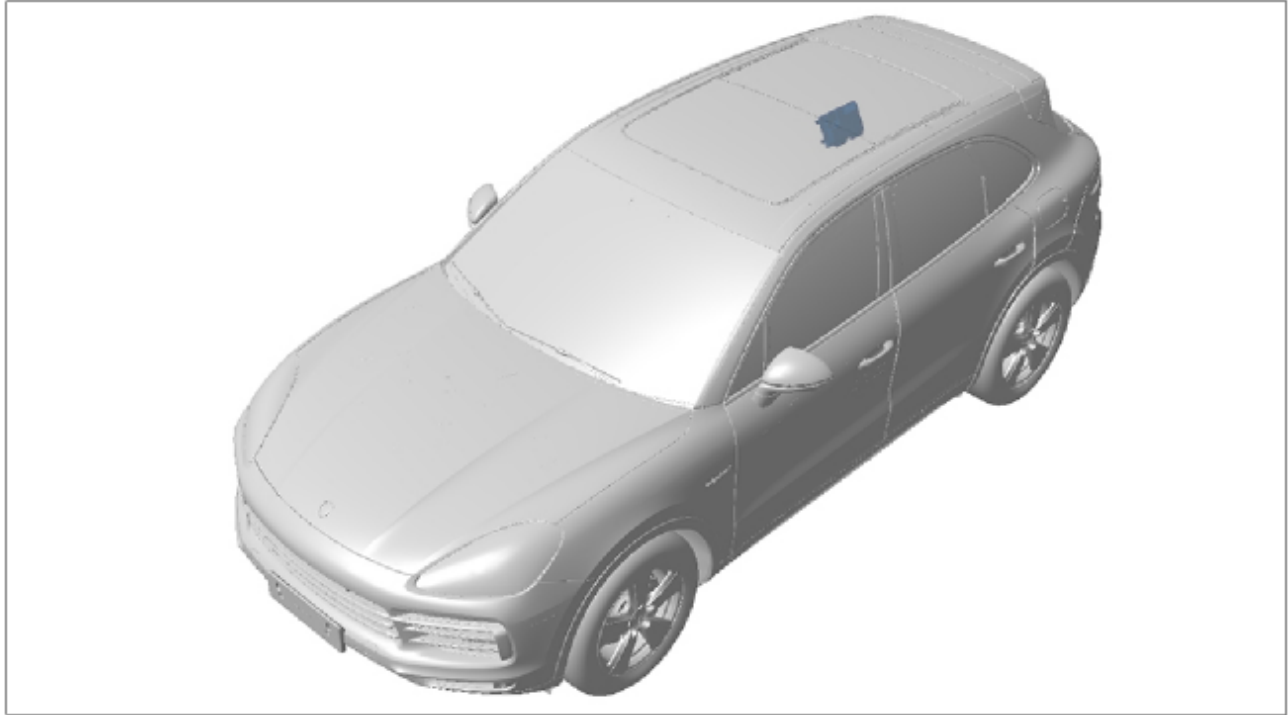
Installation position

– **(Retrofitting)** loudspeaker booster

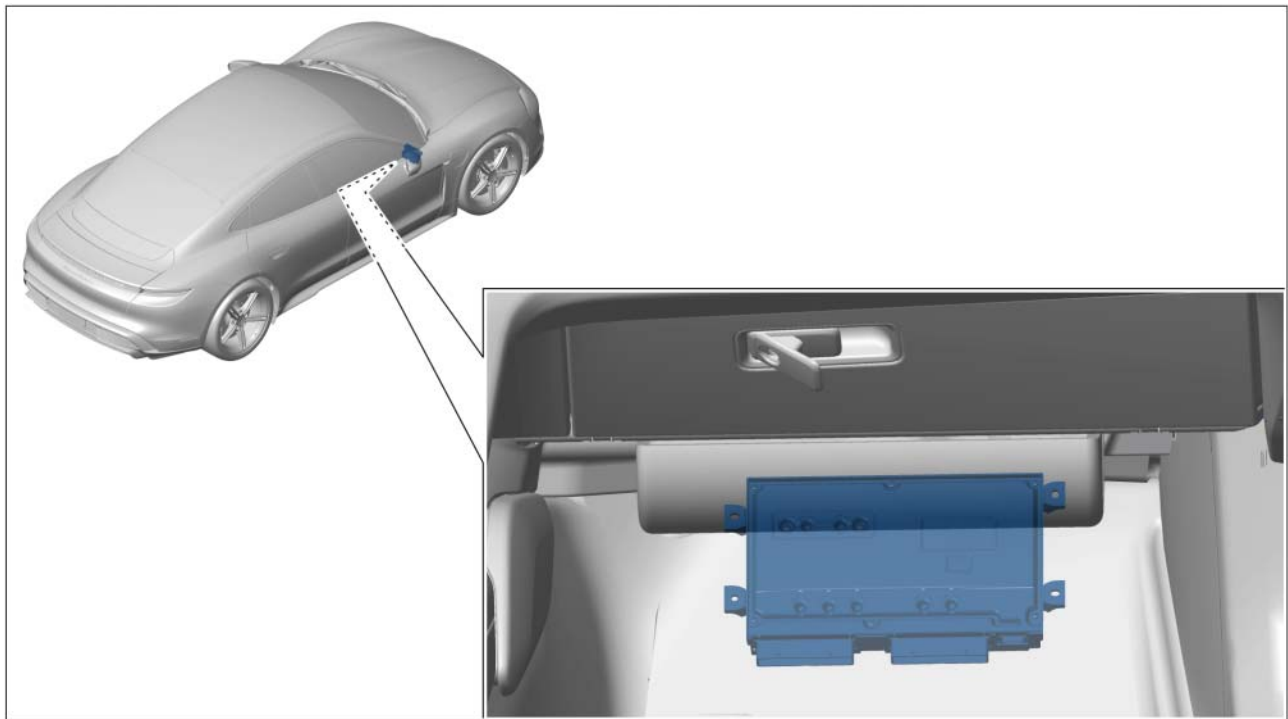
Installation position (shown on the Taycan)

– **(Retrofitting)** loudspeaker booster

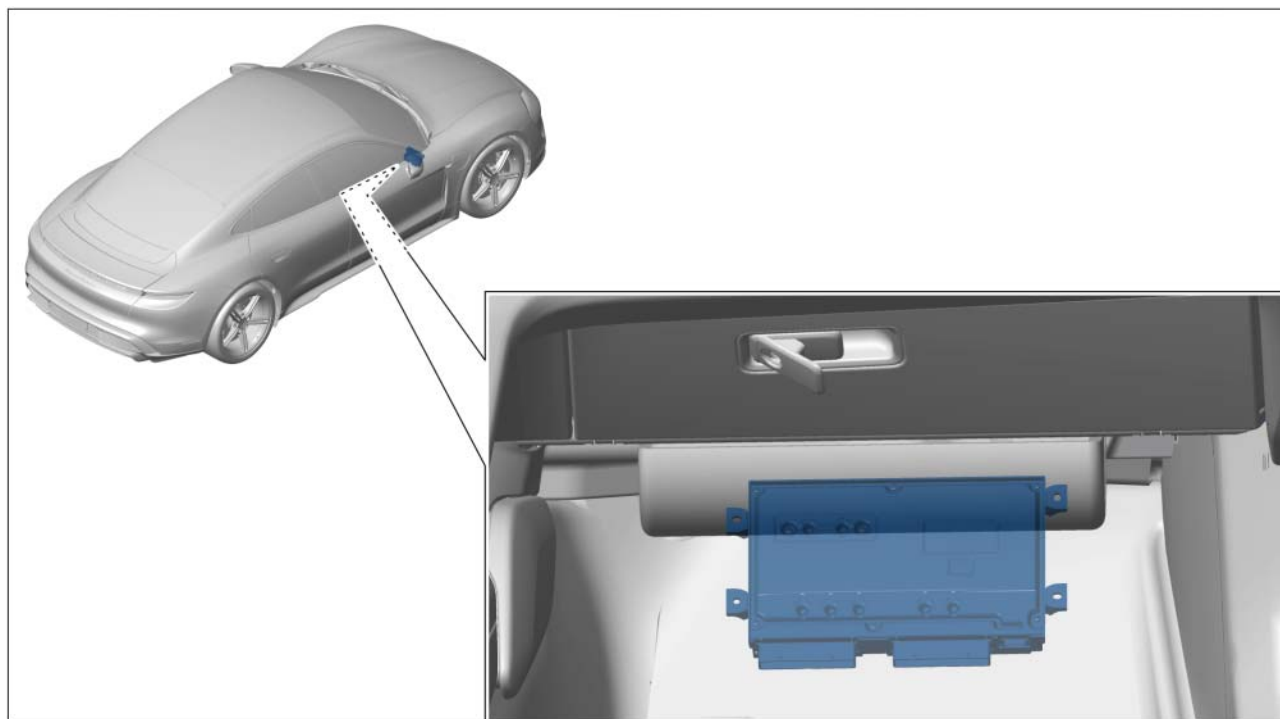
Installation position

- (Retrofitting) loudspeaker booster

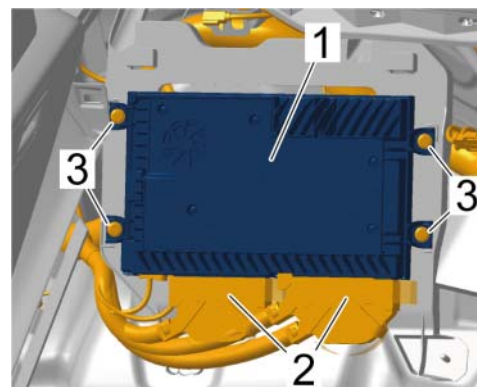
Loudspeaker booster

2 Unscrew existing fastening screws ⇒ *Loudspeaker booster -3-* and set them aside.

3 Position loudspeaker booster ⇒ *Loudspeaker booster -1-*, screw in fastening screws ⇒ *Loudspeaker booster -3-* and secure loudspeaker booster with **Tightening torque 6 Nm (4.4 ftlb.)**.

4 Plug in and lock electric plug connections ⇒ *Loudspeaker booster -2-*.

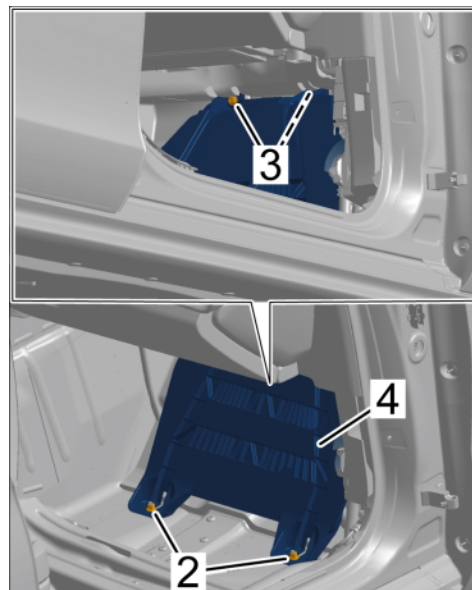
Footrest

- Always wear approved work clothes and shoes when carrying out assembly work.
 - Do not remove new parts from ESD protective packaging until shortly before installation.
 - Do not touch electric pins and plug contacts.
- 1 Fold over carpet on the front passenger side until the footrest is accessible. ⇒ *Workshop Manual '704119 Removing and installing carpet'*
 - 2 Remove footrest ⇒ *Footrest-4-*.
 - 2.1 Unscrew and remove fastening nuts ⇒ *Footrest-2-*.
 - 2.2 Unscrew fastening screws ⇒ *Footrest-3-*.

- 2.3 Guide footrest ⇒ *Footrest-4-* out of the footwell.

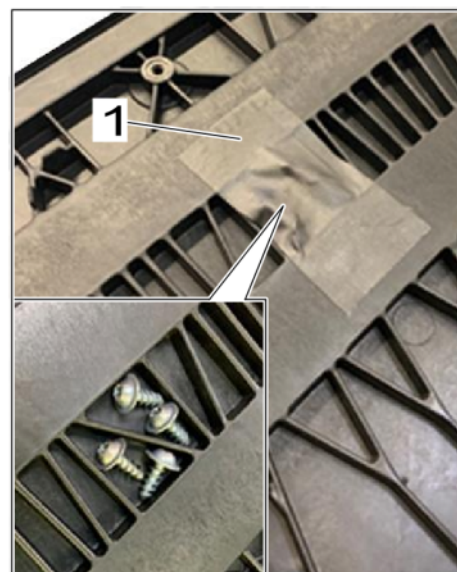
Adhesive strip on footrest

- 3 Pull adhesive strip off the ⇒ *Adhesive strip on footrest-1-* footrest, remove fastening screws ⇒ *Adhesive strip on footrest* and set them aside.
- 4 Install loudspeaker booster ⇒ *Loudspeaker booster-4-*.

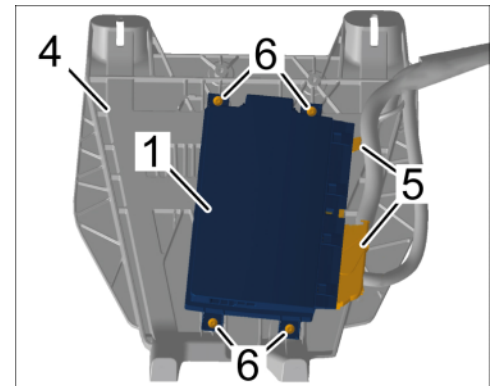
Loudspeaker booster

- 4.1 Position loudspeaker booster ⇒ *Loudspeaker booster-1-* on the back of the footrest ⇒ *Loudspeaker booster-4-*, screw in fastening screws ⇒ *Loudspeaker booster-6-* and tighten loudspeaker booster **Tightening torque 2.5 Nm (1.8 ftlb.)**.
- 4.2 Position footrest in the footwell.
- 4.3 Plug in and lock electric plug connections ⇒ *Loudspeaker booster-5-*.

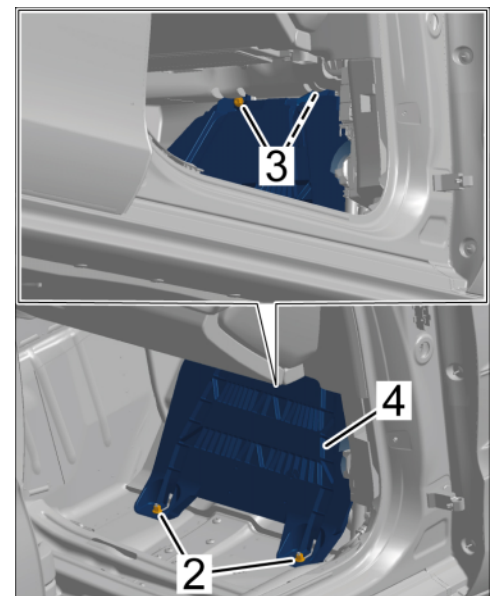
Footrest

- 5 Secure the footrest ⇒ *Footrest-4-*.
 - 5.1 Screw in fastening screws ⇒ *Footrest-3-* and tighten with **Tightening torque 8 Nm (5.9 ftlb.)**.
 - 5.2 Screw in fastening nuts ⇒ *Footrest-2-* and tighten with **Tightening torque 2.5 Nm (1.8 ftlb.)**.

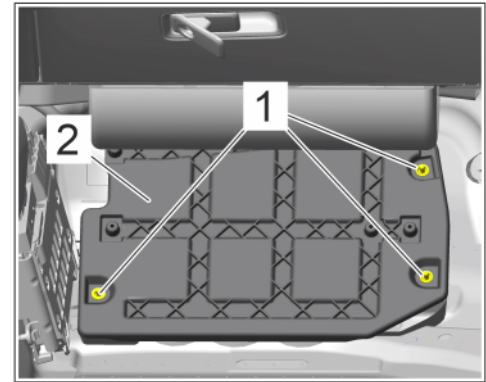
Footrest

- Always wear approved work clothes and shoes when carrying out assembly work.
 - Do not remove new parts from ESD protective packaging until shortly before installation.
 - Do not touch electric pins and plug contacts.
- 1 Fold over carpet in the front passenger footwell until the footrest is accessible. ⇒ *Workshop Manual '70411902 Removing and fitting carpet on passenger's side'*
 - 2 Remove footrest ⇒ *Footrest-2-*.
 - 2.1 Unscrew fastening screws ⇒ *Footrest-1-*.

2.2 Guide footrest ⇒ *Footrest -2-* out of the footwell.

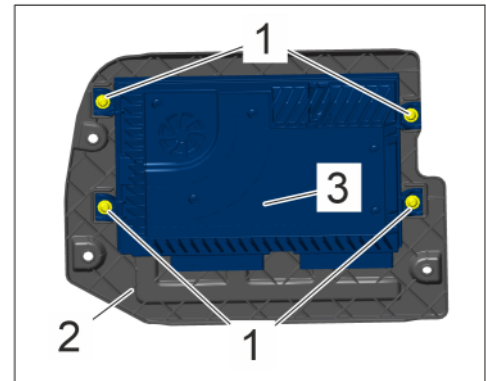
Loudspeaker booster

3 Install loudspeaker booster ⇒ *Loudspeaker booster -3-*.

3.1 Position loudspeaker booster ⇒ *Loudspeaker booster -1-* on the back of the footrest ⇒ *Loudspeaker booster -2-*, screw in fastening screws ⇒ *Loudspeaker booster -1-* and tighten with **Tightening torque 4 Nm (3 ftlb.)**.

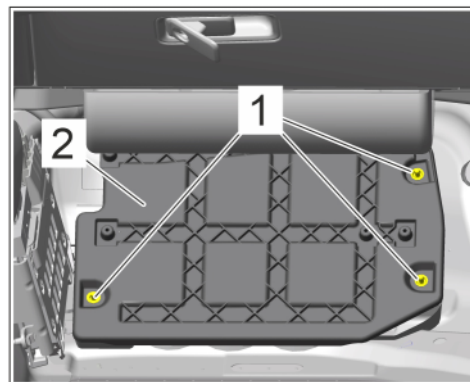
Footrest

- 4 Screw in fastening screws ⇒ *Footrest -1-* and tighten footrest **Tightening torque 8 Nm (5.9 ftlb.)**.
- 5 Install floor covering on passenger's side. ⇒ *Workshop Manual '70411902 Removing and fitting carpet on passenger's side'*
- 6 After installing the loudspeaker booster, proceed as follows:

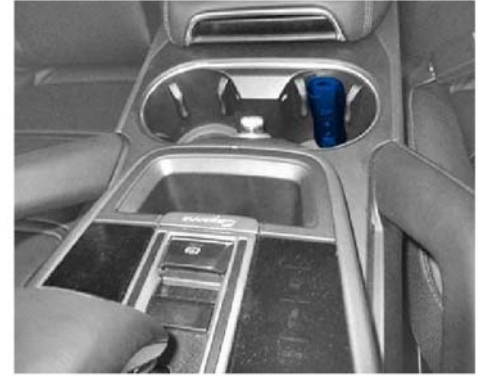
Emergency start tray

- 2 Place original remote control in emergency start tray.
⇒ *Emergency start tray*
- 3 Switch on ignition.
- 4 Select the **Amplifier** control unit in the **Overview**.
Press •F12" ('Next') to continue.

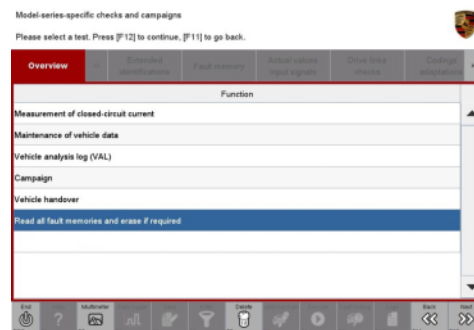
Erase fault memory

- 18.2 **Read out all fault memories and erase them if necessary** must now be selected. Press **•F12** ("Next") to continue. ⇒ *Erase fault memory*

- 18.4 Press **•F8** to delete fault memory entries.
- 18.5 Press **•F12** ("Yes") in response to the question asking whether you really want to delete all fault memory entries.

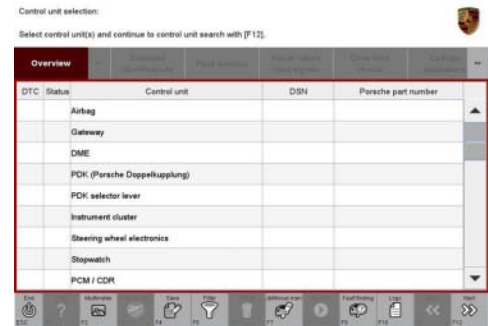
Control unit selection

- 18.6 Once you have erased the fault memories, select the **'Overview'** menu to return to the control unit selection screen ⇒ *Control unit selection*.
- 19 Exit the diagnostic application. Switch off ignition. Disconnect the Tester from the vehicle.
- 20 Perform function test on loudspeaker booster and check whether audio output is available.
- 21 Enter the campaign in the Warranty and Maintenance booklet.

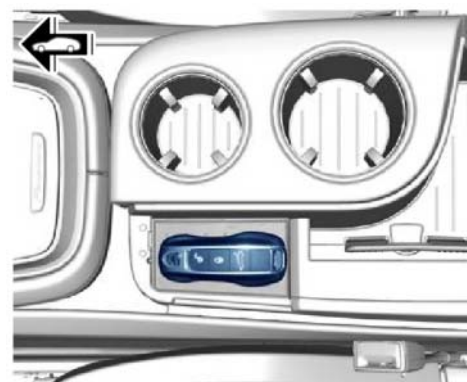
Emergency start tray

- 2 Place original remote control in emergency start tray . ⇒ *Emergency start tray*
- 3 Switch on ignition.
- 4 Select the vehicle type if necessary.
- 5 In the **Overview**, press •F7" to switch to the **Additional menu**.

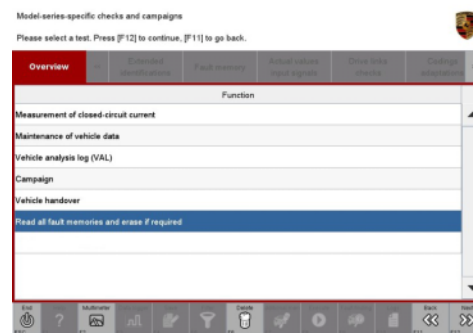
Erase fault memory

- 14.2 **Read out all fault memories and erase them if necessary** must now be selected. Press •F12" ('Next') to continue ⇒ *Erase fault memory*.

14.4 Press •F8" to delete fault memory entries.

14.5 Press •F12" ("Yes") in response to the question asking whether you really want to delete all fault memory entries.

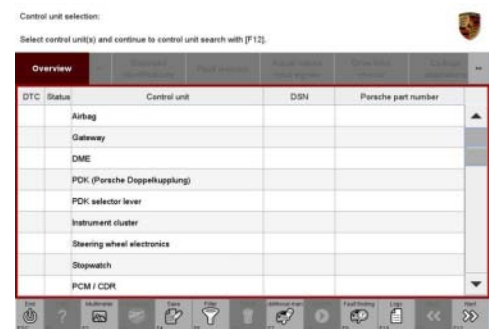
Control unit selection

14.6 Once you have erased the fault memories, select the **'Overview'** menu to return to the control unit selection screen ⇒ *Control unit selection*.

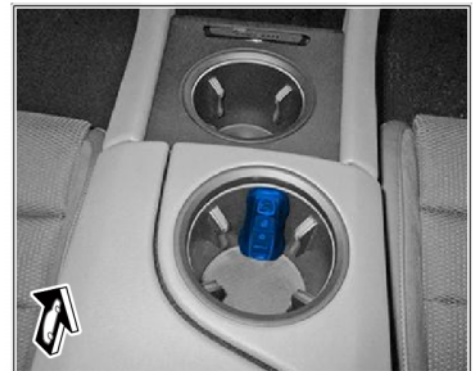
Emergency start tray

- 2 Place original remote control in emergency start tray
. ⇒ *Emergency start tray*
- 3 Establish operational readiness.
- 4 Select the vehicle type if necessary.

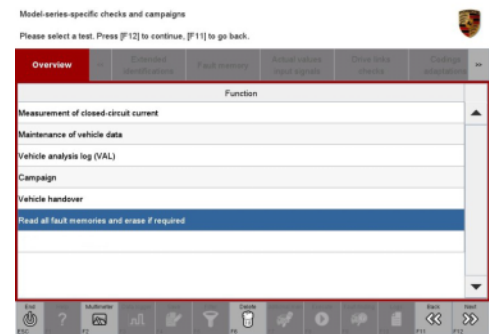
Erase fault memory

- 12 Select **Commission component protection**. Follow instructions and procedure. Press •F12" ('Next') to continue.
- 13 Once component protection has been commissioned successfully, return to the **Overview**.
- 14 Teach combination sensor.
 - 14.1 Select the **Airbag** control unit in the **Overview**.
 - 14.2 Select **Maintenance/repairs**.
 - 14.3 Select **Teach combination sensor**. Follow instructions and procedure. Press •F12" ('Next') to continue.
- 15 Read out and erase the fault memories of all control units.
 - 15.1 Press •F7" in the control unit selection screen ('Overview' menu) to call up the Additional menu.
 - 15.2 **Read out all fault memories and erase them if necessary** must now be selected. Press •F12" ('Next') to continue ⇒ *Erase fault memory*.

- 15.4 Press •F8" to delete fault memory entries.
- 15.5 Press •F12" ('Yes') in response to the question asking whether you really want to delete all fault memory entries.

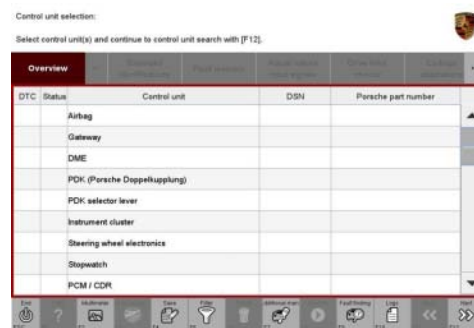
Control unit selection

15.6 Once you have erased the fault memories, select the **'Overview'** menu to return to the control unit selection screen ⇒ *Control unit selection*.
