Body/Chassis – SVR Carbon Fiber Hood Repairs

18-21MY Range Rover Sport SVR

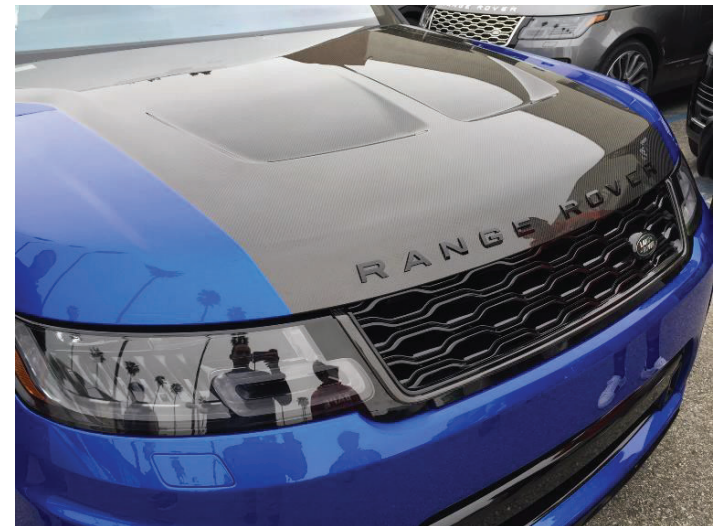
- A customer may complain that the clear coat paint on the vehicle hood is peeling, wrinkling or becoming discolored.

- This affects only Range Rover Sport SVR vehicles with the carbon pack option (exposed carbon fiber in center of hood).
- The clear coat paint may start to wrinkle (orange peel), discolor (get an amber hue) and start to peel/flake off due to UV damage.

- The carbon fiber hood finish is repairable in almost all circumstances.
- The clear coat paint can be removed (sanded off) to the carbon fiber gelcoat layer and refinished.
- SSM 75913 is being published for this concern.

Please Note: Any paint related repair over 8 hours in labor required prior approval via FRED for warranty repairs.
