## 3.0L Cam Carrier Inspection Update Prior to Sale Campaigns N763 and H426

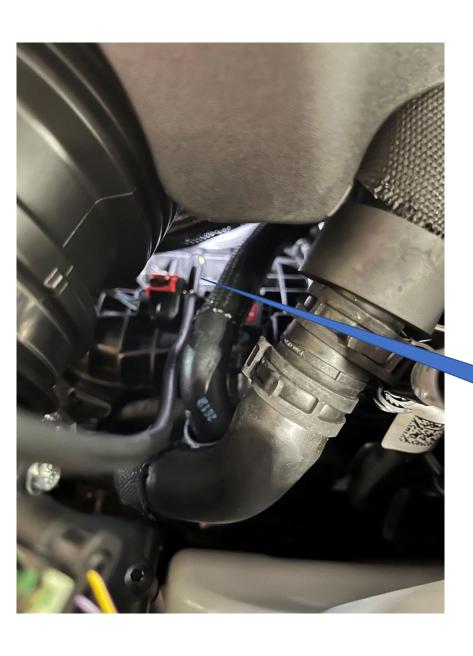
Using a suitable borescope, slide the end of the scope below the air intake on the left hand side, above the intake air sensor connector, just in front of the coolant hose.

The engine cover does not need to be removed to complete the inspection.

The drill marks to be inspected are on the side of the cylinder head, straight in from where the end of the borescope is in the picture.

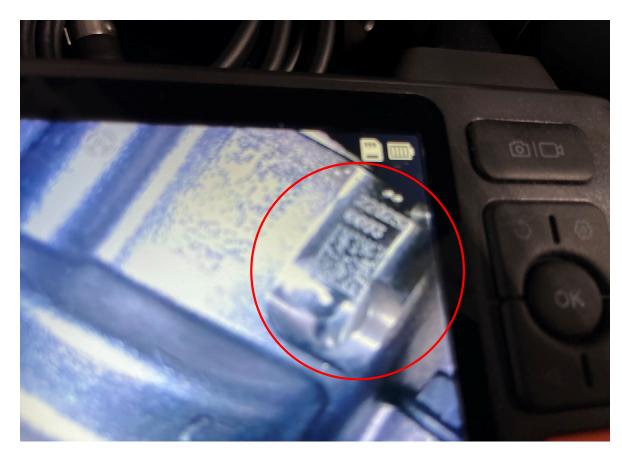
The markings to inspect are just below the QR code.

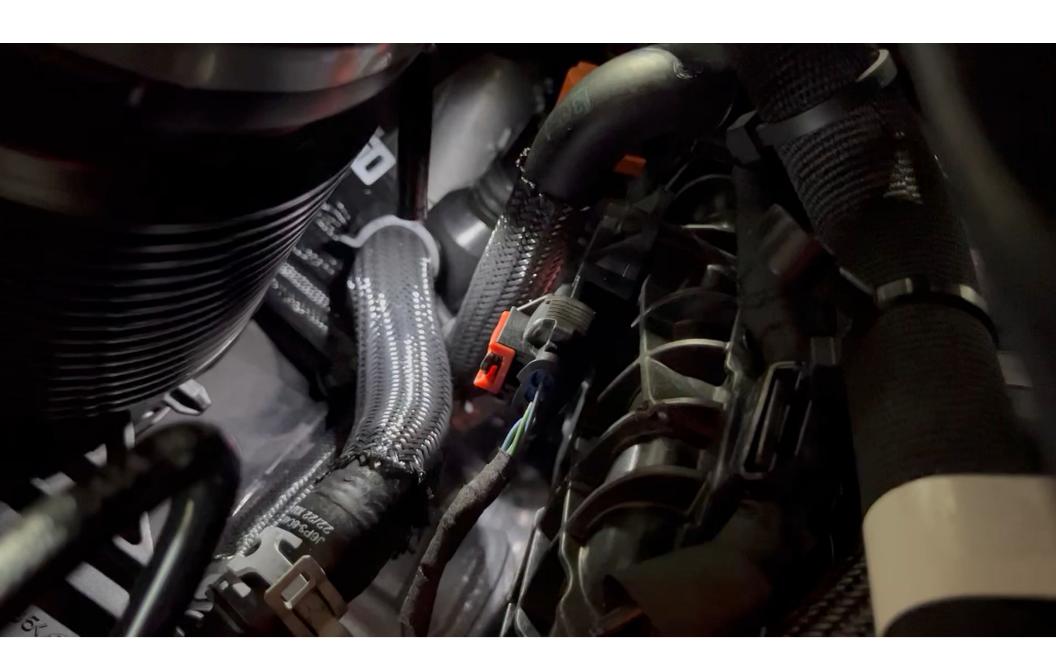
The video on the left and on the following slide shows the borescope being inserted to inspect the markings.
