**NUMBER:** 23-002-23

Steering Wheel Leather Peeling at Lower Ring

This bulletin involves inspecting the leather wrap on the steering wheel and possibly replacing the steering wheel and lock nut.

2022 (WL) Jeep Grand Cherokee

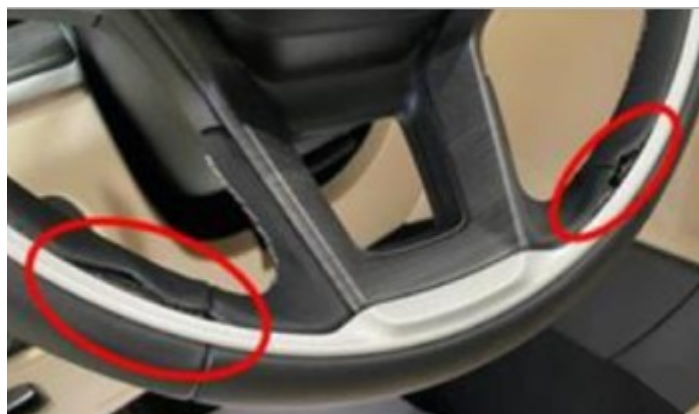
**Fig. 1**  
**Leather Wrap Peeling**

- Steering wheel leather wrap loose or peeling due to lack of glue around the three to five and/or the seven to nine o'clock positions. (Fig. 1) .

1. Replace the steering wheel and hex lock nut. Refer to the detailed service procedures available in DealerCONNECT/Service Library under: Service Info> 19 - Steering /Column /Wheel, Steering /Removal and Installation.

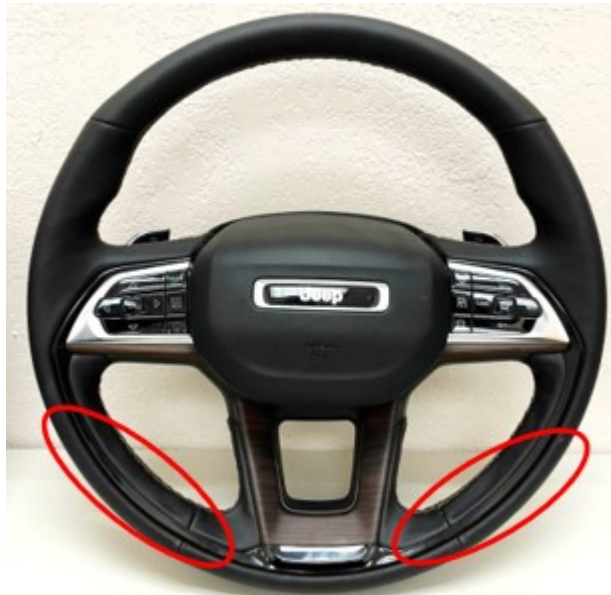
**Fig. 2**  
**Decorative Ring Area**

1. Inspect the steering wheel leather wrap around the three to five and/or the seven to nine o'clock positions.
2. Look for any evidence of exposed leather edges along the decorative ring area (Fig. 2) .

3. Run your thumb along the ring twisting from the outside of the wheel to see if the leather is loose next to the ring (Fig. 2) .

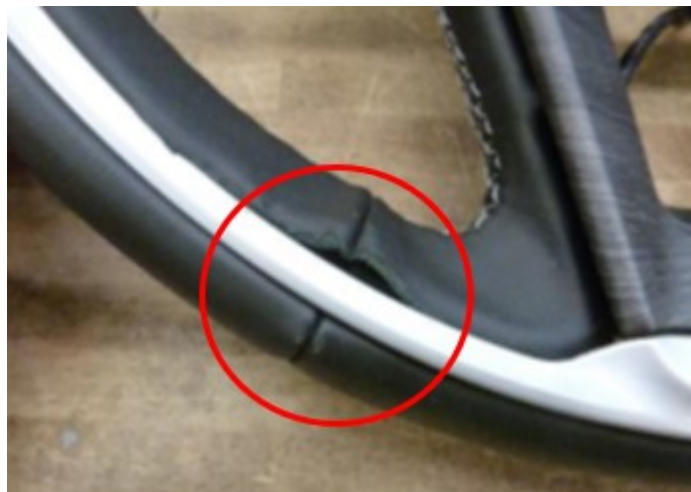
**Fig. 4**  
**Leather Peeling**

5. Is the leather loose, or peeling around the three to five and/or the seven to nine o'clock positions (Fig. 4) and (Fig. 5) ?

- YES>>> Proceed to [Step 1](#) of the Repair Procedure.
- NO>>> This bulletin does not apply. Use Inspection LOP (19-85-01-9E) to close the active RSU.
