# **Technical Journal**

TITLE:					
Internet Connectivity symbols in CCD					
REF NO:	ISSUING DEPARTMENT:	CAR MARKET:			
TJ 36187.3.0	Technical Service	United States and Canada			
	PARTNER:	ISSUE DATE:	STATUS DATE:		
3 US 7	7510 Volvo Car USA	2023-01-04	2023-01-11		
FUNC GROUP:	FUNC DESC:				
3975	Mobile data services, general	Page 1 of 4

# **Technical Journal 36187.3.0**

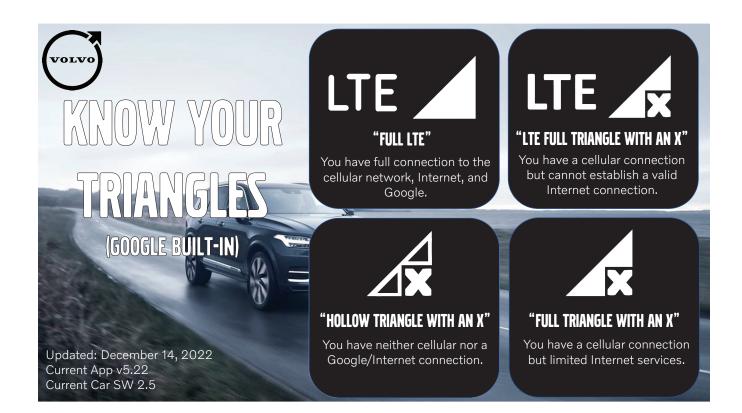
If the vehicle has no internet connection and shows either the "Hollow Triangle With An X" or "LTE Full Triangle With An X" (see attached "Know Your Triangles.pdf") symbol in the CCD please see advice under "Service."

### Hollow Triangle with X:

#### This symbol will most likely appear when there is an issue relating to the TCAM unit.

#### LTE Full Triangle With An X:

When LTE is displayed this means that the TCAM unit is connected to a network. Issue is likely to be caused by either a network issue or communication issue between IHU and TCAM.

- If the customer has done a TCAM <u>restart</u> via the front defrost button and 24-48hrs have passed without any improvement, please try to <u>reset</u> the TCAM through the VIDA application.
- If no diagnostic connection is possible, a <u>hard reset</u> of the TCAM BUB (Back-Up Battery) and 12V Main battery (by physically disconnecting power) is needed. Please observe that the BUB needs to be disconnected **prior** to disconnecting the 12V Main battery.

- Perform an IHU restart by pressing and holding the home button for approximately 20 seconds.
- If symptom is still present, do a TCAM <u>restart</u> by pressing and holding the front defrost button for approximately 20 seconds.
- If no change after 24-48 hours and no known network disturbances have occurred, please fault trace as normal using VIDA.
