Rear Taillight Access Panel (XT)

Bulletin Type:	SRP	Publication Date:	March 2023
Bulletin #(s):	23-092	Make(s):	Jayco & Entegra Coach
Job Code(s):	<i>If affected unit has warranty remaining, submit your claim following the normal process</i>	Model(s):	Accolade XT (3JL, 3JU) Seneca XT (4JL, 4JU)
Flat Rate(s):		Model Year(s):	2023

REAR TAILLIGHT ACCESS PANEL REPLACEMENT INSTRUCTIONS

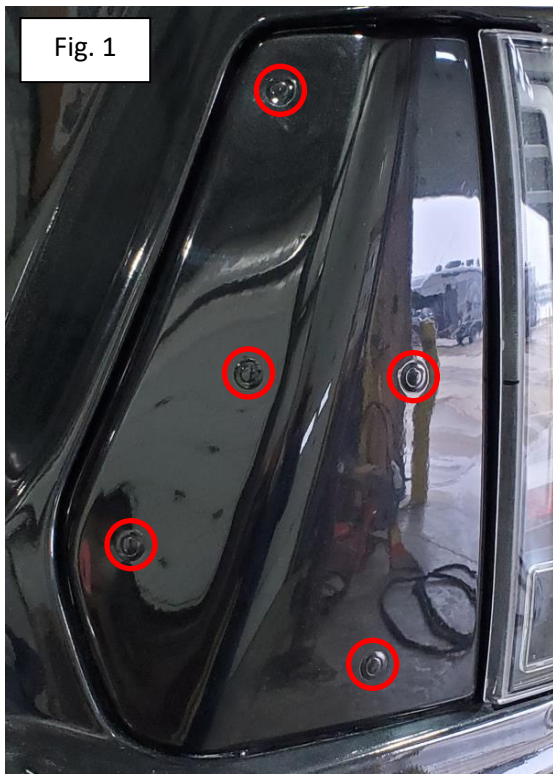
1. Removing the existing taillight access covers. (Figure 1)
 - A. Open the screw retainer to expose the five mounting fasteners.
 - B. Remove mounting fasteners to remove the taillight access cover.
2. Installing the new taillight access covers. (Figure 2)
 - A. Hold new taillight access cover in place and drill four mounting holes with .368 drill bit.
 - B. Install the push rivets to secure the taillight access cover.
3. Repeat for opposite side.

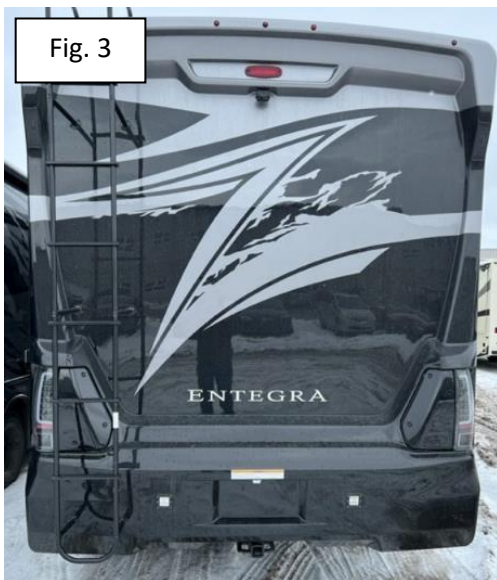
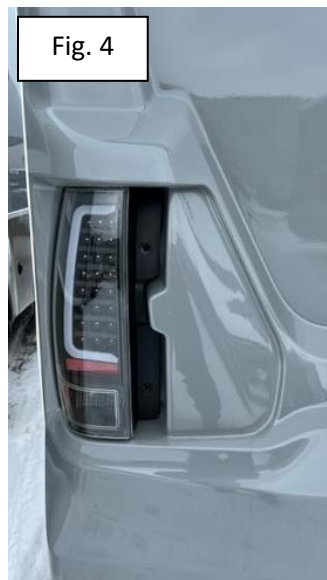
4. The finished repair should look like figures 3 and 4.
