Technical Service Bulletin

Mazda North American Operations Irvine, CA 92618-2922

LEATHER STEERING WHEEL SURFACE WEAR / PEEL

Bulletin No.: 06-001/23

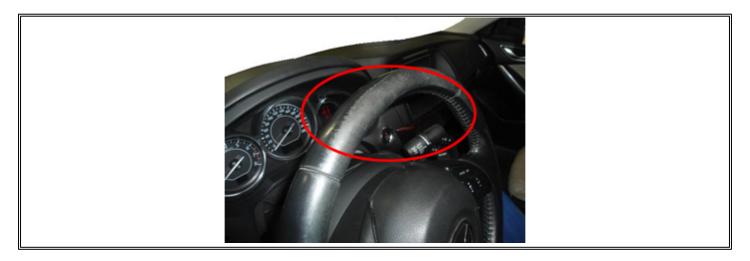
Some vehicles may exhibit wear/peel-off of the leather steering wheel surface causing a poor appearance. This concern may be caused by an insufficient wear resistance of the steering wheel surface.

NOTE: Slight wear on a seam of the steering wheel is not applicable to this bulletin. It is inevitable since friction and force are applied while turning the steering wheel.

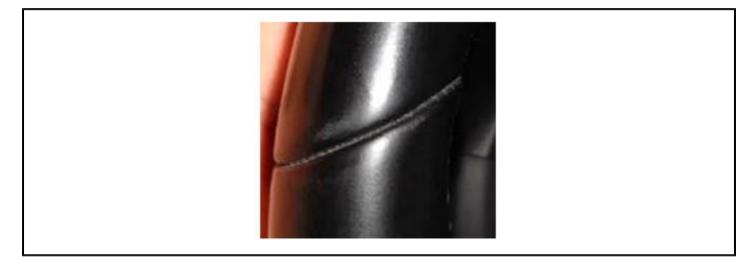
NOTE: Dirt on the steering wheel may be misinterpreted as leather discoloration or a worn coating. This is not applicable to this bulletin. Refer to TIPS WHEN HANDLING LEATHER STEERING WHEEL below to remove dirt.

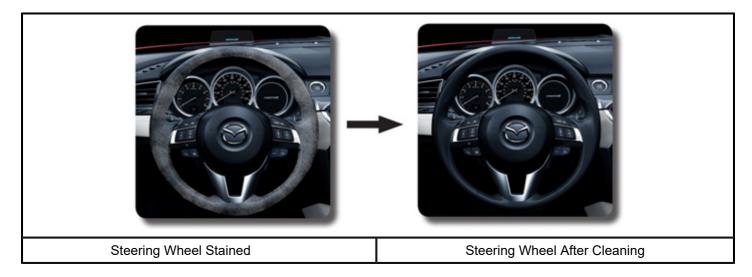
1. Use a clean towel damped in leather/vinyl cleaner or mild soap to clean the steering wheel.

NOTE: Some vehicles may have steering wheel stains caused by chemicals such as hand lotions.

2. Is the steering wheel wear/peel concern present after cleaning the steering wheel?

- Yes Go to Step 3.
- No This service bulletin does not apply.

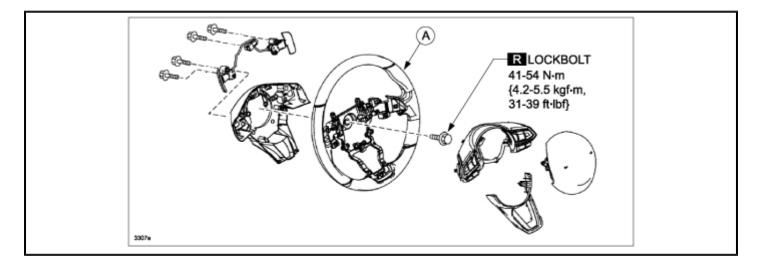
3. Replace the steering wheel (A) according to the repair instructions on MGSS online:

- Mazda3 STEERING WHEEL AND COLUMN REMOVAL/INSTALLATION.
- Mazda6 STEERING WHEEL AND COLUMN REMOVAL/INSTALLATION.
- CX-3 STEERING WHEEL AND COLUMN REMOVAL/INSTALLATION.
- CX5 STEERING WHEEL AND COLUMN REMOVAL/INSTALLATION.
- CX9 STEERING WHEEL AND COLUMN REMOVAL/INSTALLATION.

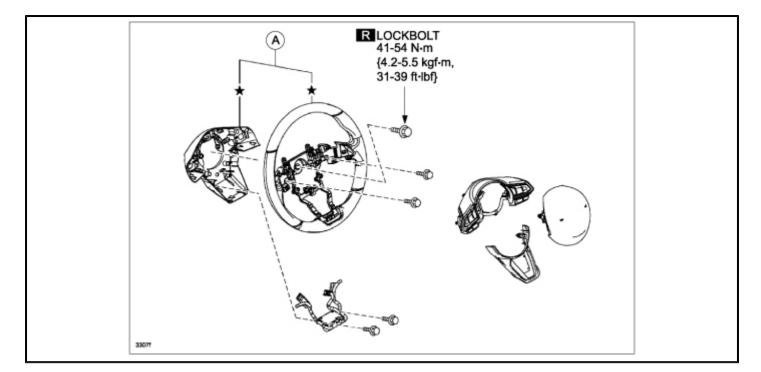
NOTE: For vehicles with a steering wheel warmer, replace the steering wheel hub kit (A).

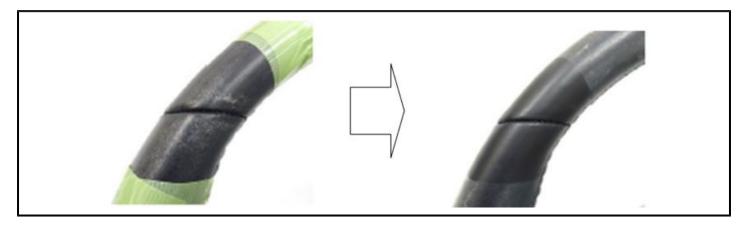
If the leather surface is dirty, wipe it off with a moist cloth using warm water. After wiping, dry off the remaining moisture with a clean dry towel.

NOTE: To avoid wear to the leather, do not use a rough surface towel or wipe off with too much force.

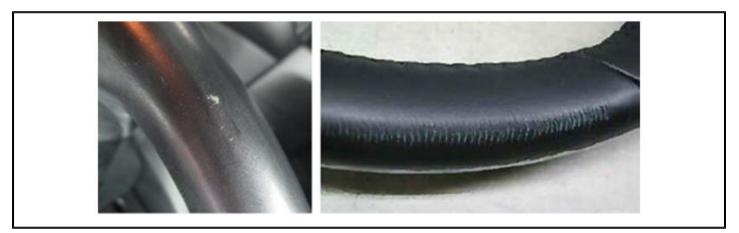
- Do not use general leather cleaners or waxes when wiping off dirt since it may deteriorate the leather coating of the steering wheel. In addition, perfumes, cosmetics, hand creams, sun screens, wet tissue papers, excessive sweat and sebum may also deteriorate the coating.
- Do not scratch or scrub the leather with anything hard, such as a belt buckle, wrist watch, bracelet or rings etc.

NOTE: The examples above are caused by outside influence and therefore not covered under this bulletin.
