<b>HYUNDAI</b> <b>Technical Service Bulletin</b>	<b>GROUP</b> <b>CAMPAIGN</b>	<b>NUMBER</b> <b>23-01-013H</b>
	<b>DATE</b> <b>MARCH, 2023</b>	<b>MODEL(S)</b> <b>TUCSON (NX4a),  SANTA CRUZ (NXT)</b>
<b>SUBJECT: SUNROOF INITIALIZATION GUIDE (SERVICE CAMPAIGN T9H)</b>

**Description:** Some 23MY Tucson and Santa Cruz vehicles' sunroofs were not programmed at the factory. This causes the sunroof to become inoperable. This bulletin provides information to program sunroof operation.

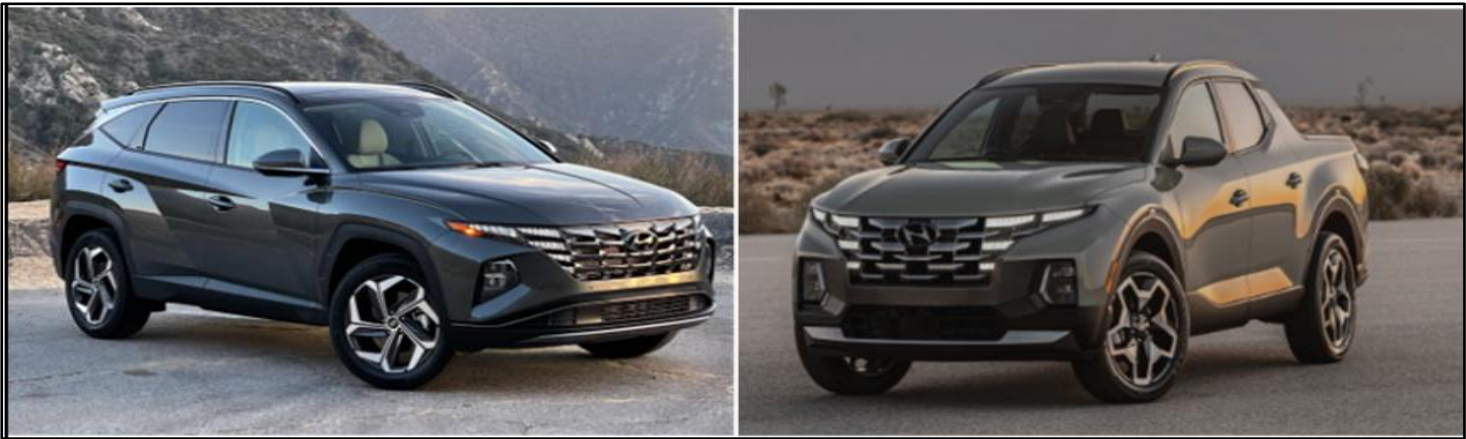
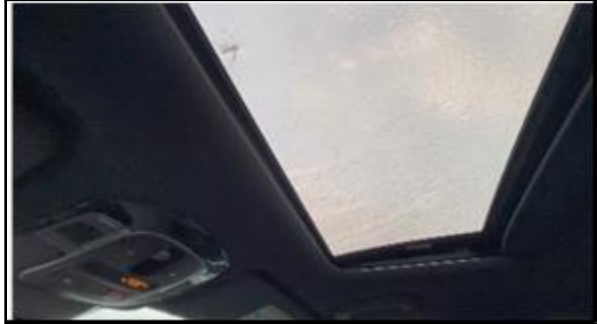
1. Turn the ignition key to the ON position and then close the sunroof completely.
2. Release the sunroof control lever.
3. Press and hold the CLOSE button for more than 10 seconds until the sunroof is closed and it has moved slightly.
4. Release the sunroof control lever.
5. Press and hold the CLOSE button once again within 3 seconds until the sunroof does as follows: Tilt down → Slide Open → Slide Close. Then, release the lever.
6. Reset procedure of sunroof system is finished.
