# INSTRUCTION TO SERVICE

ITS-60660		March 4, 2023
<b>SECTION:</b>	549-HVAC SYSTEM	
<b>WRITTEN BY:</b>	Mark Reitz	
<b>SUBJECT:</b>	Hose clamp replacement for Eberspaecher auxiliary heater fuel supply lines.	
<b>ISSUE:</b>	Coach auxiliary heater installations have been found with the incorrect size hose clamps on the fuel supply lines.	
<b>SUMMARY:</b>	Performing this procedure will ensure the proper fuel line clamps are being used.

# ITS-60660

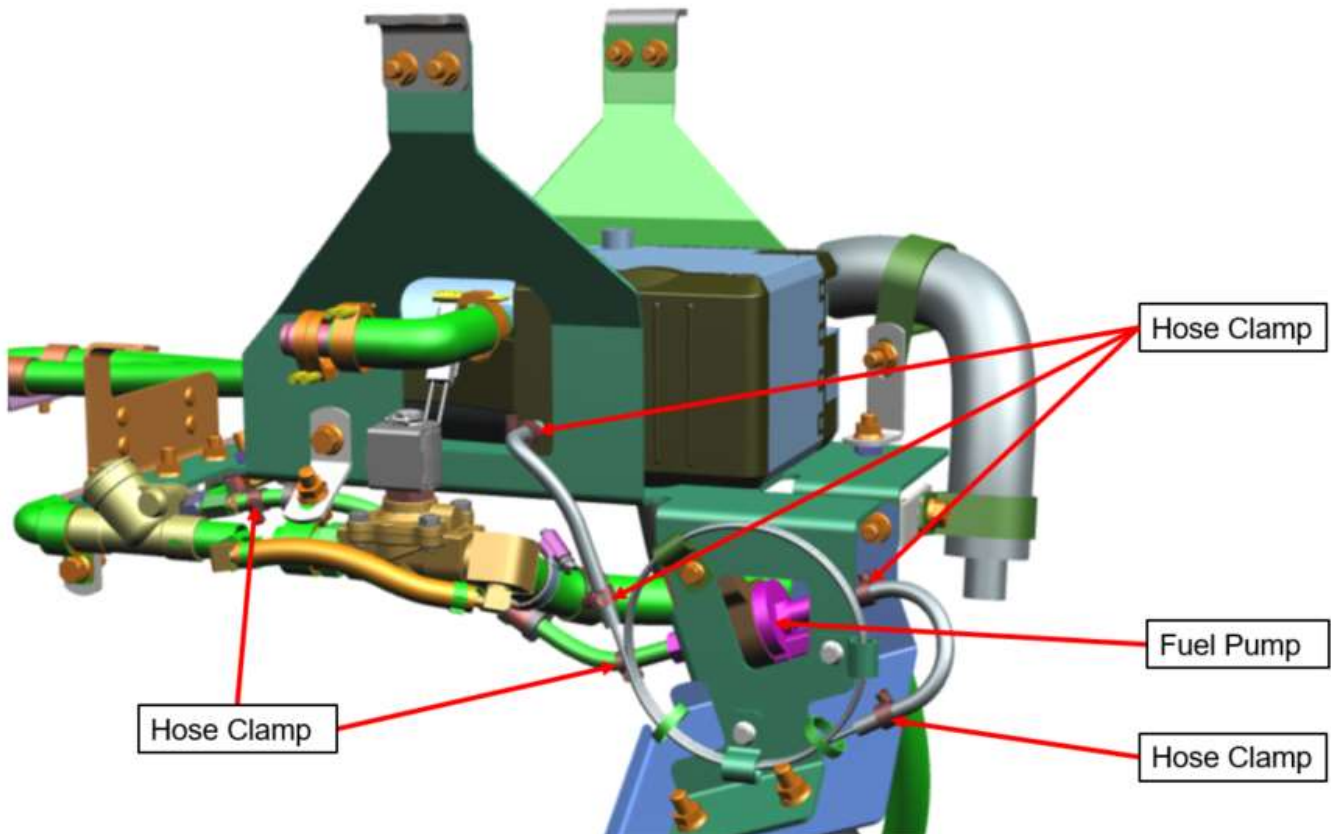
1. Set park brake and chock wheels.
2. Turn the main battery disconnect switch to the "OFF" position.
3. Ensure the engine has cooled down to room temperature.
4. Locate the six (6) hose clamps attached to the auxiliary heater fuel supply hoses. Remove and discard existing clamps.
5. Install new hose clamp, PN 8410272, at all six (6) locations. Torque hose clamps to 12-14 IN-LBS.

6. Start coach and the auxiliary heater and check for leaks.
