90 Instrument cluster: Audi virtual cockpit is blank

90 23 16 2064844/2 March 17, 2023. Supersedes Technical Service Bulletin Group 90 number 21-27 dated November 29, 2021, for reasons listed below.

Model(s)	Year	VIN Range	Vehicle-Specific Equipment
A4, A4 allroad, S4, A5, A5 Cabriolet, A5 Sportback, S5, S5 Cabriolet, and S5 Sportback	2020 – 2023		
A7 e quattro	2021 – 2022		
RS 5, RS 5 Sportback, A6, A6 allroad, S6, RS 6 Avant, A7, S7, RS 7, e-tron quattro, e-tron Sportback quattro, Q5, Q5 e quattro, Q5 Sportback, SQ5, SQ5 Sportback, Q7, SQ7, Q8, SQ8, and RS Q8	2021 – 2023	All	Virtual Cockpit

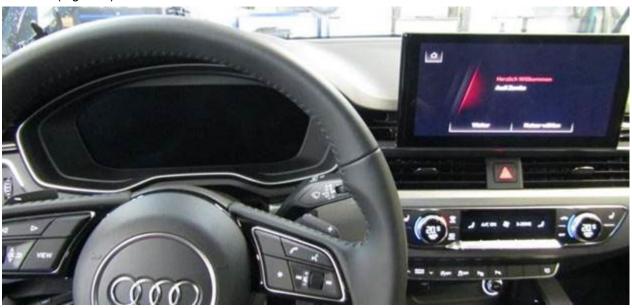
After the ignition is switched off and back on, the display may return to normal operation, but might also remain blank (Figure 1).

Figure 1. Audi virtual cockpit does not start-up; the screen remains blank (example).

The customer concern may be caused by an intermittent hardware issue in certain Audi virtual cockpit displays.

- Please check the production date of the currently installed instrument cluster.
 The production date can be read via ODIS:
 Self-diagnosis → Address: 0017 System name: 0017 Instrument cluster → Identification: → Production date
- 2. Please add a note in the claim comments if the production date is on or after Feb 8th 2023.
- 3. Please replace the Audi virtual cockpit according to the instruction in the Elsa Repair Manual.

Replacement parts can be used regardless of their production dates.
