August 2021  
D21M6 **REV4**

## **Subject: Gen 5 Customer Demo Unit (CDU) and Pre-Series Unit Retrofits**

**Models Affected: Specific 2021 Freightliner New Cascadia model vehicles, powered with DETROIT™ Gen 5 DD15 Engines manufactured February 3, 2020, through December 14, 2020**

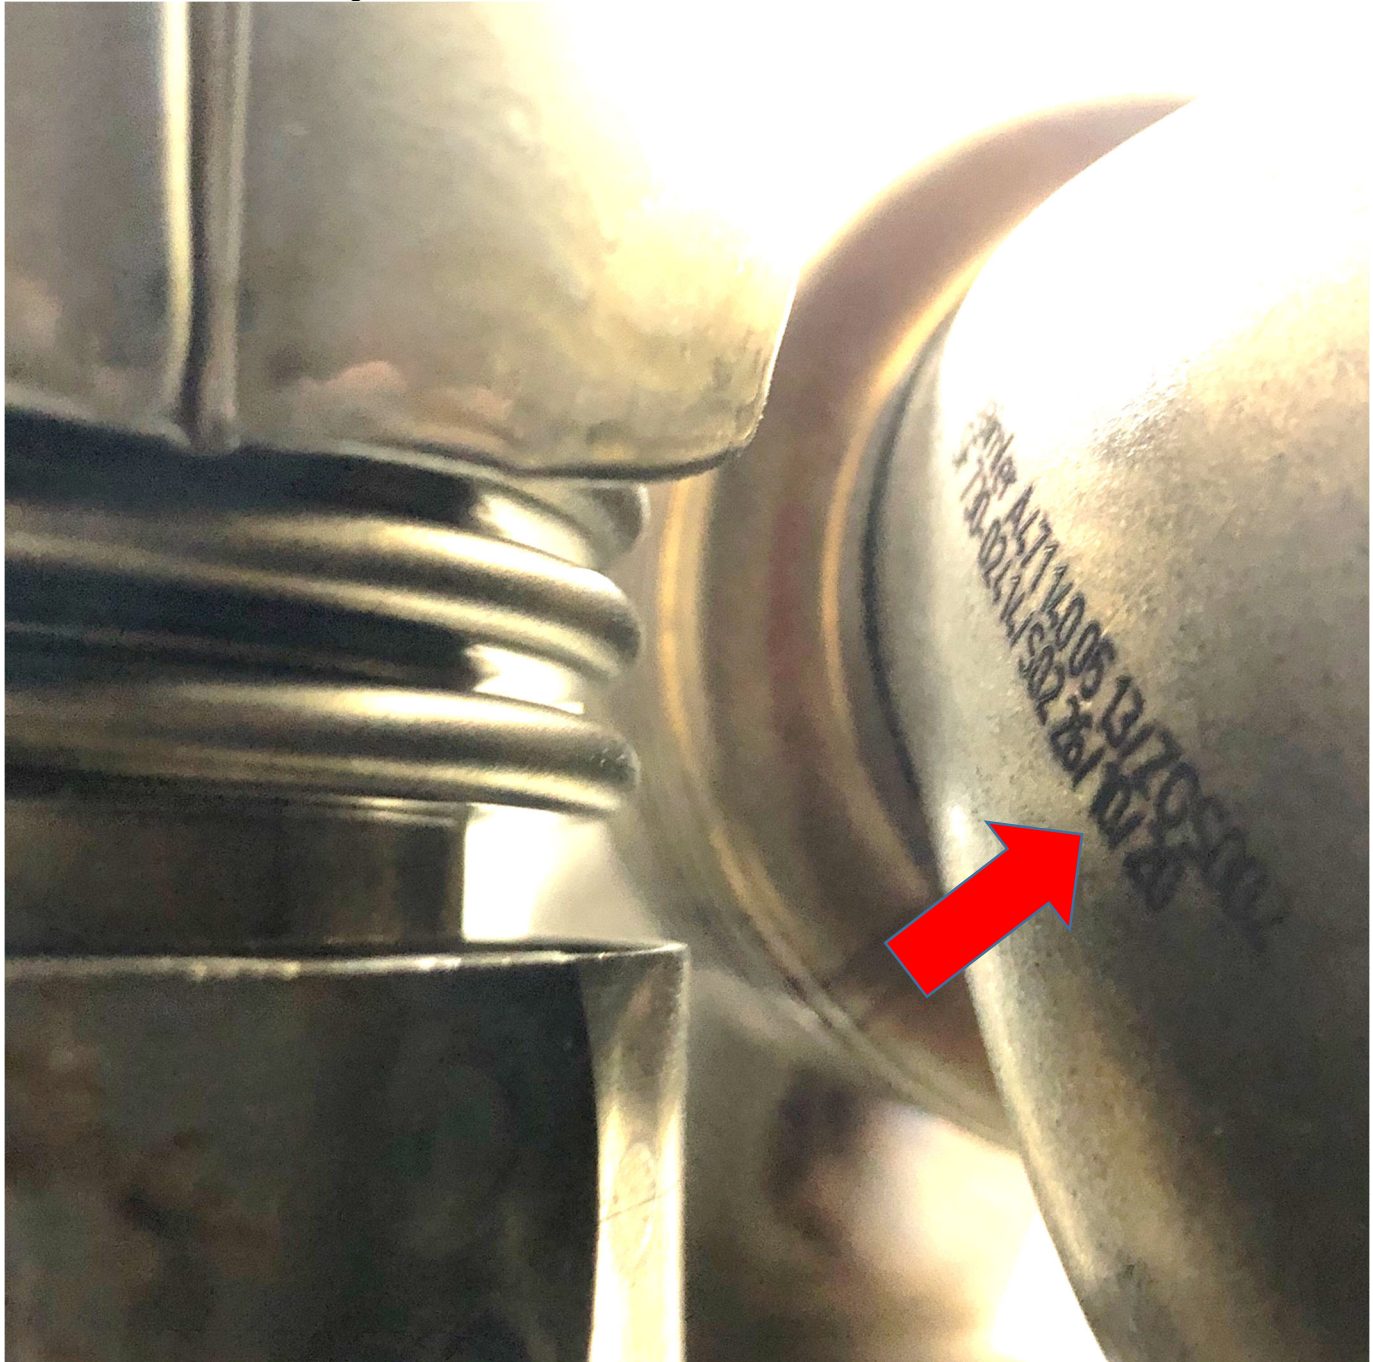
1. Please refer to the image below.

2. The red arrow is pointing to the date found on the EGR hot pipe. The date format is DD/MM/YY.
3. If the date is 31/07/20 or earlier, the EGR hot pipe needs to be replaced. Otherwise, it can be reused.
