# Advanced Technical Information

Bulletin #: 2014.4

## **AC Charging Hardware and Cable Temperature**

#### Vehicles Affected

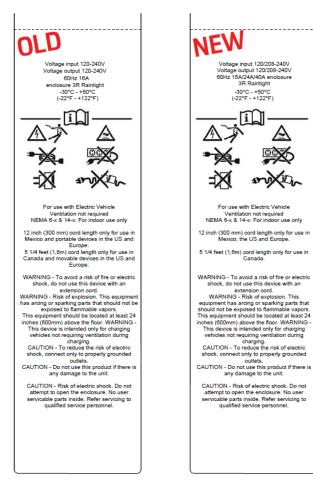
Errors may exist in the label affixed to supply cables provided with vehicles and cables produced through Calendar Year 2020.

Only one label variant exists and is affixed to all supply cables in USA and Canada (NEMA5-15, 6-/14-30, and 6-/14-50). Figure 1 shows the existing label with errors. Figure 2 shows the updated label.

Supply cables fitted with labels with errors are addressed with Workshop Campaigns WMP4 or WNM6.
