| <b>Tesla, Inc.</b><br>Service Bulletin | | <b>Replace Occupant Classification System (OCS) of Front Passenger Seat while Servicing Subcomponents</b> | |
| <b>SB-23-20-002</b><br>March 15, 2023 | | <b>R1</b> | |

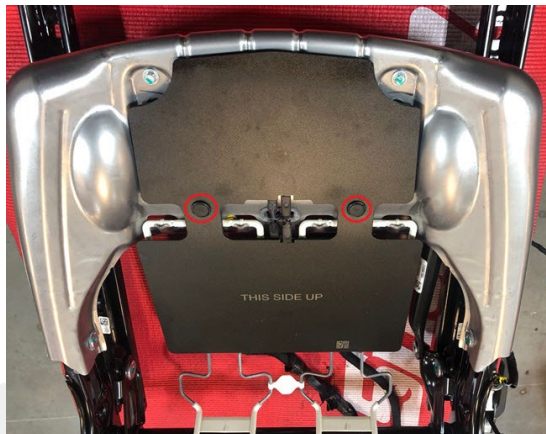
**Figure 1 – Model 3 shown; Model Y similar**

4. Remove the push clips (x2) that attach the front passenger seat OCS sandwich sensor to the seat frame (Figure 1).

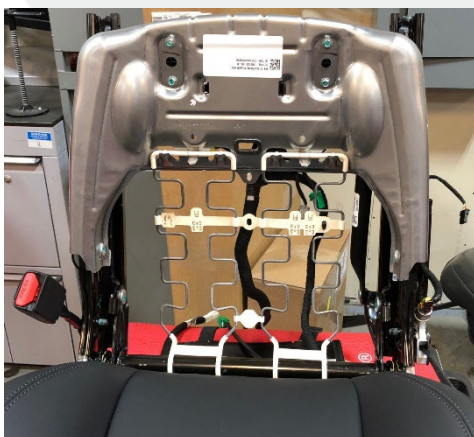
**Figure 2**

5. Remove and discard the front passenger seat OCS sandwich sensor from the seat frame (Figures 2 and 3).

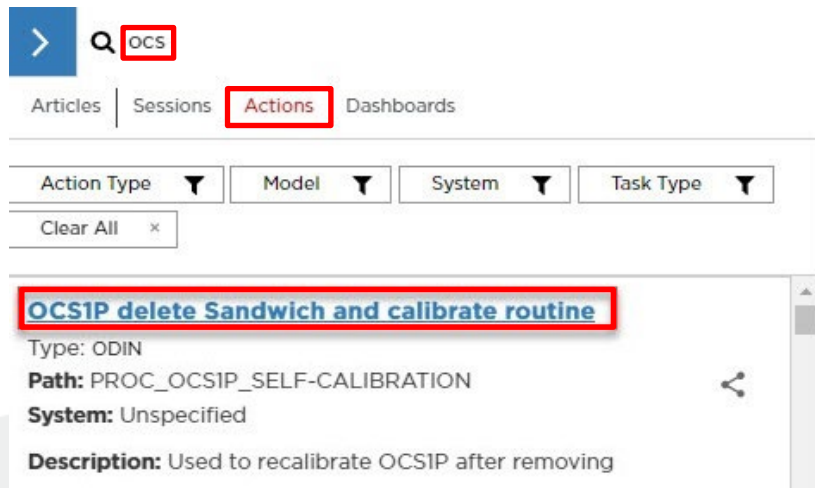
Figure 4

9. Click the **Actions** tab, search for “OCS”, and then select **OCS1P delete Sandwich and calibrate routine** (Figure 4).

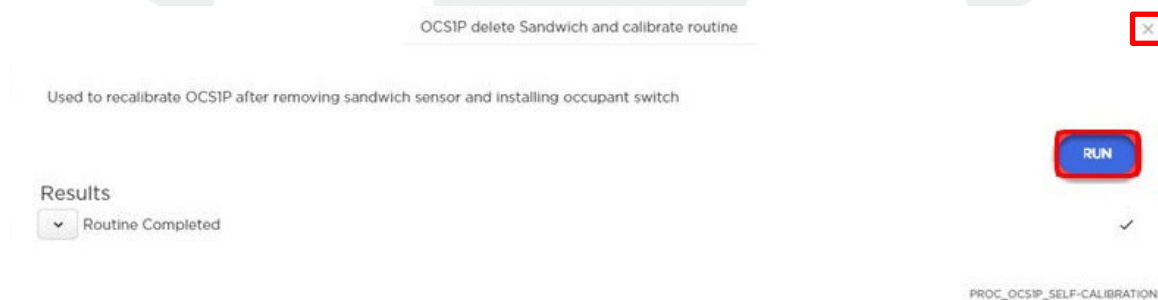
Figure 5

10. Click **Run** and allow the routine to complete. Select **X** at the top right of the window to exit once the routine is complete (Figure 5).

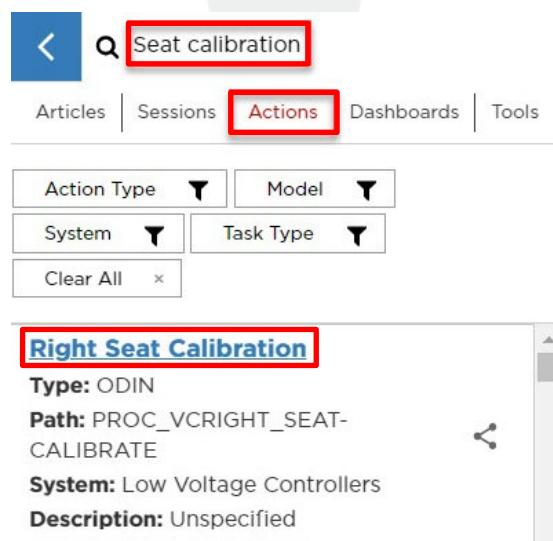
Figure 6

11. Click the **Actions** tab, search for “Seat calibration”, and then select **Right Seat Calibration** (Figure 6).

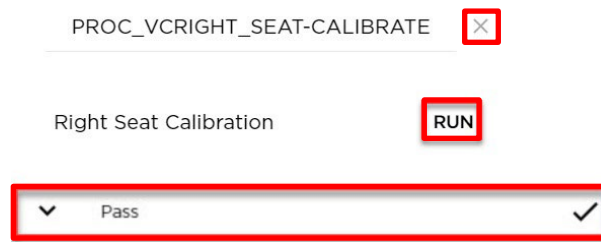
**Figure 7**

12. Click **Run** and allow the routine to complete. Select **X** at the top right of the window to exit once the routine is complete and “Pass” is displayed (Figure 7).
