GROUP	MODEL
Voluntary Service Campaign	2022-2023MY Telluride (ON)
NUMBER	DATE
SC254 (Rev 1, 04/18/2023)	January 2023

DRIVE BELT INSPECTION/REPLACEMENT (SC254)

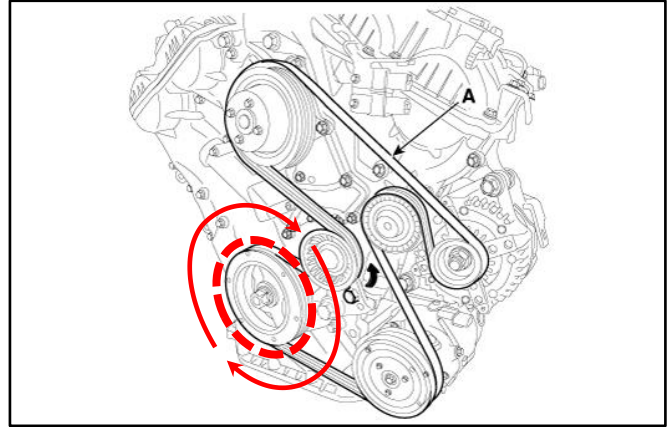
1. Open the hood.
2. Using the SST Crank Rotator Wrench (KQ231 2T102QQK) or equivalent tool, slowly rotate the crankshaft pulley clockwise until the **lot date** on the drive belt (A) is visible.

The lot date/number is printed in white text.

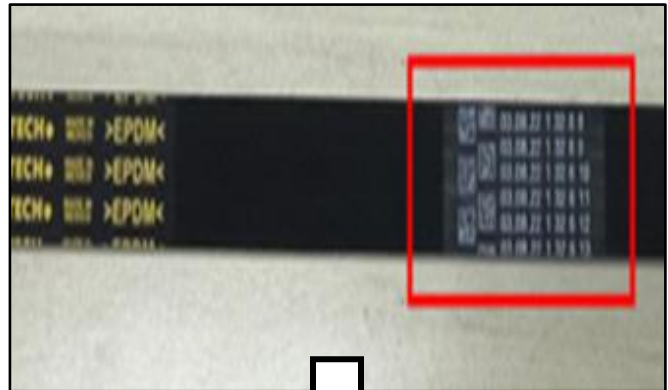
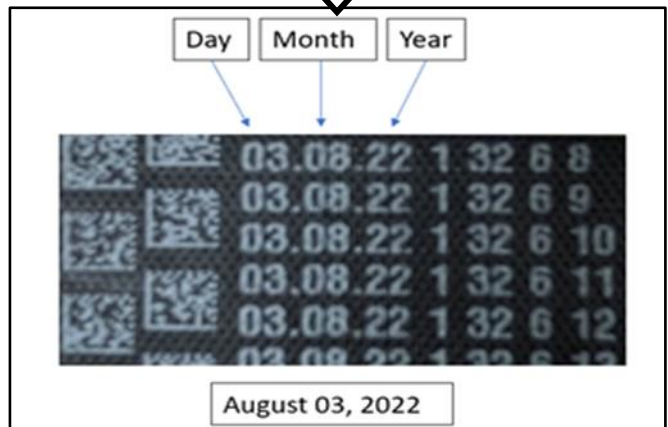
3. Record the drive belt manufacturing date as shown on the belt.

Note: The lot date is formatted as follows:

DAY . MONTH . YEAR

When recording the lot number date, ensure to write the date in the order shown on the belt in the repair comments when submitted for warranty.

4. If the manufacturer date is between **(NG)**:
 - **21.08.21 to 12.11.21** (August 21, 2021 to November 12, 2021) or
 - **between 29.03.22 to 25.05.22** (March 29, 2022 to May 25, 2022), then replace the drive belt with the new part by referring to "Maintenance → Drive Belt → Repair procedures" in the applicable Shop Manual on KGIS.

If the manufacturer date is between **(OK)**:

- **13.11.21 to 28.03.22** (November 13, 2021 to March 28, 2022) or
- **after 26.05.22** (May 26, 2022), then no further action is required.
