GROUP	MODEL
ELE	2021-2022MY Sorento HEV, PHEV (MQ4 P/HEV)
NUMBER	DATE
271	April 2023

TECHNICAL SERVICE BULLETIN

SERVICE ACTION: INVERTER COOLANT/DEBRIS FLUSHING/REPLACEMENT FOR CLUSTER MESSAGE

"REFILL INVERTER COOLANT" (SA515)

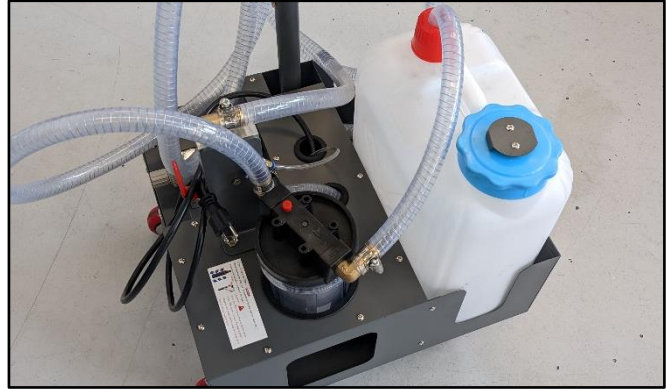
1. Refer to TSB [SST080](#) 'Coolant Flushing Machine Guide' for initial setup/cleaning instructions before beginning work.

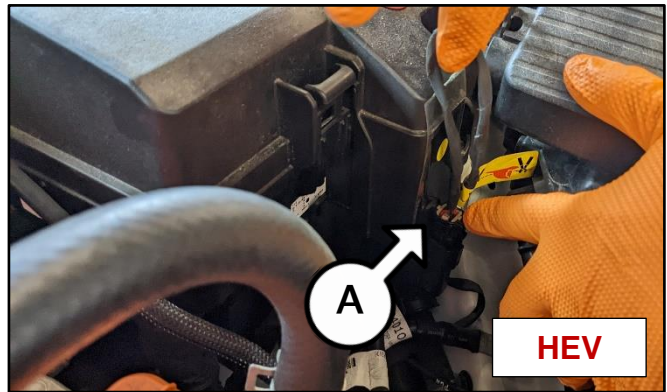
- HEV

2. Open the hood and remove the service interlock connector (A).

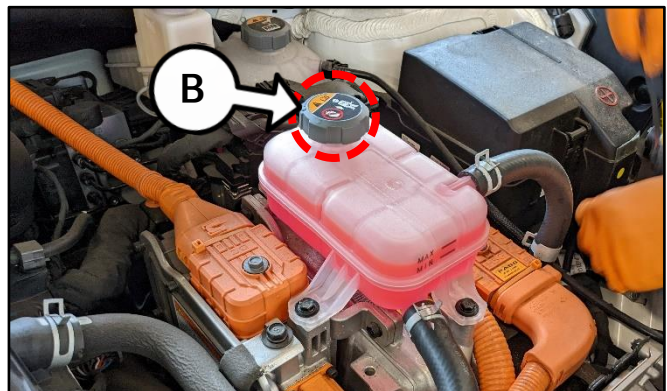
3. Remove the coolant reservoir cap (B).

(HEV model shown above for reference purpose only)

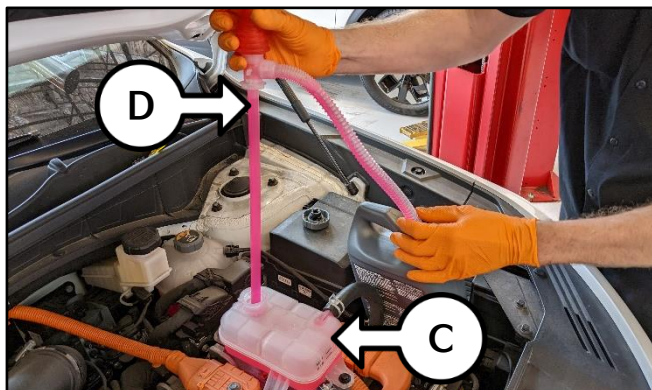
4. Drain the coolant from the reservoir (C) into an empty container using the SST kit 'syphon pump' (D).

(HEV model shown above for reference purpose only)

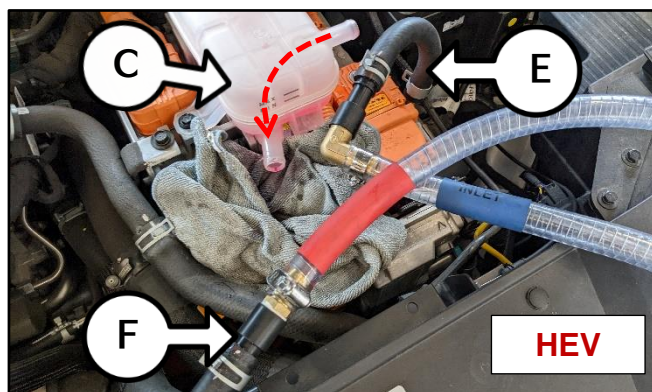
5. **HEV:** Remove both the inlet (E) and outlet (F) circulation hoses (HEV model shown) from the coolant reservoir (C).

Connect the Inlet (E) and Outlet (F) hoses from the flushing machine to the detached circulation hoses (E and F) as shown.

Remove the coolant reservoir (C).

(HEV model shown above for reference purpose only)

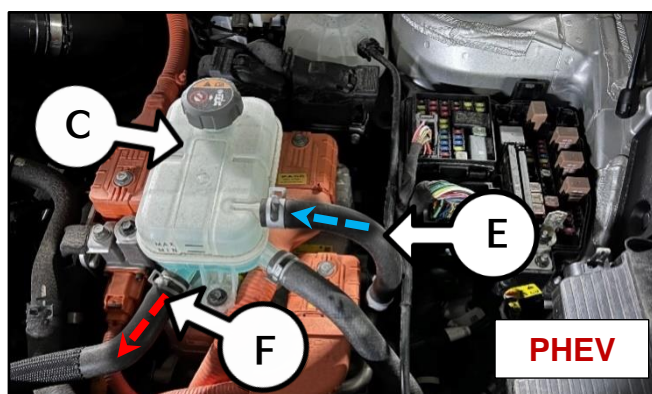
PHEV: Remove both the inlet (E) & outlet (F) circulation hoses (HEV model shown) from the coolant reservoir (C).

Connect the Inlet (E) and Outlet (F) hoses from the flushing machine to the detached circulation hoses (E and F) as shown.

Remove the coolant reservoir (C).

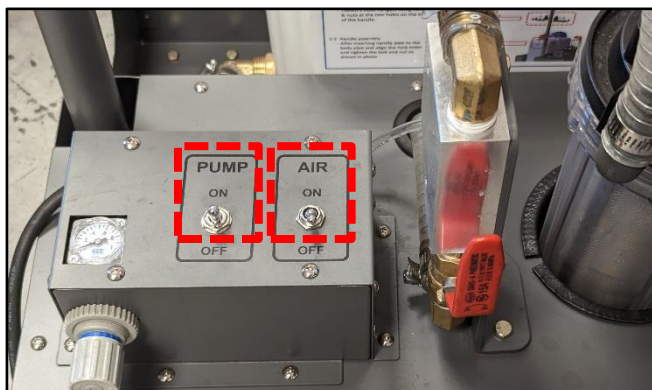
6. Turn the 'Air' and 'Pump' toggle switches of the flushing machine to the 'ON' position to begin the 1st flush of the coolant pipe. Follow the outlined instructions to **complete three (3) coolant flushes** for both HEV & PHEV.

NOTE: An additional separate flush of the air separator is required for PHEV ONLY.

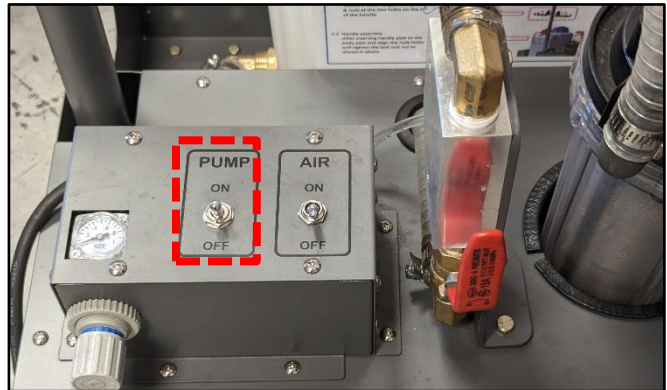
- After the three (3) minutes have passed, turn the flushing machine 'Pump' toggle switch to the 'OFF' position.

Note: Keep the 'Air' toggle switch in the 'ON' position to drain excess coolant remaining in line for at least thirty (30) seconds.

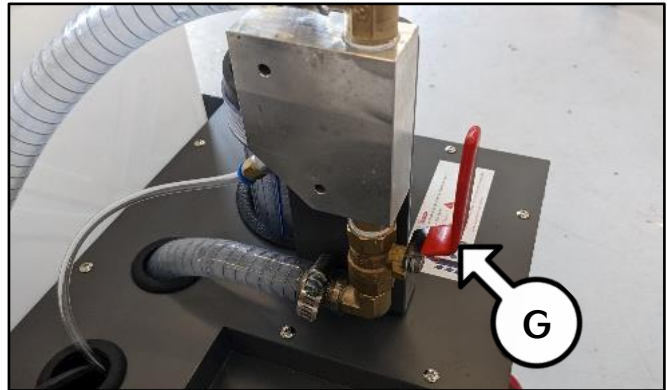
Note: The coolant 'Pump' should be turned 'OFF' and the 'Inlet Valve' (G) closed. When the 'Inlet Valve' is opened, air may flow back and the coolant drain.

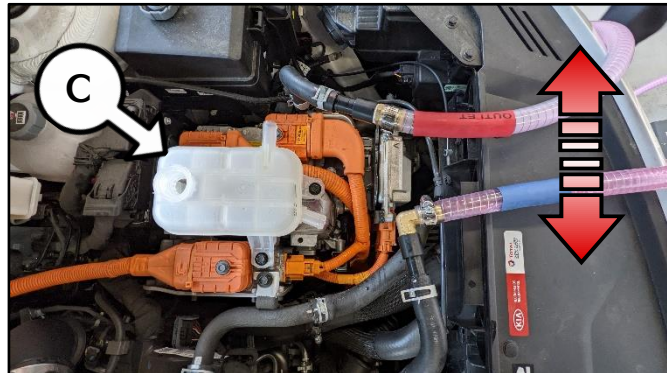
- Detach the Inlet/Outlet hoses from the vehicle and then reverse (switch) the flushing machine Inlet/Outlet hoses to the vehicle as shown.

Note: Outlet to Inlet and Inlet to Outlet

- Reinstall the coolant reservoir (C) in the reverse order of removal.

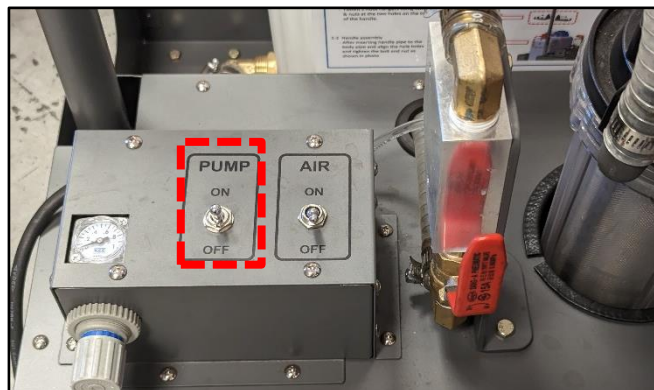
11. Turn the flushing machine 'Pump' toggle switch to the 'ON' position and allow the flushing machine to run for three (3) minutes to begin the **2nd flush** of the coolant pipe.

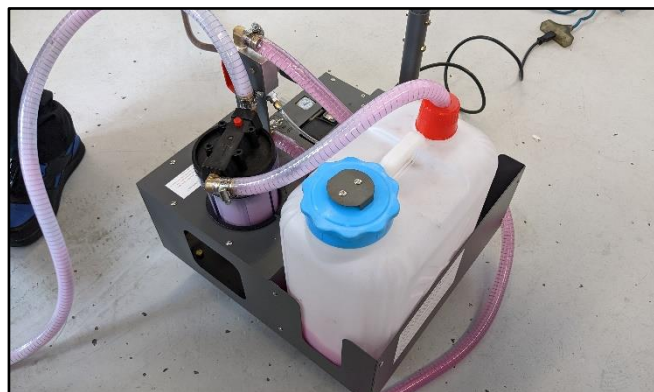
12. After the **2nd flush** is complete, repeat step 8 for a **3rd flush** to complete flushing of the coolant pipe.

13. After the three (3) minutes have passed, turn the flushing machine 'Pump' toggle switch to the 'OFF' position.

Note: Keep the 'Air' toggle switch in the 'ON' position to drain excess coolant remaining in line for at least thirty (30) seconds.

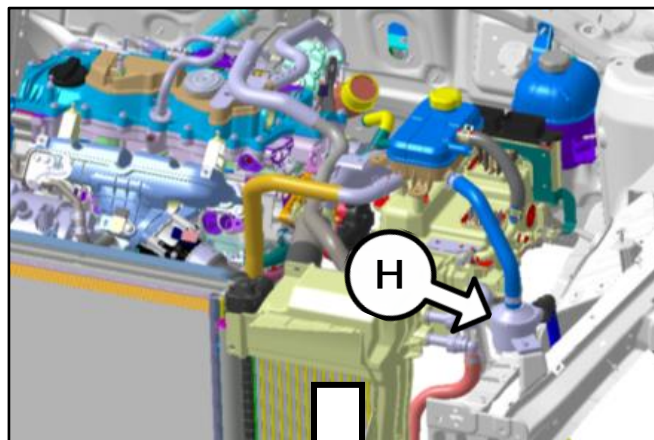
14. **PHEV ONLY:** Locate the two (2) inlet (E) & outlet (F) circulation 'quick-connect' hoses (PHEV ONLY) from the air separator (H) and disconnect them from the air separator.

PHEV ONLY: The air separator (H) may be removed for more access.

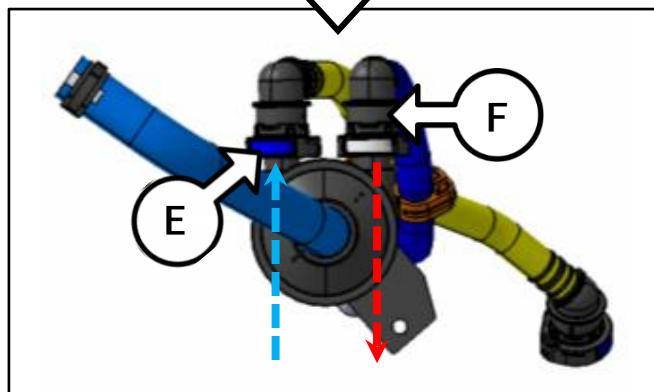
15. Connect the Inlet and Outlet hoses from the flushing machine to the detached circulation hoses (E and F) shown.

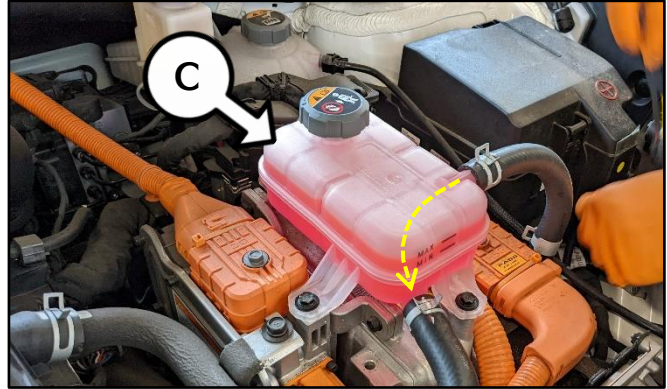
18. Reattach the coolant reservoir (C) Inlet and Outlet hoses in the reverse order of removal and fill the coolant reservoir (C) with the applicable new coolant/antifreeze for the vehicle.

(HEV model shown above for reference purpose only)

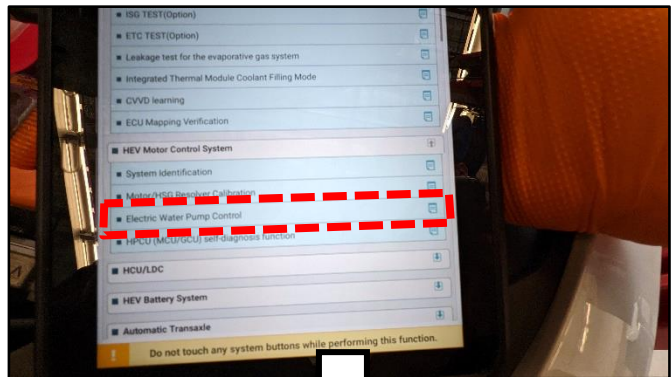
19. Perform air bleeding using KDS by running the HEV Motor Control System > Electric Water Pump Control.

Note: Continue filling the coolant reservoir (B) with the applicable new coolant/antifreeze as needed to complete the air bleeding process.

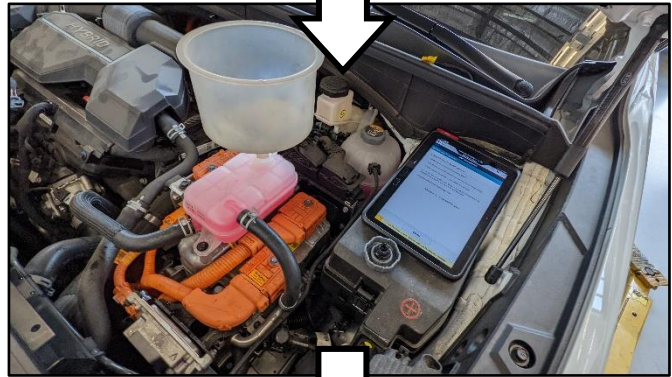
20. Install the coolant reservoir cap and secure tight.
21. Confirm normal vehicle operation.

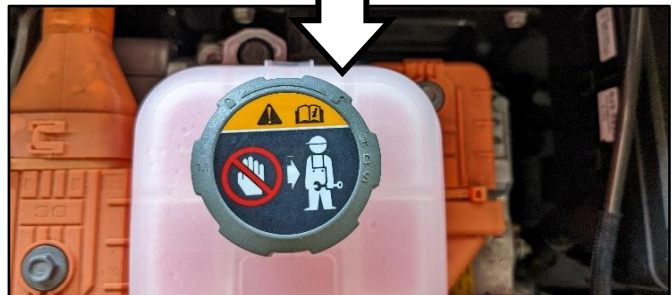
22. Replace the coolant reservoir cap label.
23. Insert Leaflet in the Owner's Manual.
