# Technical Journal

**Upper front suspension creaking/knocking noise**

<b>REF NO:</b> TJ 36512.1.0	<b>ISSUING DEPARTMENT:</b> Technical Service	<b>CAR MARKET:</b> United States and Canada	
<b>PARTNER:</b> 3 US 7510 Volvo Car USA		<b>ISSUE DATE:</b> 2023-02-06	<b>STATUS DATE:</b> 2023-02-09
<b>FUNC GROUP:</b> 7233	<b>FUNC DESC:</b> Mounting	Page 1 of 3

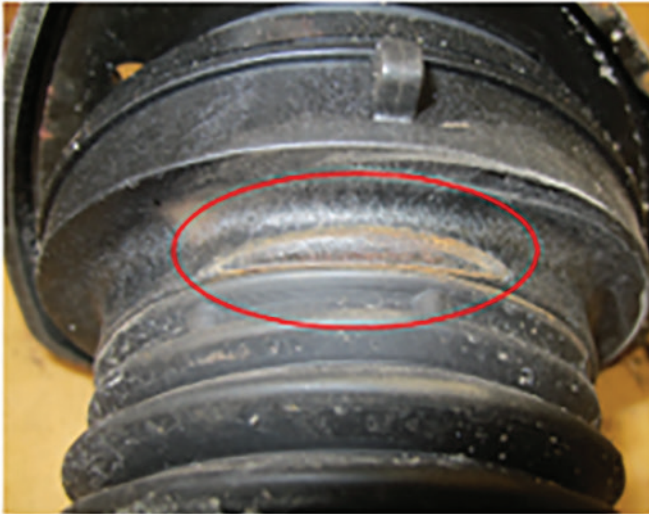
- During acceleration/braking (knocking noise.MOV and picture 1)
- During (slowly) driving over bumps and into turns (knocking noise.MOV and picture 1)
- During turning to left or right when standing still (Creaking noise.mp4 and picture 2)
- During parking maneuvering (Creaking noise.mp4 and picture 2)

Only replace the upper bearing according to VIDA.

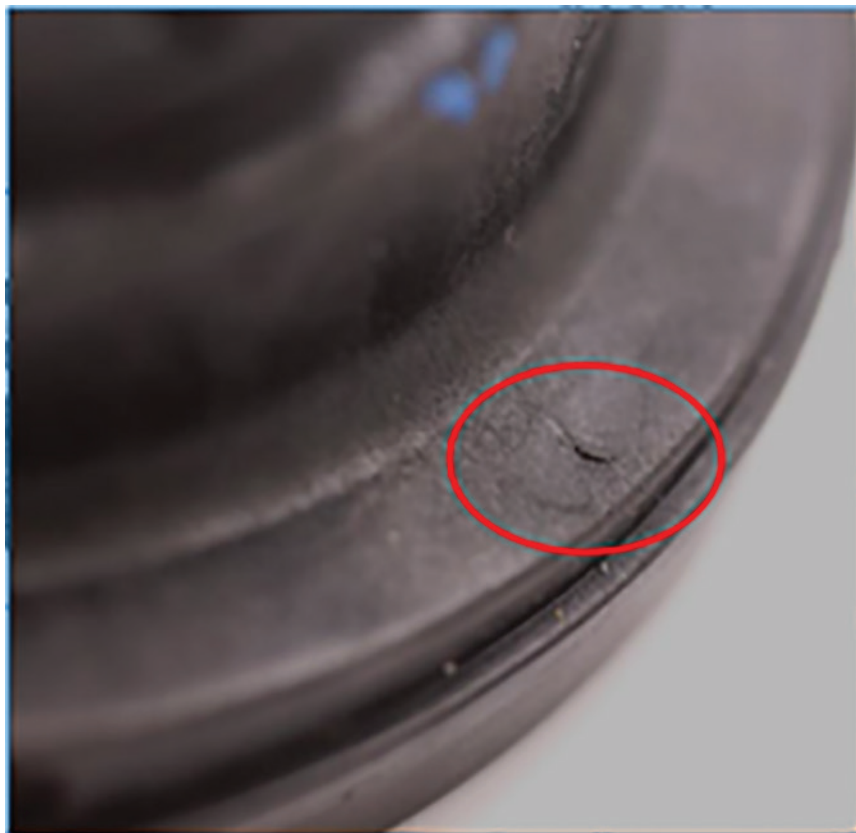
If there is a confirmed creaking/knocking noise from the upper front suspension:
