Technical Service Bulletin

GROUP	NUMBER
CAMPAIGN	23-01-040H
DATE	MODEL(S)
APRIL 2023	NEXO (FE)

SUBJECT: HMU UPDATE & PRESSURE RELIEF VALVE (PRV) REPLACEMENT (SERVICE CAMPAIGN T9A)

Description: Some NEXO (FE) vehicles may exhibit charging interruptions during hydrogen charging due to sensitive leak detection logic diagnostic conditions. This bulletin outlines the procedure to update the HMU controller software and replace the PRV (Pressure Relief Valve).

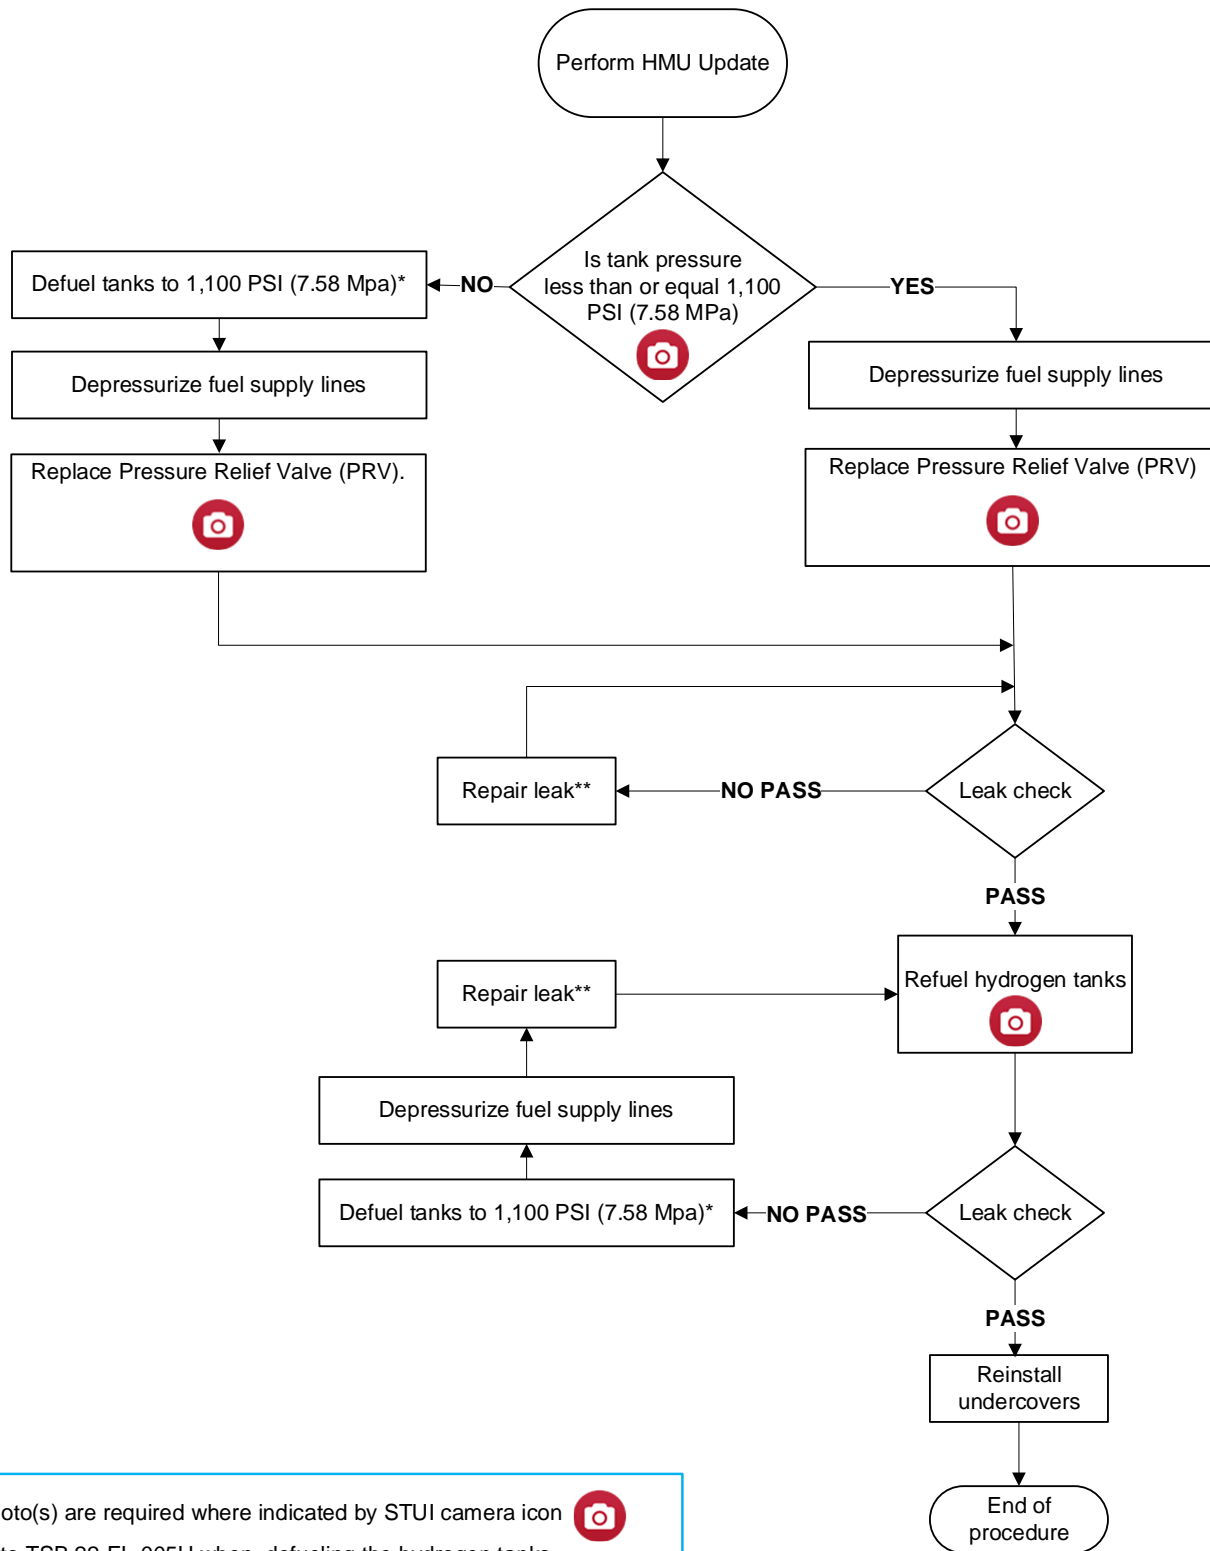
HMU Update & Pressure Relief Valve (PRV) Replacement

STUI photo(s) are required where indicated by STUI camera icon

*Refer to TSB 22-FL-005H when defueling the hydrogen tanks

**Refer to shop manual to perform leak check and repair leaks

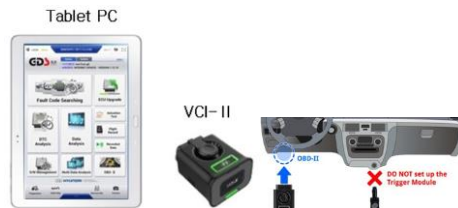
Connect the VCI-II into the vehicle's driver side instrument panel OBD-II port and verify the device is operational.

Do not set up the trigger module.

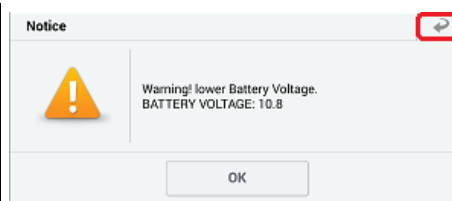
6. If the low battery warning message appears, then select the BACK arrow

and run the fuel cell to ensure the battery is adequately charged for the update.

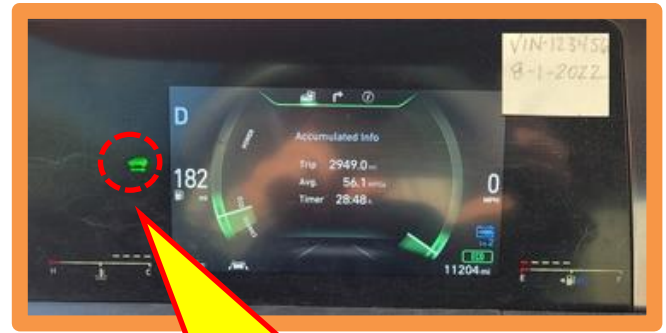
- Place the vehicle in **READY** mode using the **START / STOP** push button. Photograph the fuel gauge level and a paper showing the last **6 digits** of the VIN or RO #, and the date of defueling. Similar to the photo to the right.

Using **STUI**, photograph the fuel gauge. Include in the photos a piece of paper containing the last **6 digits** of the VIN or the RO #, and the date of the defueling. Ensure the photo is in focus and captures the fuel gauge display, odometer, and note. Upload the photo to **STUI**.

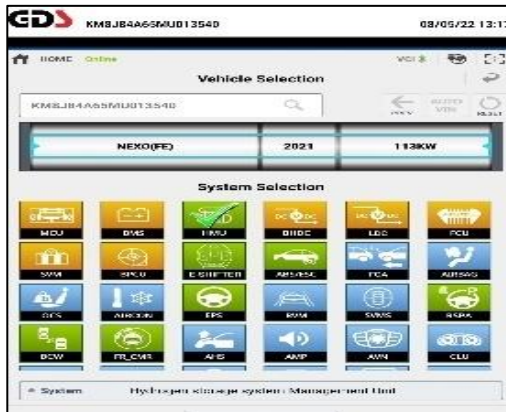
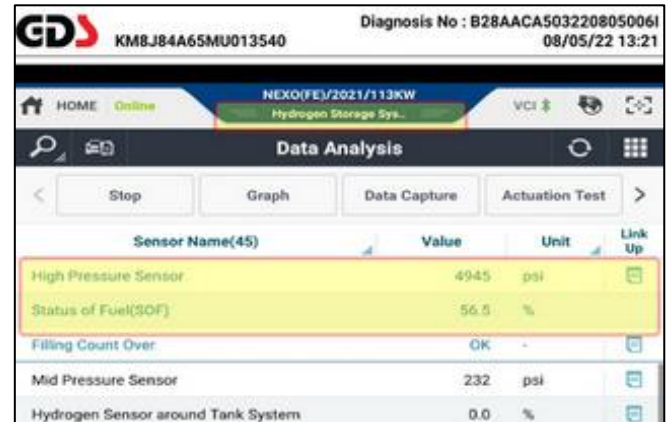
- Connect the GDS-M, select the **HMU**, and then confirm the storage tank pressure.

- If storage tank pressure is **less than or equal to 1,100 PSI**, then deplete residual fuel supply pressure by referring to **TSB 22-FL-005H—VENTING NEXO FUEL CELL ELECTRIC VEHICLES** or the latest version.
- If storage tank pressure is **greater than 1,100 PSI**, then defuel storage tanks to less than 1,100 PSI and deplete residual fuel supply pressure by referring to **TSB 22-FL-005H—VENTING NEXO FUEL CELL ELECTRIC VEHICLES** or the latest version.

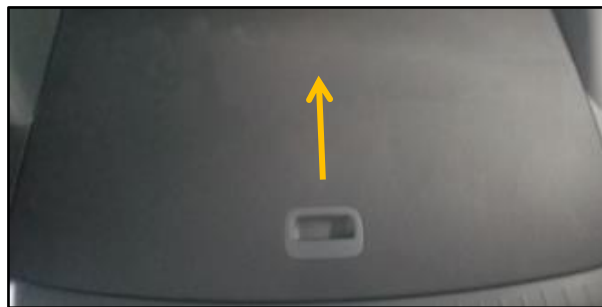
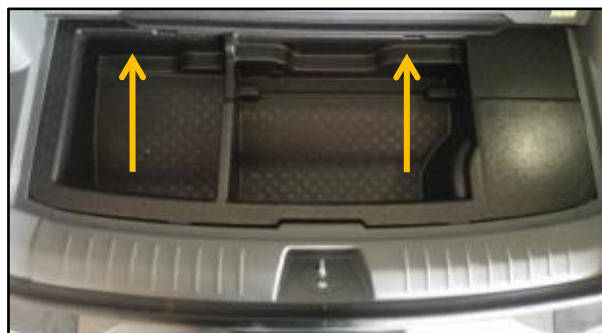
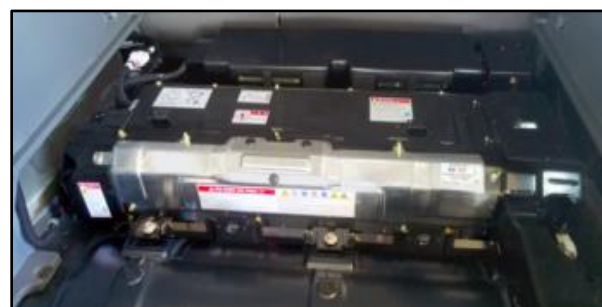
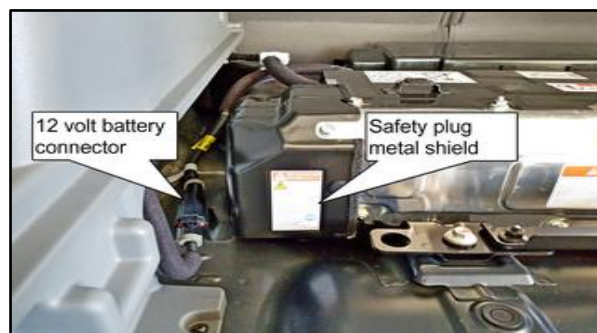
1. In the rear cargo area, remove the floorboard and cargo tray to access the 12 volt battery connector and high voltage battery Safety Plug.

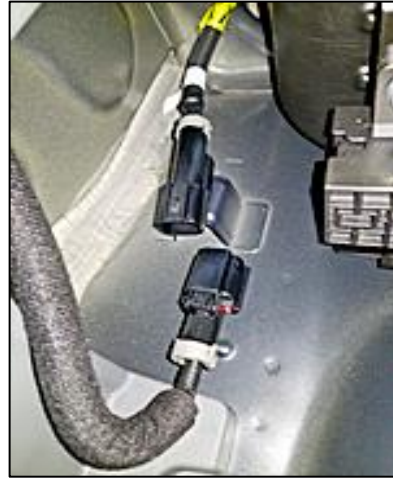
2. Disconnect the 12 volt battery negative (-) connector.

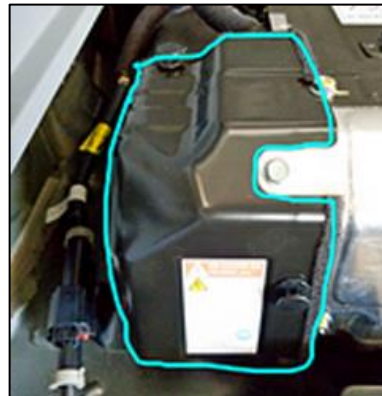
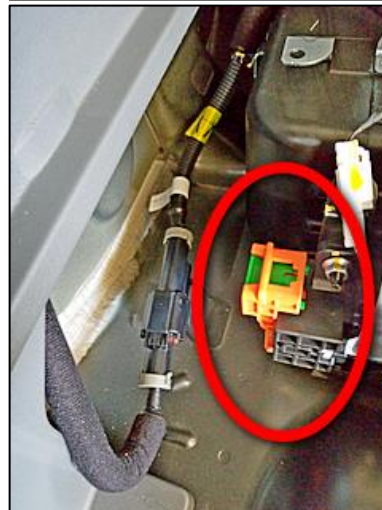
3. Remove the metal shield to access the High Voltage Safety Plug.

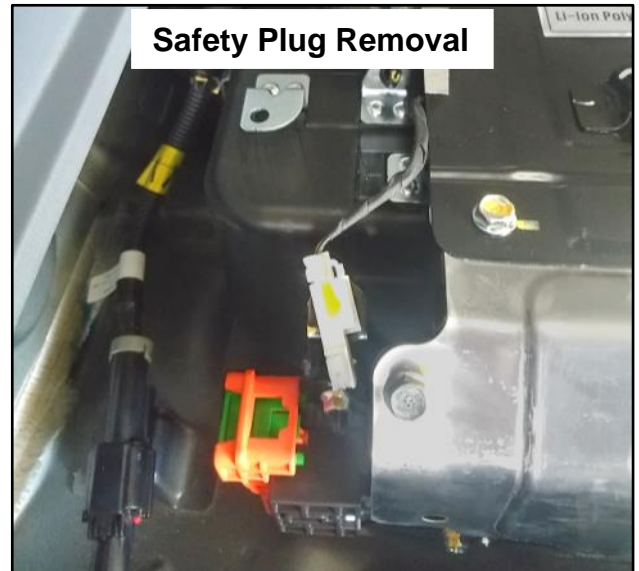
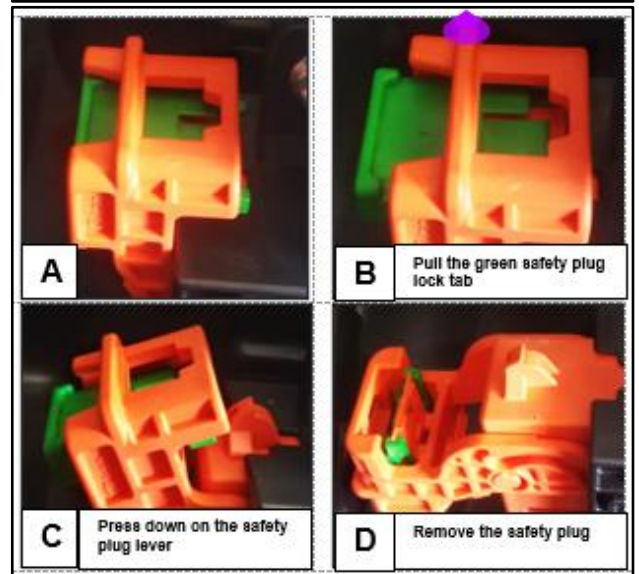
4. Follow A-D below to remove the orange high voltage safety plug.
Store the removed safety plug in a secure location outside and away from the vehicle.

5. Wait 5+ minutes to allow the high voltage system capacitor to discharge.

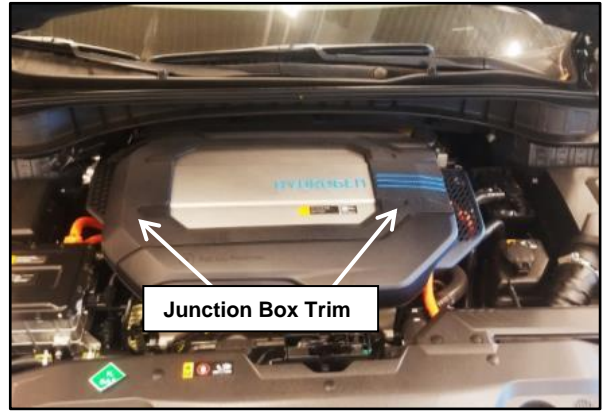
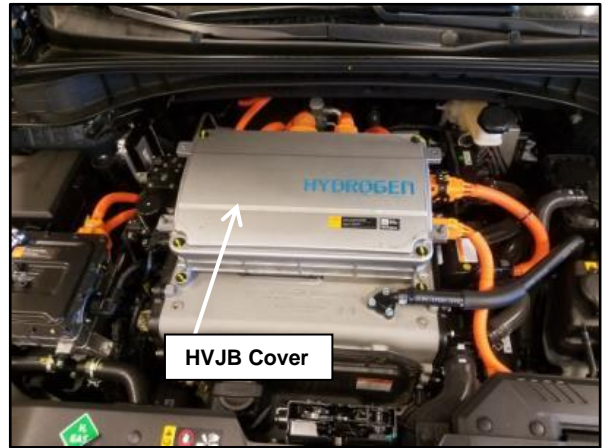
- Open the hood. Remove the junction box trim and cover.

High voltage junction box cover: Assembly bolt torque 7.2~8.7lb-ft (1.0 ~ 1.2 kgf.m, 9.8 ~ 11.8 N.m)

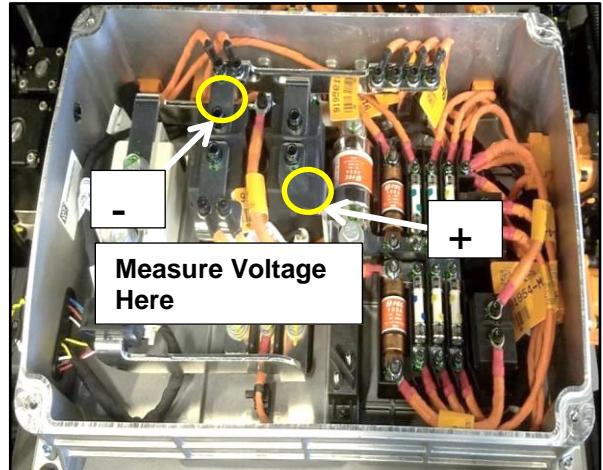
- Using a Digital Volt Ohm Meter (DVOM), measure the voltage across the inverter positive and negative bus bar terminals to inspect for capacitor discharge. If the measured voltage is below 30 volts, the High Voltage Circuit is properly shut down.

- Electrocution hazard - The High Voltage Junction Box (HVJB) may be electrically energized up to 450 volts.

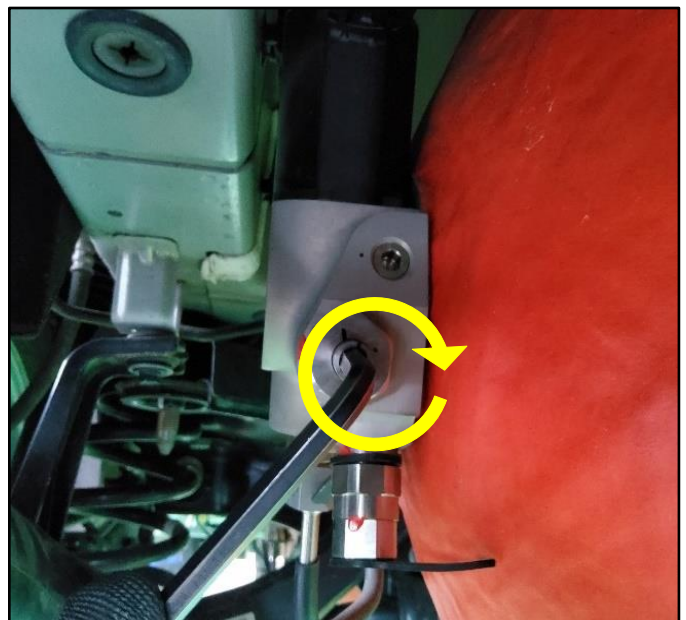
8. Close the manual valves on all **3** hydrogen tanks.
Using a **6mm** Allen wrench turn the manual valve clockwise until it stops.

Closing Torque:

3.6 ~ 7.2 lb-ft (4.9 ~ 9.8 Nm)

- Some components of the manual valve may be damaged if over-torqued.

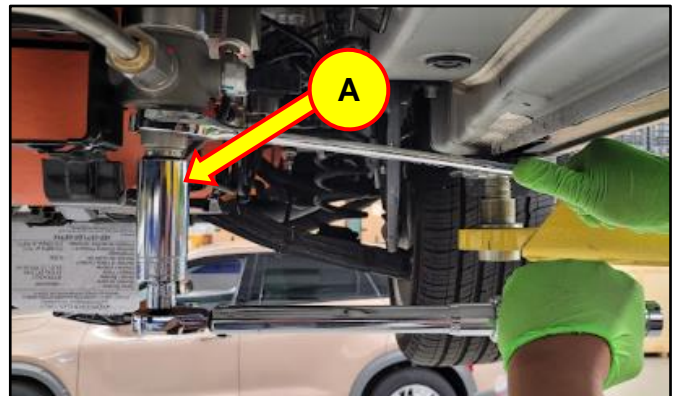
9. Remove the pressure relief valve (PRV) (A) using a 24mm socket & ratchet. Turn the PRV counterclockwise to remove. Use a 32mm wrench to hold the Regulator while removing the PRV.

- Be careful not to damage the fuel supply tube and regulator mounting bracket.

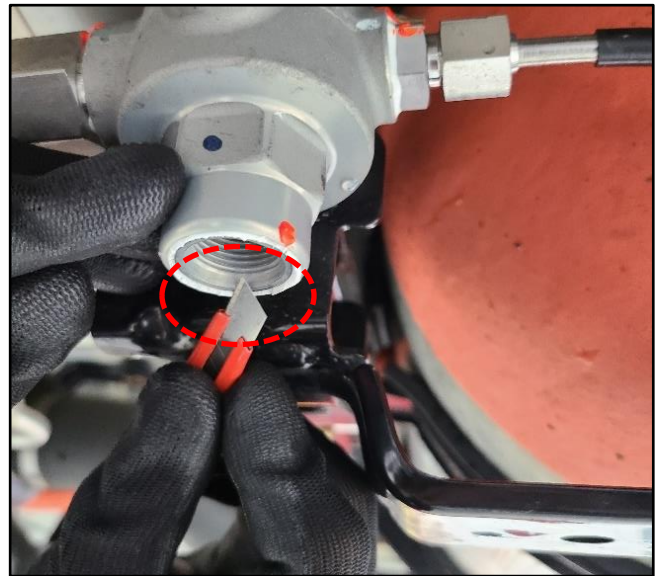
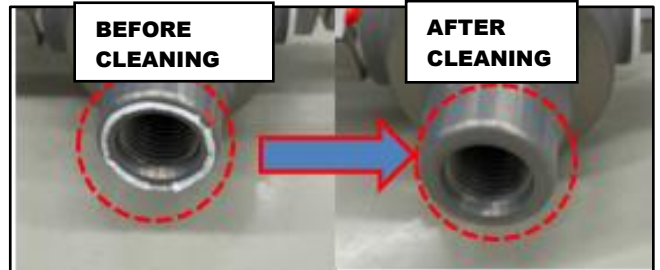
10. Remove the PRV sealant using a razor blade.

- Ensure work area cleanliness to prevent foreign substances from entering the PRV openings to prevent clogging the PRV.
- Do not use an air gun to remove foreign substances.

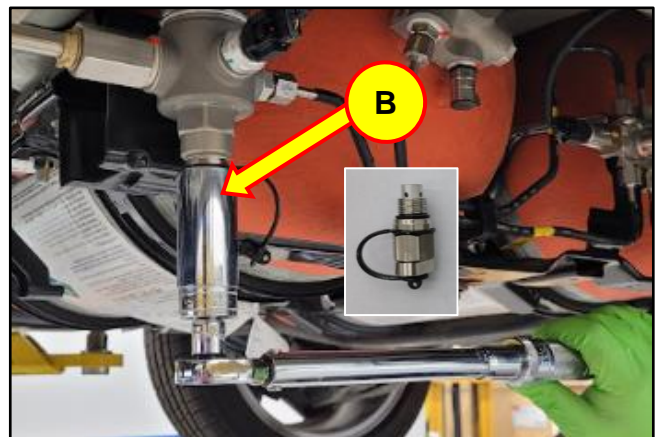
11. Install the new PRV (B) turning it clockwise.

Tightening Torque:
 54.2 ~65.8 lb-ft (73.5~89.2 Nm)

- Keep the PRV vertical during installation so that internal components will not fall out of the PRV.

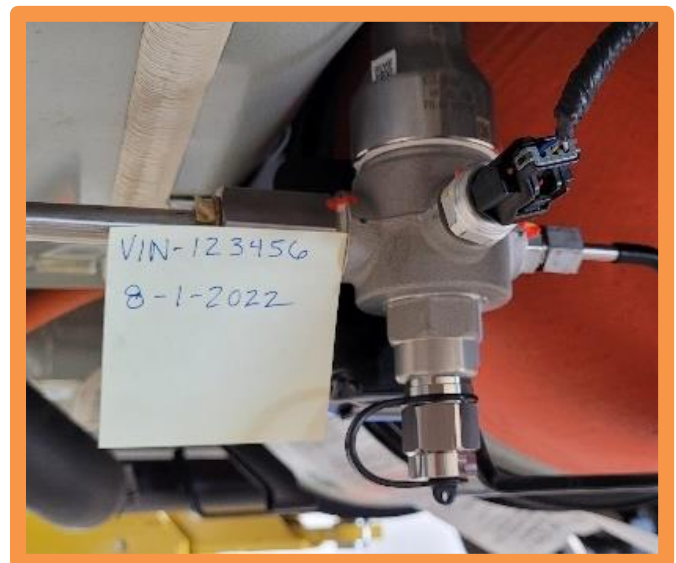
12. Before applying sealant in the next step, take a photograph of the newly installed PRV and a paper showing the last six digits of the VIN or RO #, and the date of installation. Similar to the photo to the right.

Using STUI, photograph the newly installed PRV. Include in the photo a piece of paper containing the last 6 digits of the VIN or the RO #, the date of the installation. Ensure the PRV, and note are captured and in focus. Upload the photo to STUI.

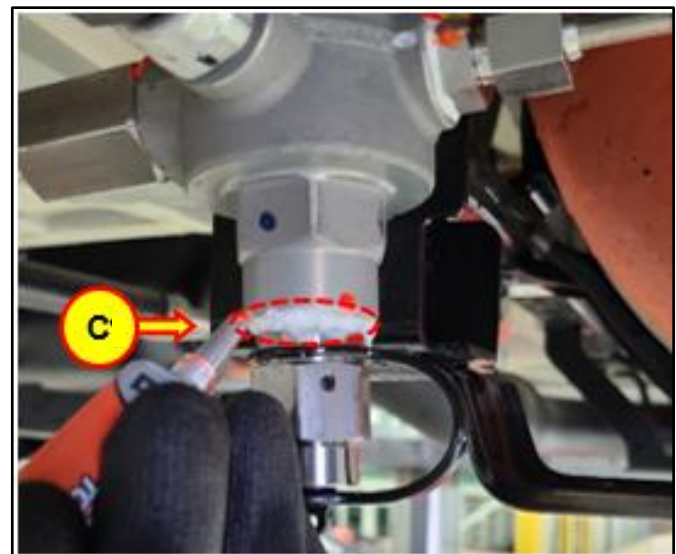
13. Apply the sealant (C) between the PRV and the body of the high-pressure regulator.

- Use gas detector or Snoop liquid leak detector to test if there is any gas leakage.
- Do not apply Snoop liquid on the part where the sealant is applied.
- If there is any leakage on the part where the sealant is applied, the sealant may inflate.
- Apply the sealant by using the nozzle included in the box.

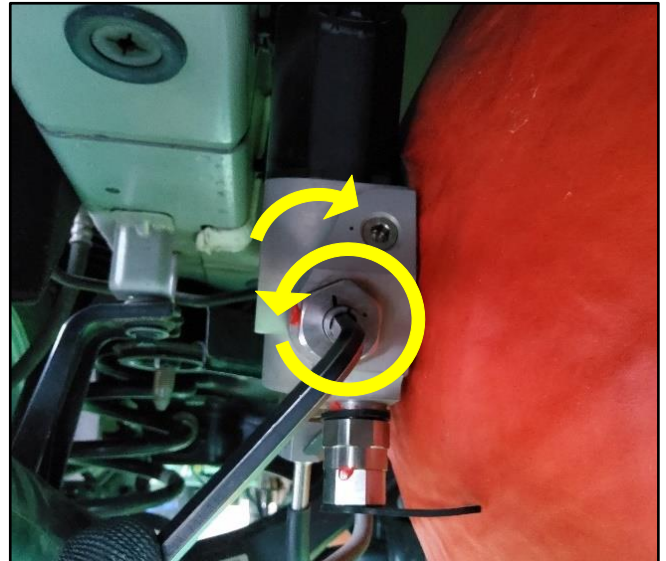
14. Open the manual valves on all **3** hydrogen tanks.
Using a **6mm** Allen wrench turn the manual valve counter-clockwise until it stops then rotate manual valve one half turn clockwise.

Opening Torque:

3.6 ~ 7.2 lb-ft (4.9 ~ 9.8 Nm)

- Some components of the manual valve may be damaged if over-torqued.

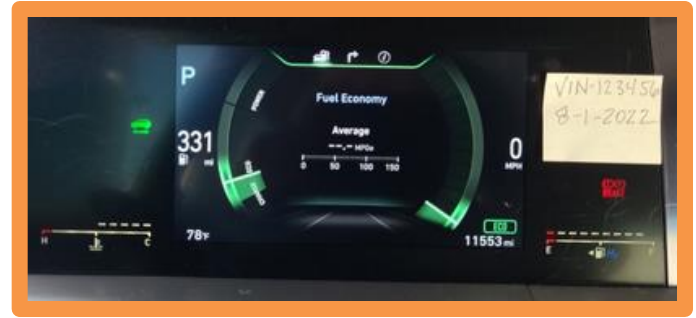
18. After refueling the vehicle, use the Push Button Start Stop (PBSS) switch and place the vehicle systems into the READY mode. Photograph the fuel level gauge and a paper showing the last six digits of the VIN or RO #, and the date of refueling. Similar to the photo to the right.

Using STUI, photograph the fuel gauge. Include in the photo a piece of paper containing the last 6 digits of the VIN or the RO #, the date of the refueling. Ensure the fuel gauge display, odometer, and note are captured and in focus. Upload the photo to STUI.
