Service Bulletin

Bulletin No.: 22-NA-210

Subject: Broken Ground Stud on LM2 Light Duty Trucks

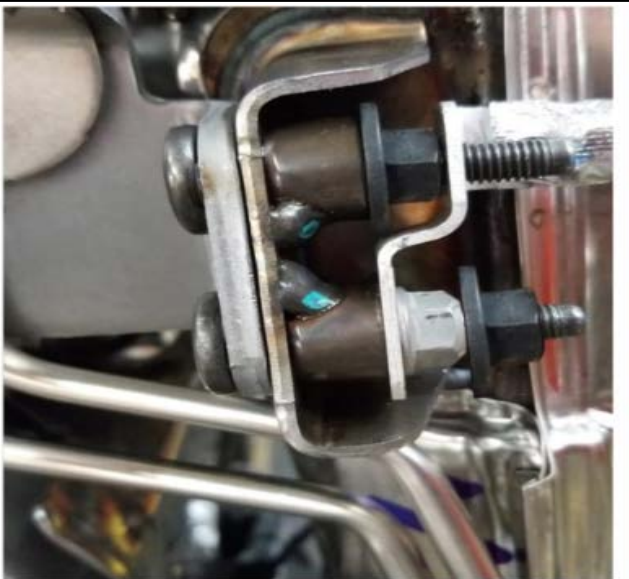
Involved Region or Country	North America		
Condition	Some technicians may find that the stud at the G134 location is broken.		
Cause	This condition may be caused by vibration fatigue.		
Correction

<p style="text-align: right;">6340661</p> <p>Note: The graphic depicts the location of the ground and stud.</p> <ol style="list-style-type: none"> 1. Replace the NOx catalyst with the broken stud. Refer to the Service Procedure. 2. Install nut (P/N 11610091) and torque to 26 Nm (53 in lbs). 3. Install the ground strap. 4. Install second nut (P/N 11546441) and torque to 26 Nm (53 in lbs).
