MAS003405 RU 23-13

## Rapid Update 578 Grecale – Door Button Loose

DATE: APRIL 18 2023

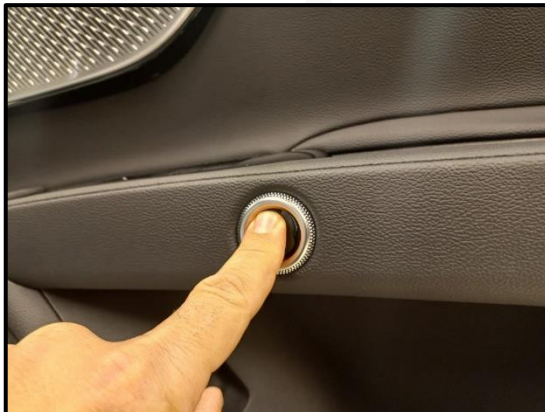
1. Always check ModisCS+ to see if the vehicle is involved in this action and if it has not been previously performed.
2. Check the functionality of the interior door open buttons for all 4 doors by performing 5 opening/closing cycles for each door.

- **OK** -> buttons remain secure to the ring plates and the door opening command works well for each cycle. Procedure complete. No other actions required.

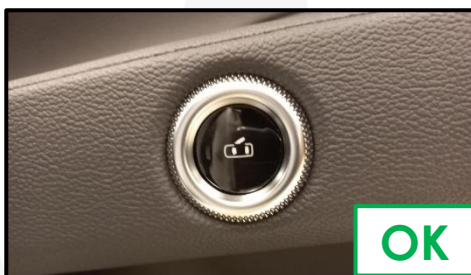
- **NOT OK** -> Push button detached partially from the ring plate and gets stuck, or it detaches totally and falls into the door panel ► Replace the faulty component following the appropriate procedure, indicated below:

- a. 08.52.071 - RH SWITCH FRONT DOOR LOCK - Removal/refitting or replacement
- b. 08.52.072 - LH SWITCH FRONT DOOR LOCK - Removal/refitting or replacement
- c. 08.52.073 - RH SWITCH REAR DOOR LOCK - Removal/refitting or replacement
- d. 08.52.074 - LH SWITCH REAR DOOR LOCK - Removal/refitting or replacement
