MAS003505 RU 23-04

Rapid Update 608 MC20 – Rear Under Tank Frame Washers

TECHNICAL SERVICE OPERATIONS

DATE: APRIL 4 2023

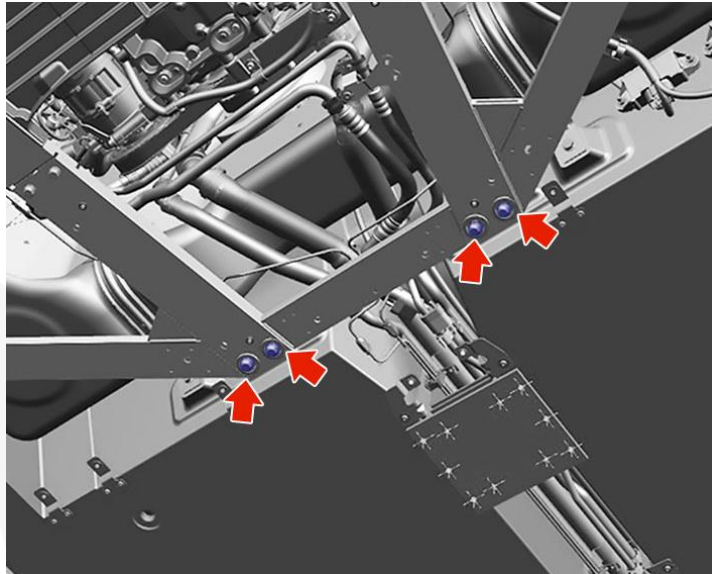
Figure 1

1. Always check ModisCS+ to see if the vehicle is involved in this action and if it has not been previously performed.
2. Safely lift the vehicle on a lift and remove the "REAR AERODYNAMIC CENTRAL COVER".
Refer to workshop procedure: **09.14.090 00 REAR AERODYNAMIC CENTRAL COVER**
3. Identify the 4 (four) screws indicated in **Figure 1**.

5. Repeat the same procedure for the 3 remaining screws indicated in **Figure 1**.
6. Restore any removed components by following the reverse procedure.
7. procedure complete.

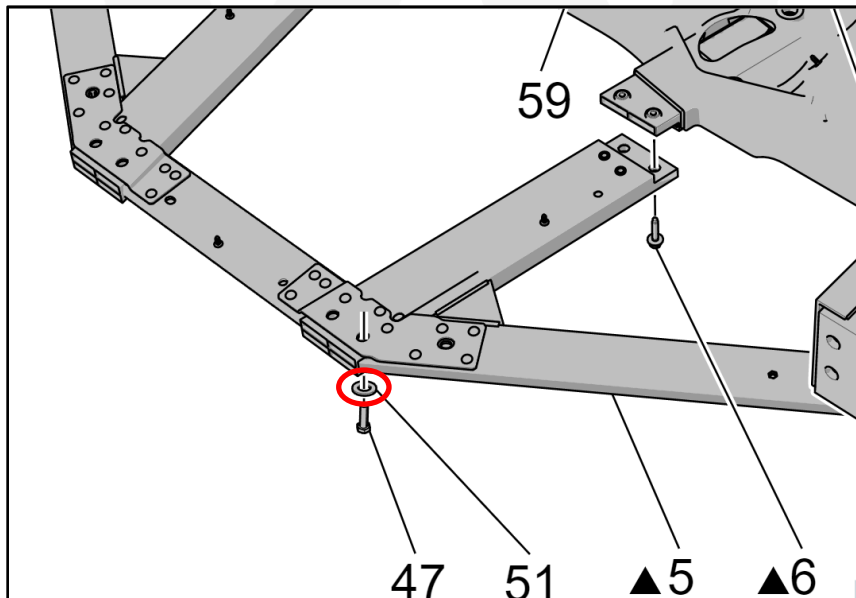
Figure 2

4. Remove one screw at a time from the frame and insert one washer for each screw (one washer per screw) (**Figure 2**). Reinstall the screw and torque it to **50Nm** (36.9 ft-lb).
