90 PSS Instrument cluster status field in driver information system is empty

90 23 26 2070448/1 May 22, 2023.

Model(s)	Year	VIN Range	Vehicle-Specific Equipment
A5, A5 Cabriolet, A5 Sportback, S5, S5 Cabriolet, S5 Sportback, RS 5, RS 5 Sportback, and Q5 e quattro	2022 – 2023	All	Analog Instrument Cluster

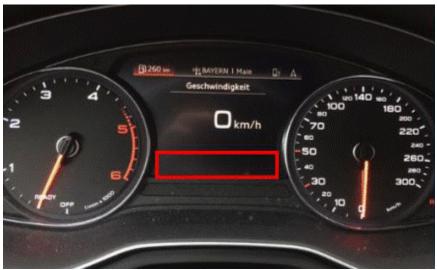
In the driver information system on the instrument cluster, content is not shown for any of the tabs (Vehicle functions, Driver messages, Radio, Media, Phone, Navigation); this issue occurs very sporadically. The area affected when the issue occurs is marked as shown (Figure 1).

Software issue in the instrument cluster.

Note: The concern is resolved after a bus sleep cycle. To perform a sleep bus cycle, turn off the ignition, lock the vehicle, and let the vehicle sit undisturbed for 10 minutes, then turn the ignition back on and check the condition again.

Explain to the customer that a solution is expected to be available by the end of the 3rd quarter of 2023 (subject to change) and that no repairs are necessary at this point. Do not replace any components for this condition since this will not resolve the customer's concern.

Create a PSS record in the PSS application through the Pending Service Solutions (PSS) link in AccessAudi (under *Related Links* >> Service).
