## STAR ONLINE PUBLICATION

**Case Number:** S2223000048 Rev. A

**Symptom/Vehicle Issue:** Heated Seat Cushion Element Inoperative

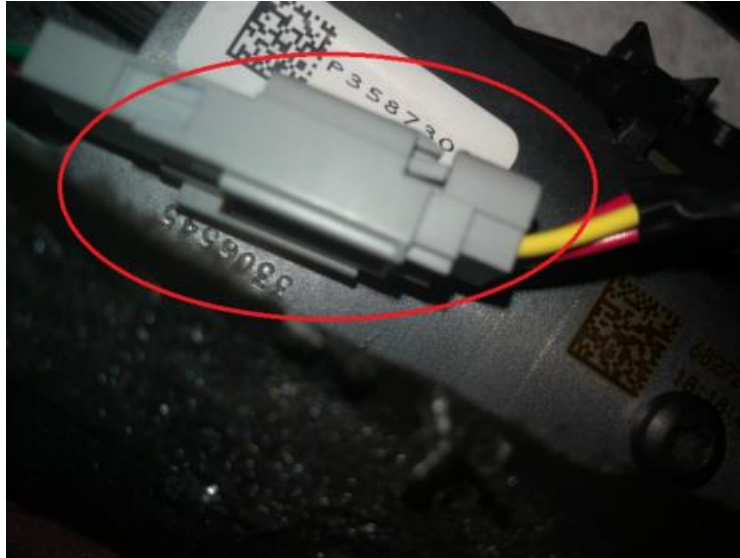
Fig 1  
Connector not fully seated.

**Discussion:** Customer may complain the seat cushion for the driver and or passenger seat is not warming. Prior to ordering replacement elements or replacing any parts, verify the connection under the seat. The connector requires an assembly method of “push, click, push, push” to ensure connection is complete. Refer to the figures below. It may not be necessary to remove the seat or disassemble to verify the connections. You may be able to access under the seat and reach the connection. If required refer to Service Library 08 - Electrical / 8G - Heated/Cooled Systems / Heated Seats / PAD, Heater Front Seat Cushion / Removal and Installation.

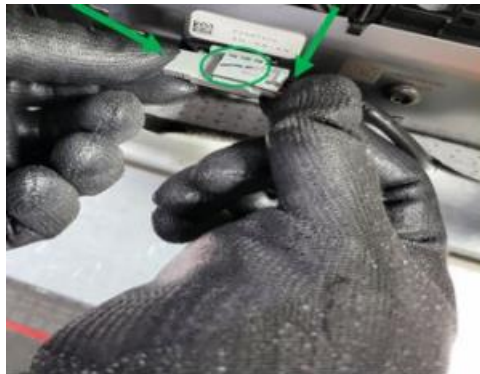
Fig 2  
Connector fully “push, click, push, push” seated.
