91 RS monitor not available in MMI

91 23 97 2070387/1 May 22, 2023.

Model(s)	Year	VIN Range	Vehicle-Specific Equipment
RS 5, and RS 5 Sportback	2021 – 2023	All	Not Applicable

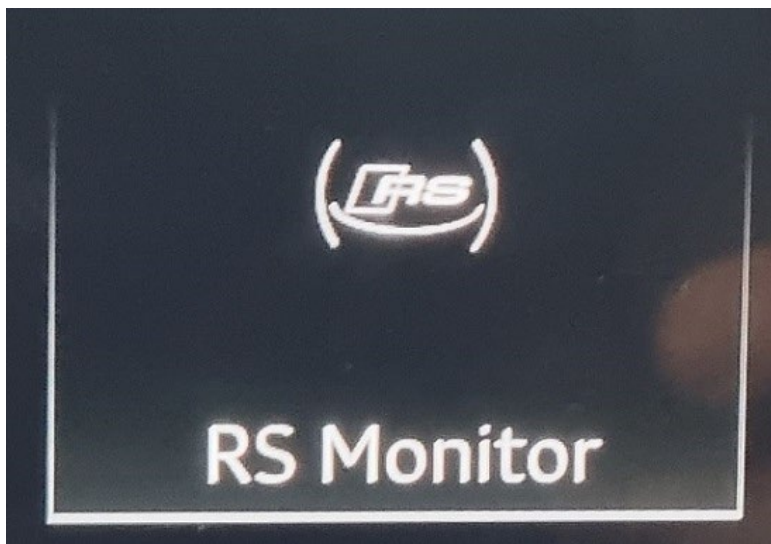
The “RS monitor” tile (Figure 1) in the MMI is only available in combination with the virtual cockpit.

Figure 1: RS Monitor tile as displayed in the MMI screen.

Please explain this to the customer.
