GROUP	MODEL
Voluntary Service Campaign	2012-2017MY Rio (UB) 2017-2018MY Forte (YD/YDm)
NUMBER	DATE
SC264 (Rev 1, 06/29/2023)	May 2023

VOLUNTARY SERVICE CAMPAIGN

APPLICATION OF ADDITIONAL ANTI-CORROSION MATERIAL (SC264)

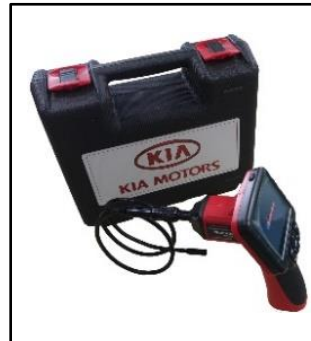
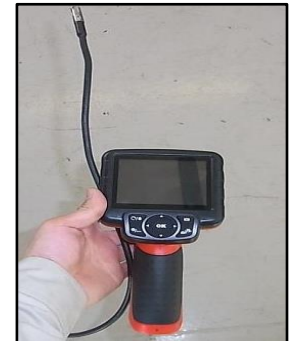
- After applying cavity wax to components, use the borescope (1K545 4D200QQK) to check for proper wax coating through the component service holes.

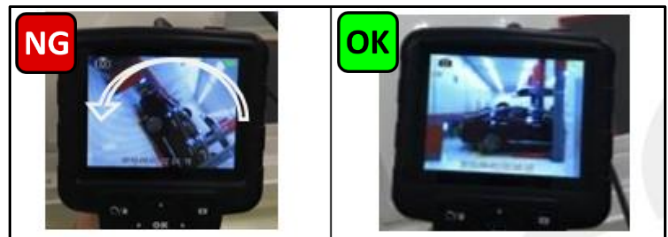
- Power up and calibrate the display orientation direction by gripping the probe and turning as required. (Apply and align the 90-degree angle adapter, as needed, for picture quality.)

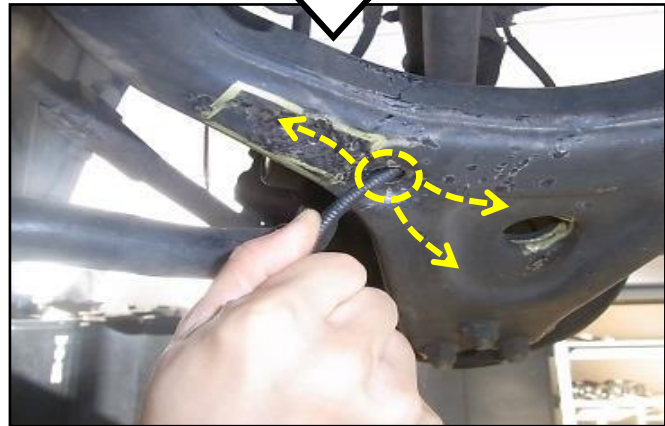
7. Rotate the camera in order to check all angles for proper wax application inside the inspected components, and to obtain your images that will be used for warranty claim submission.

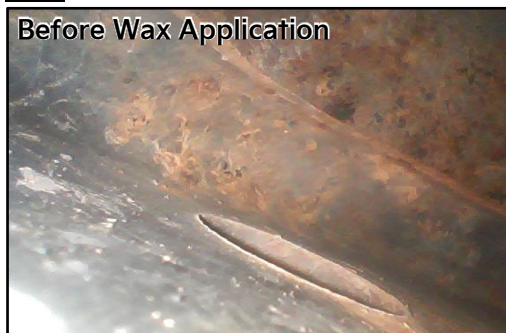
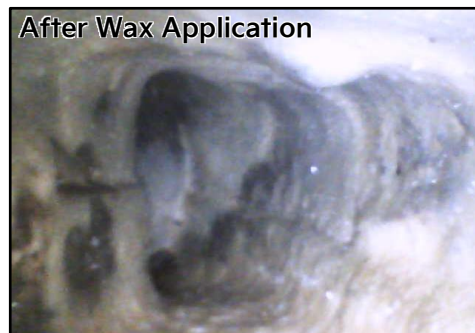
Note: See examples below of "before" and "after" wax application.

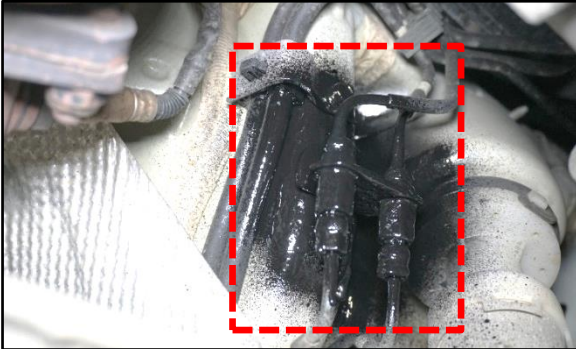
Two-way Brake Tube Connector

2. Spray undercoating on the Two-way Brake Tube Connector, Flexible Brake Hose, Fuel Tank Bands, and Parking Brake Cable Brackets.

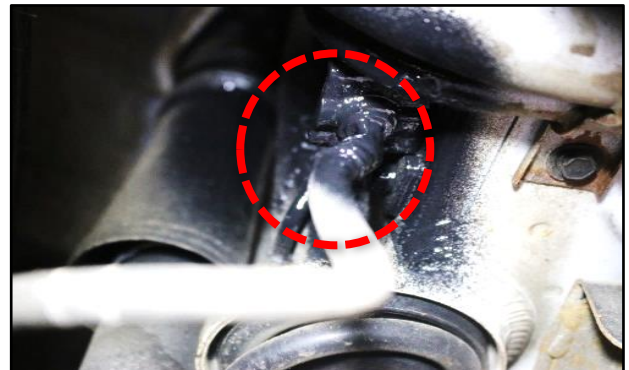
3. Be sure to completely coat the four (4) brake hose anchor clips on both sides, front and rear of the vehicle.
